# VEHICLE INSPECTION REPORT

**DK17KWZ**

## Man TGS 26.360

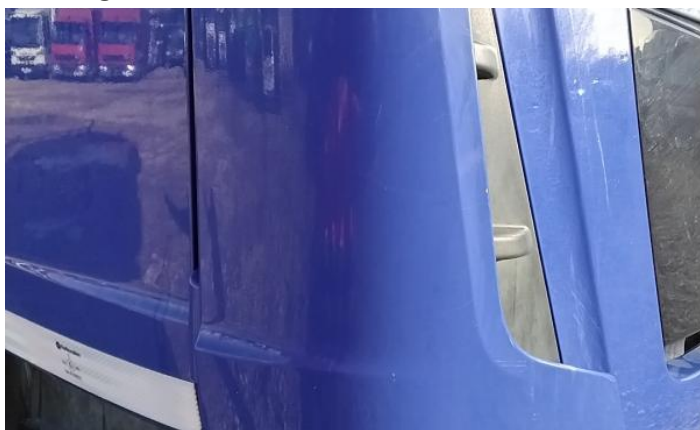
1: Wing of  
Scratched  
Over 25mm Thru Paint

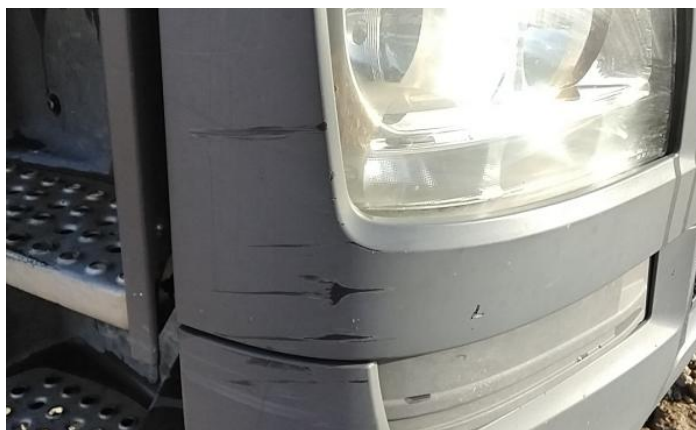
2: Fog Lamp Surround of  
Scuffed (Unpainted)  
Over 100mm

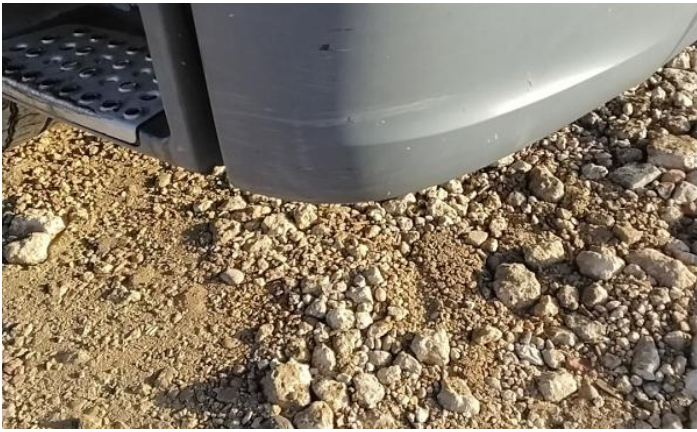
3: Bumper Front Moulding  
Scuffed (Unpainted)  
Over 100mm

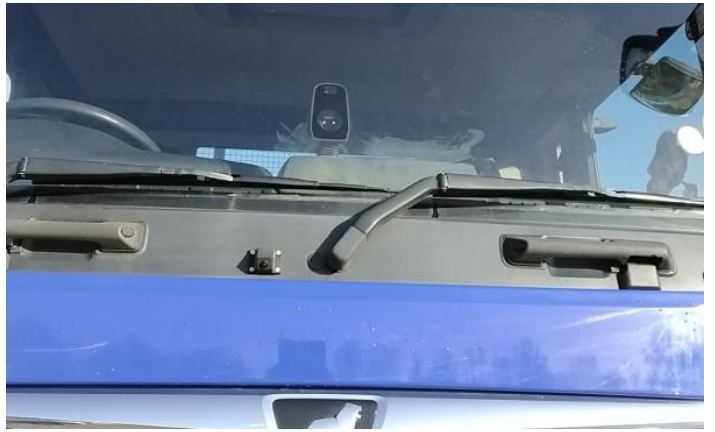
4: Screen Front  
Chipped  
UpTo 10mm

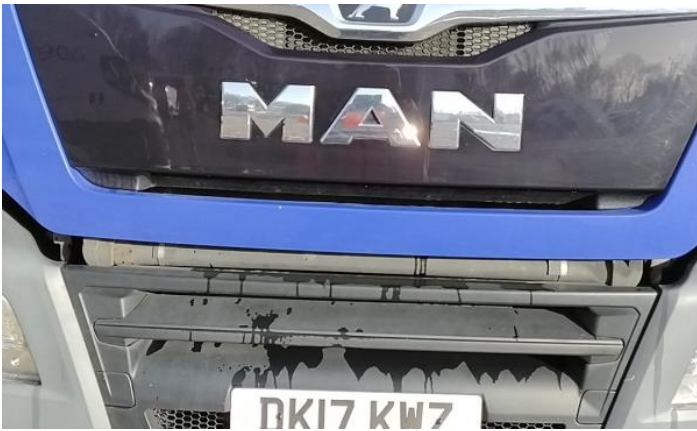
5: Bonnet  
Chipped  
Multiple Chips

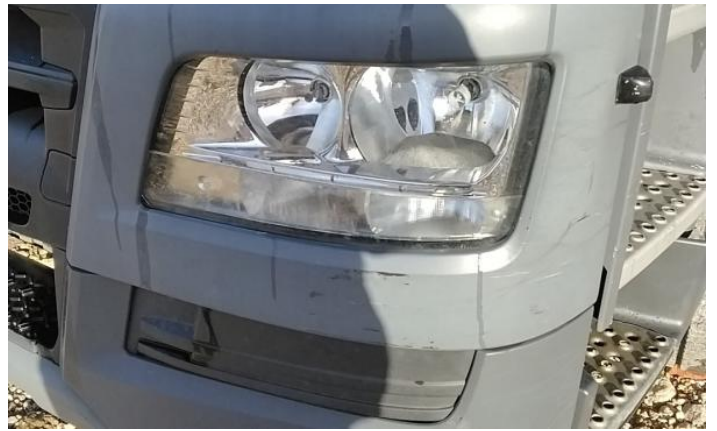
6: Fog Lamp Surround ns  
Scuffed (Unpainted)  
Over 100mm

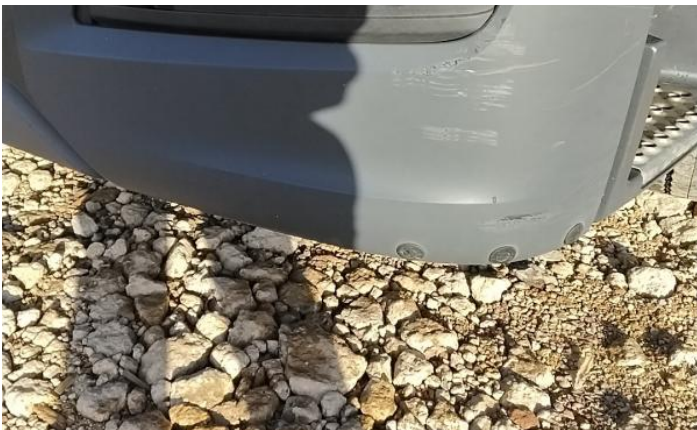
7: Bumper Front Moulding  
Scuffed (Unpainted)  
Over 100mm

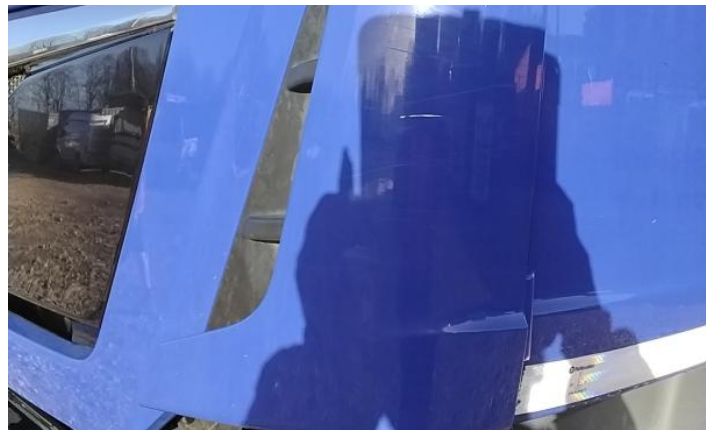
8: Wing nsf  
Scratched  
Over 25mm Thru Paint

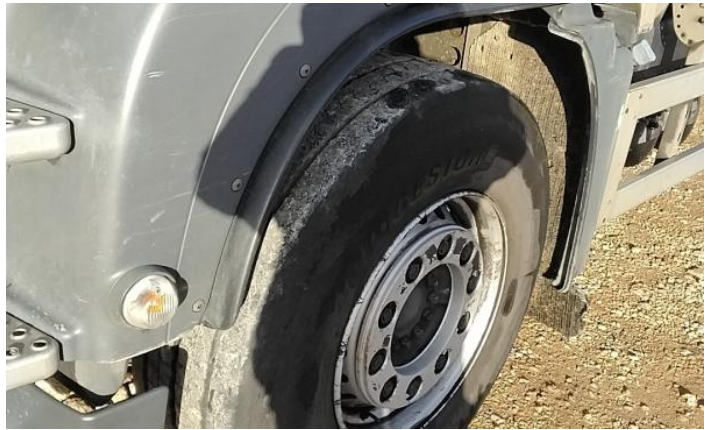
10: Wing Front Arch Extension ns  
Scuffed (Unpainted)  
Over 100mm

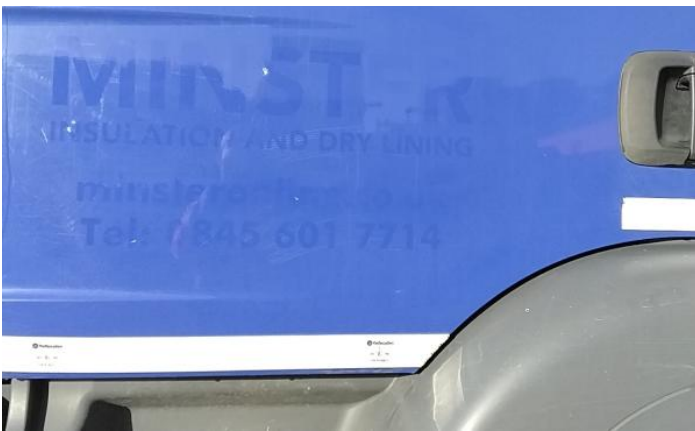
11: Door nsf  
Scratched  
Over 25mm Thru Paint

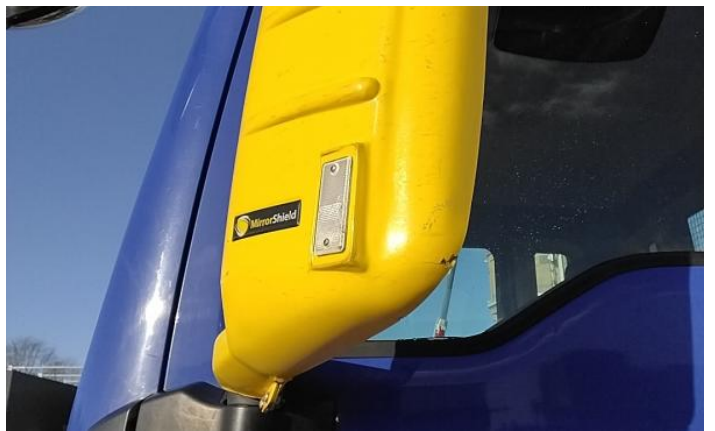
12: Door Mirror Assy nsf  
Broken  
Replace

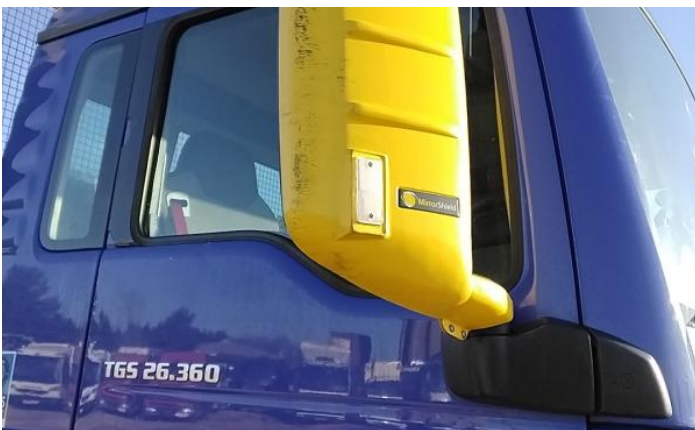
13: Door Mirror Assy osf  
Scratched (Painted)  
Over 25mm Thru Paint

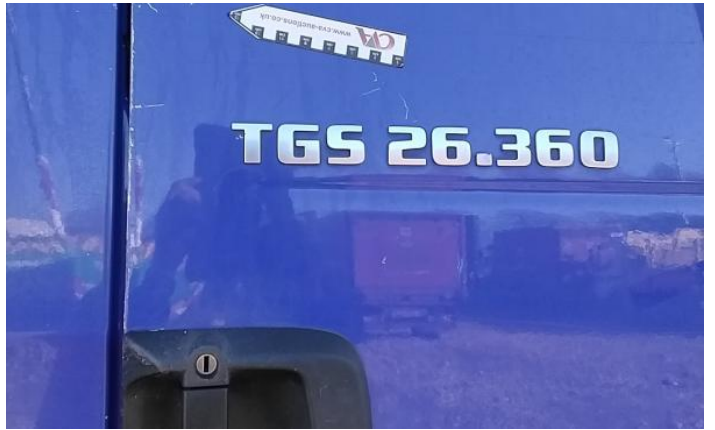
16: Door osf  
Scratched  
Over 25mm Thru Paint

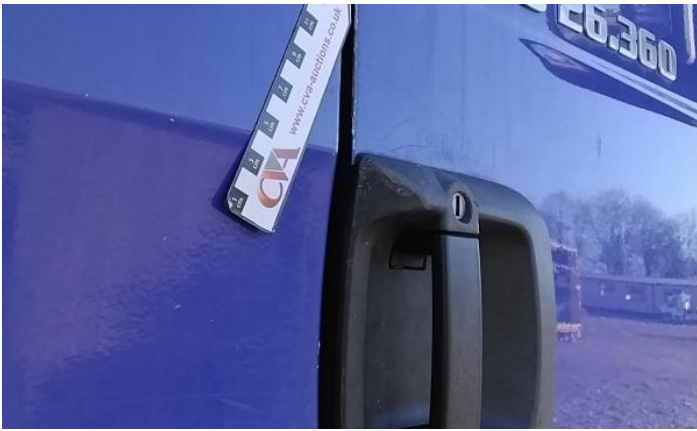
17: Door osf  
Chipped  
Edge Chip

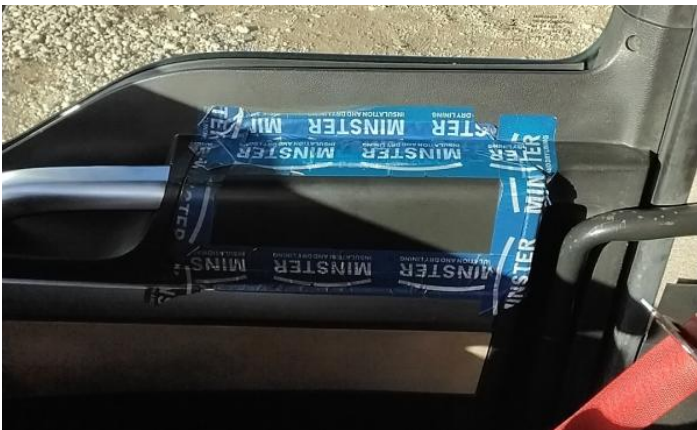
19: Door Pad osf  
Broken  
Replace
