# VEHICLE INSPECTION REPORT

**PK71JFO**

## Fiat Ducato 2.3

VIN ZFA25000002S96215

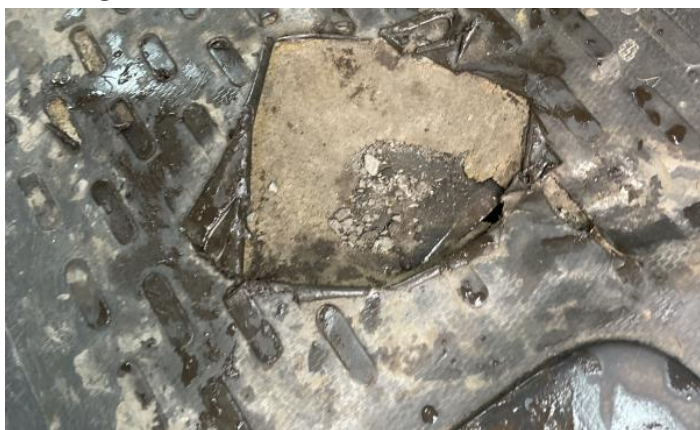
1: Carpets Front  
Torn  
Over 10mm

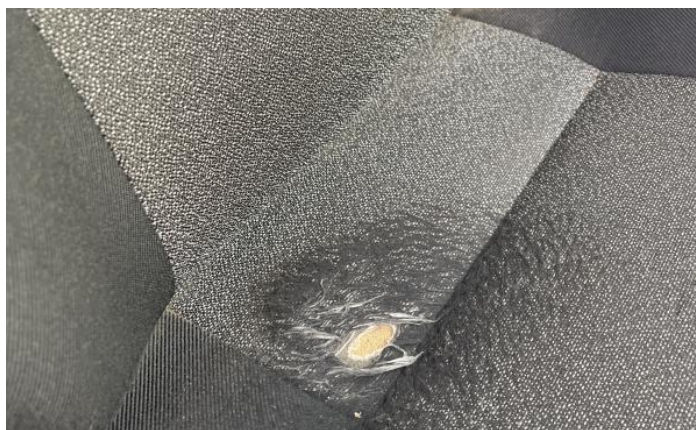
2: Seat Base Cover osf  
Torn  
Over 3mm

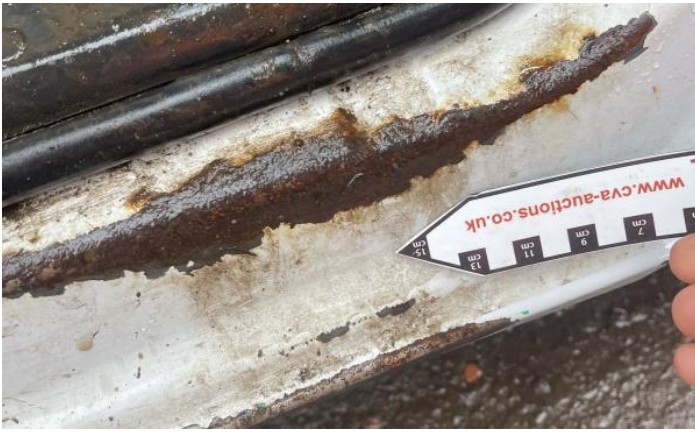
3: Sill os  
Rusted  
Over 5mm

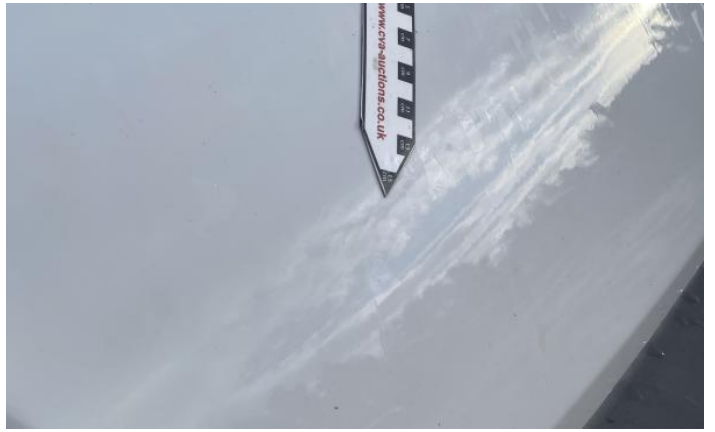
4: Bonnet  
Dented  
Over 2 UpTo 10mm

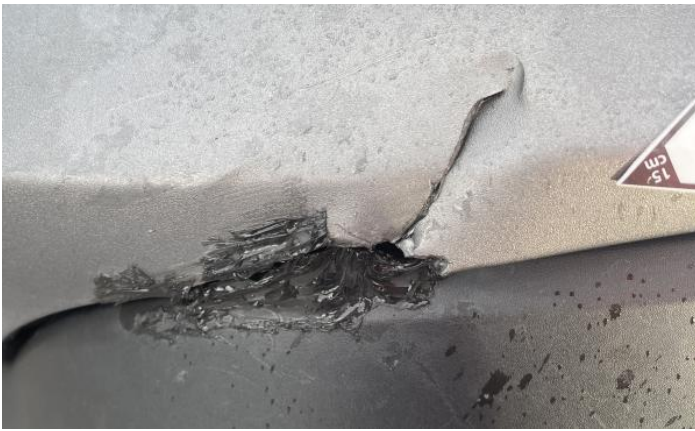
5: Bumper Front Moulding  
Broken  
Replace

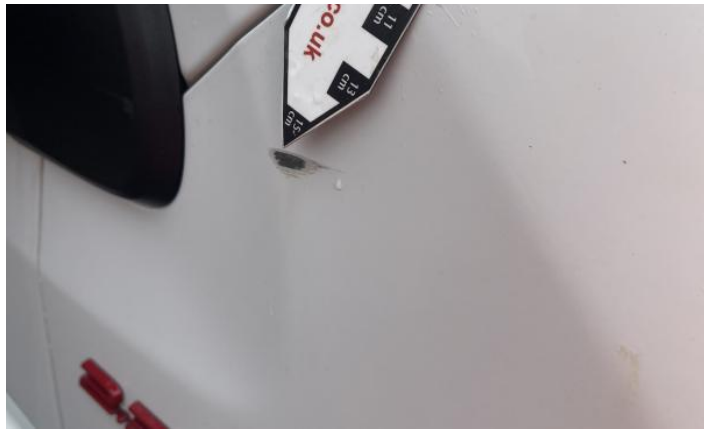
6: Wing osf  
Dented  
With Paint Damage

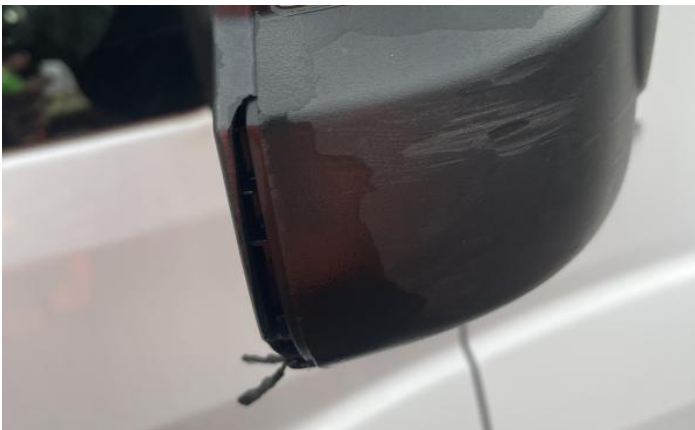
7: Door Mirror Assy osf  
Broken  
Replace

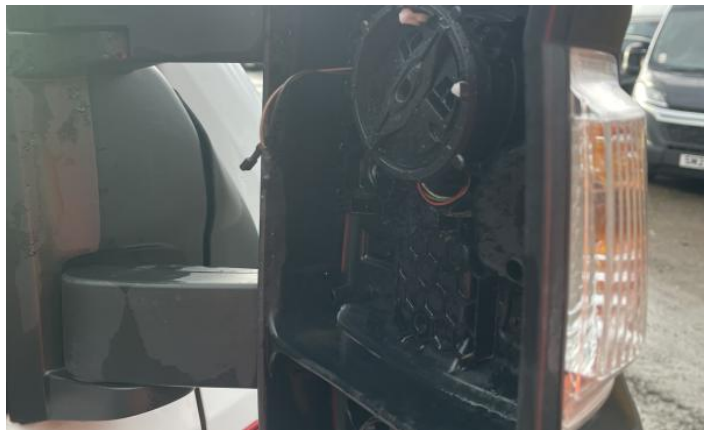
8: Door Mirror Glass os  
Missing  
Replace

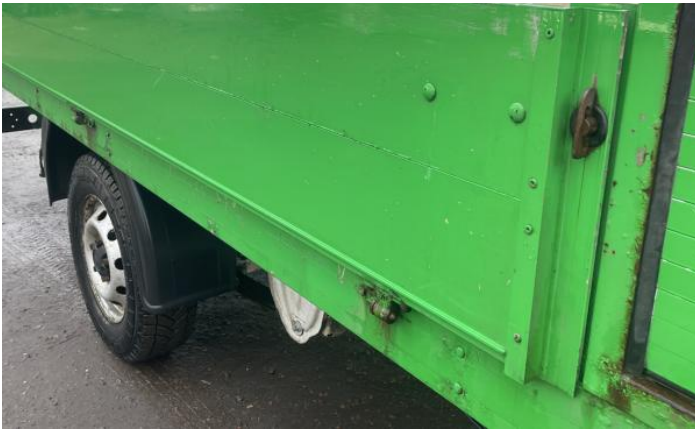
9: Qtr Panel osr  
Rusted  
Over 5mm

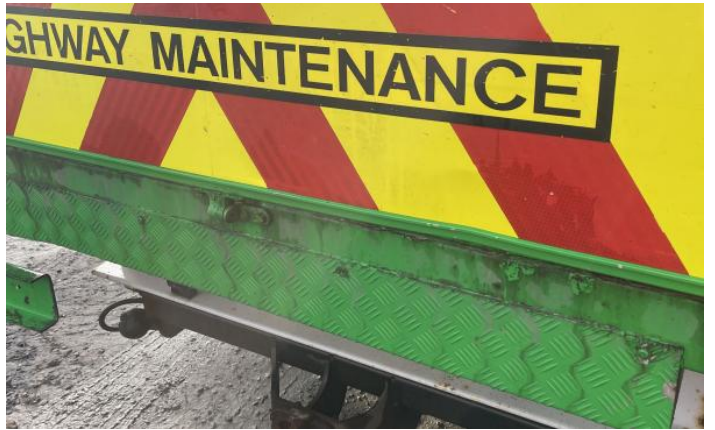
10: Tailgate  
Rusted  
Over 5mm

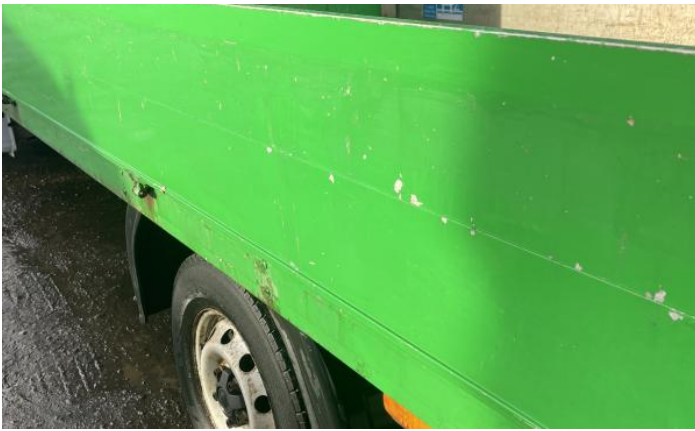
11: Qtr Panel nsr  
Dented  
With Paint Damage

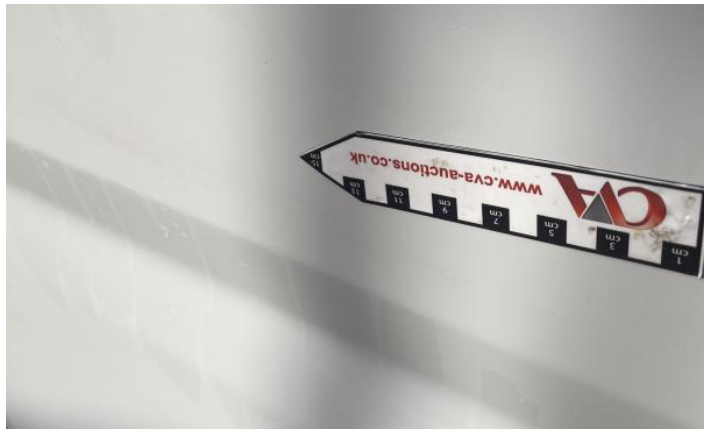
12: Door nsf  
Dented  
Over 30mm

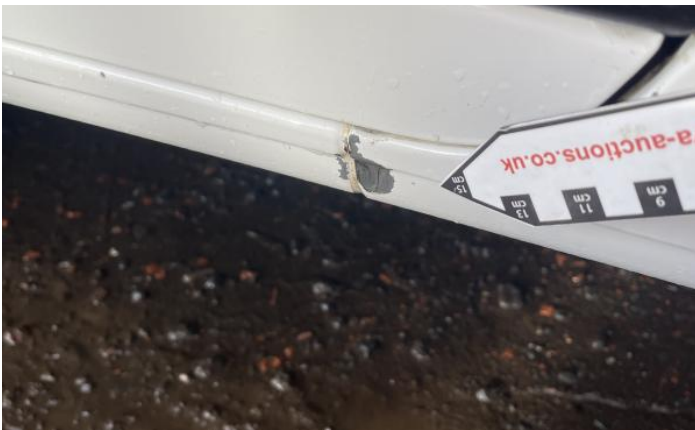
13: Sill ns  
Rusted  
Over 5mm

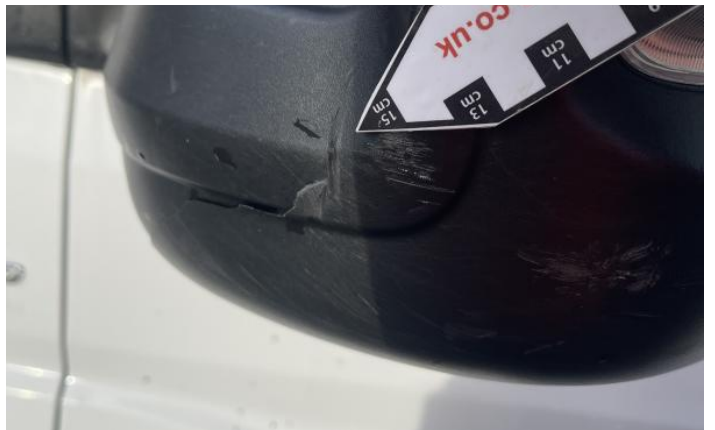
14: Door Mirror Assy nsf  
Broken  
Replace

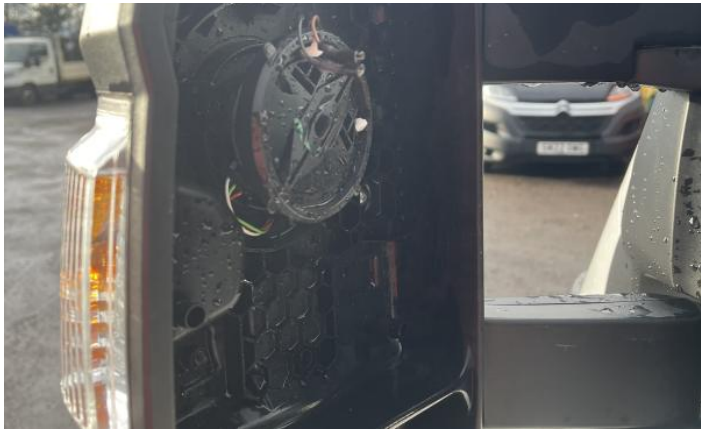
15: Door Mirror Glass ns  
Missing  
Replace
