# VEHICLE INSPECTION REPORT

**MJ67YMH**

## Daf CF 230

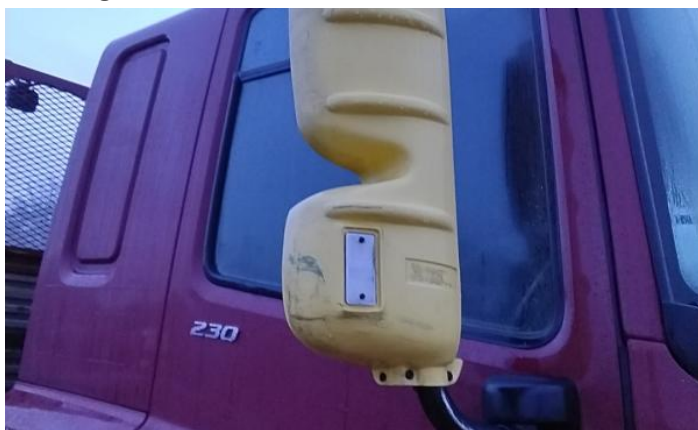
1: Door Mirror Assy osf  
Scratched (Painted)  
Over 25mm Not Thru Paint

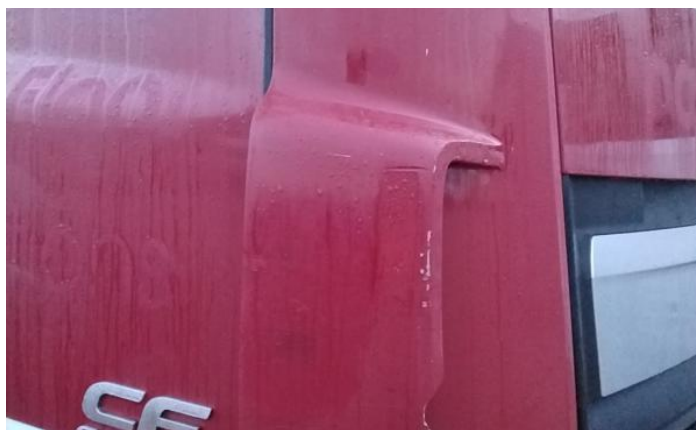
2: Wing osf  
Cracked  
Replace

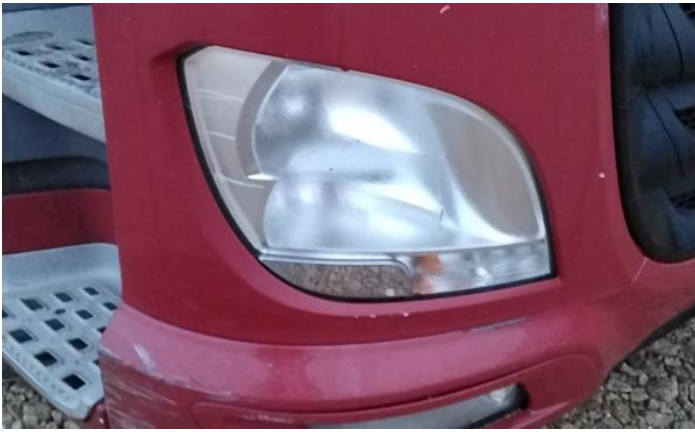
3: Fog Lamp Surround os  
Scratched (Painted)  
Over 25mm Thru Paint

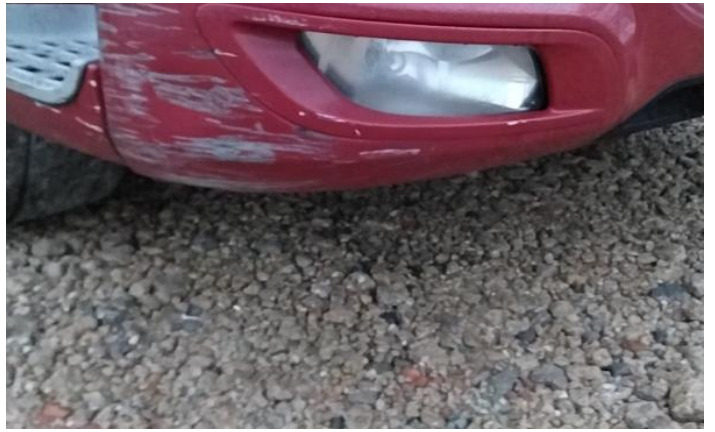
4: Bumper Front Moulding  
Scratched (Painted)  
Over 25mm Thru Paint

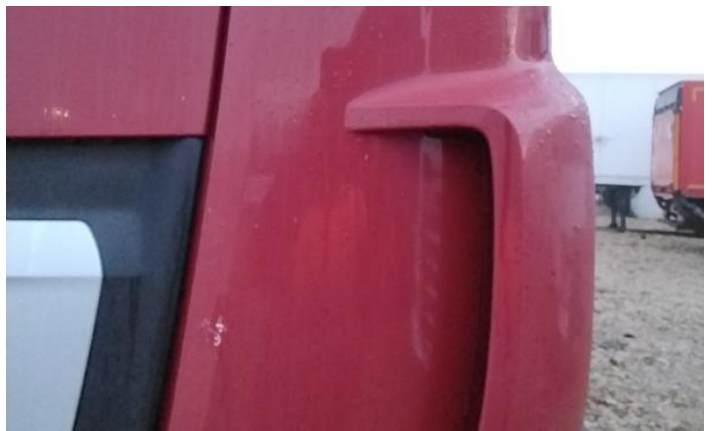
5: Bonnet  
Chipped  
Multiple Chips

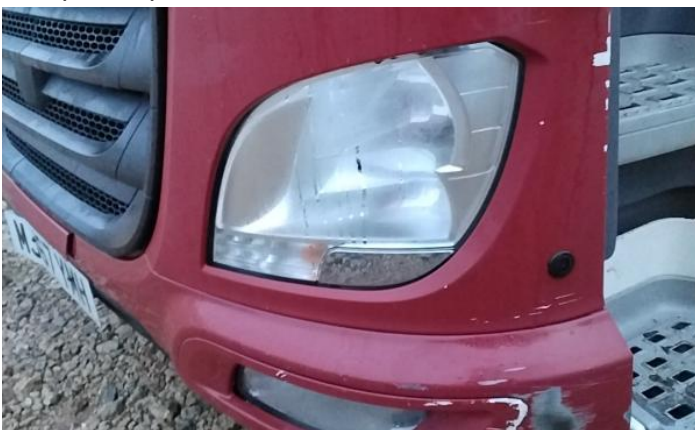
6: Wing nsf  
Chipped  
Multiple Chips

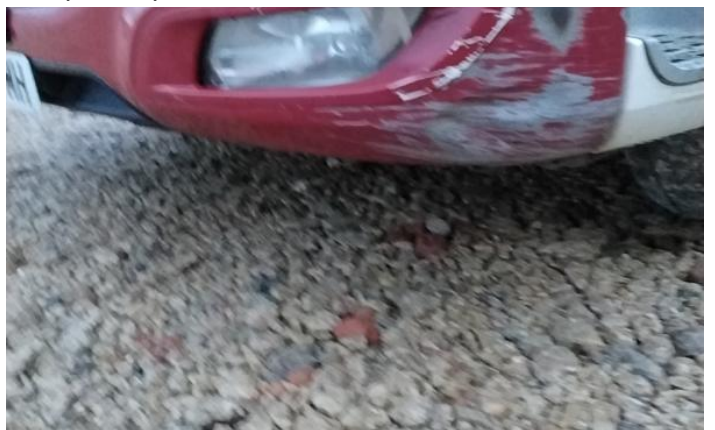
7: Fog Lamp Surround ns  
Scratched (Painted)  
Over 25mm Thru Paint

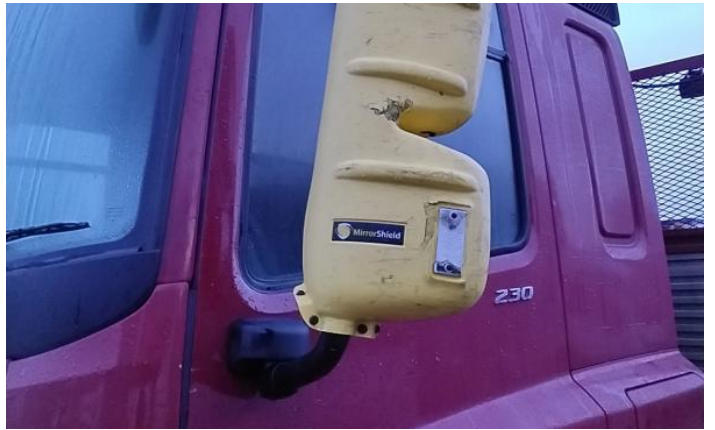
10: Door Mirror Assy nsf  
Broken  
Replace

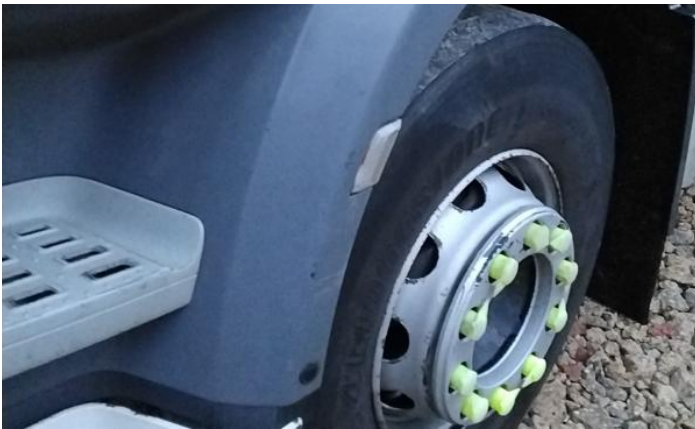
11: Wing Front Arch Extension ns  
Scuffed (Unpainted)  
Over 100mm

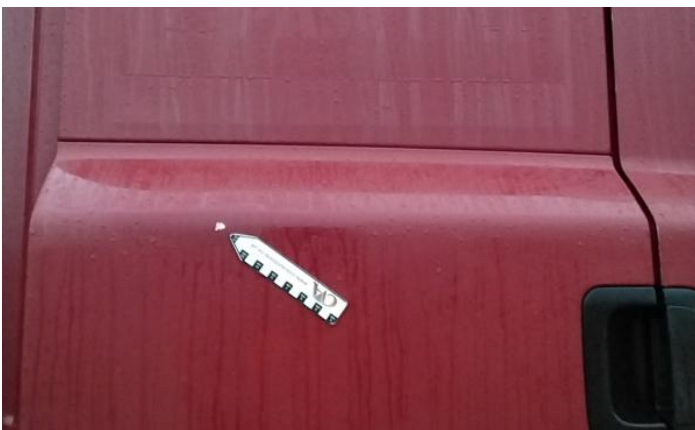
13: Qtr Panel osr  
Scratched  
UpTo 25mm Thru Paint
