# VEHICLE INSPECTION REPORT

**PG66UFA**

## Daf CF 440

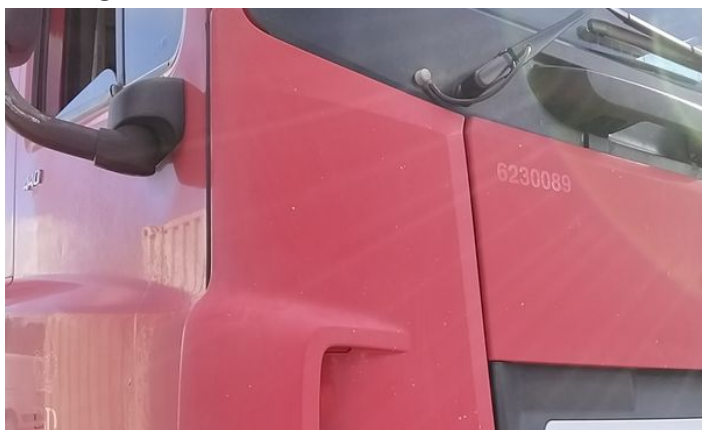
1: Wing osf  
Chipped  
Multiple Chips

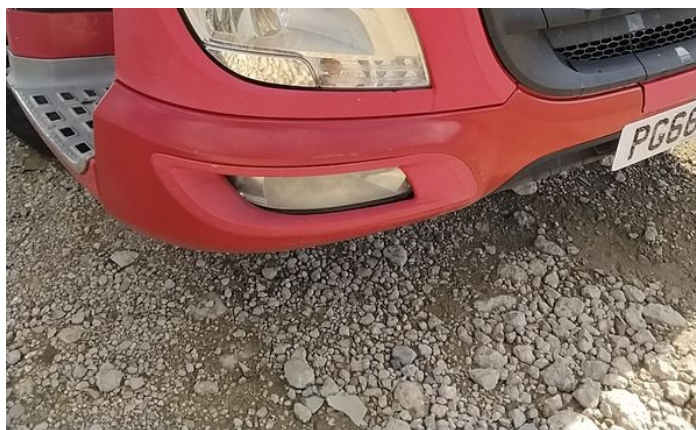
2: Fog Lamp Surround os  
Scratched (Painted)  
UpTo 25mm Thru Paint

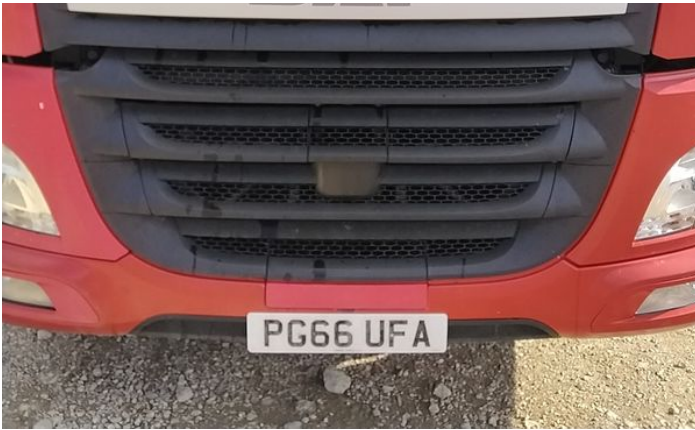
3: Bonnet  
Chipped  
Multiple Chips

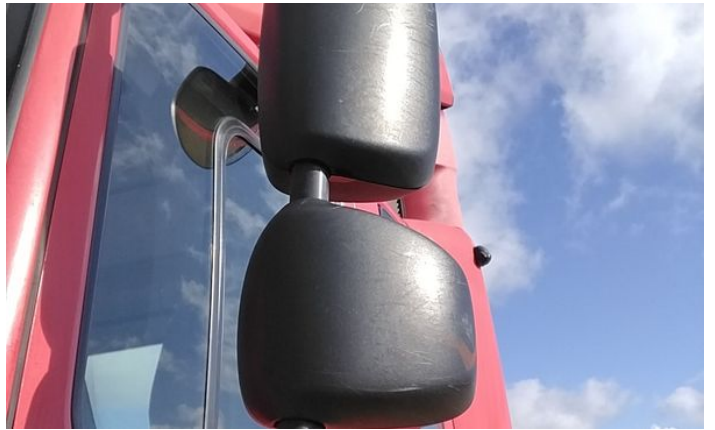
4: Door Mirror Assy nsf  
Scuffed (Unpainted)  
Over 100mm

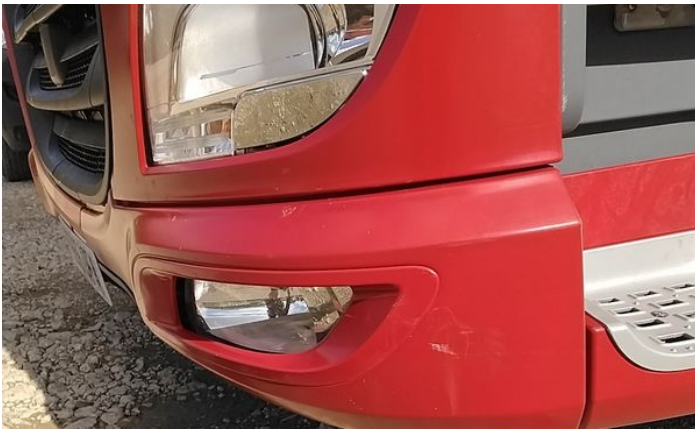
5: Bumper Front  
Scratched  
UpTo 25mm Thru Paint

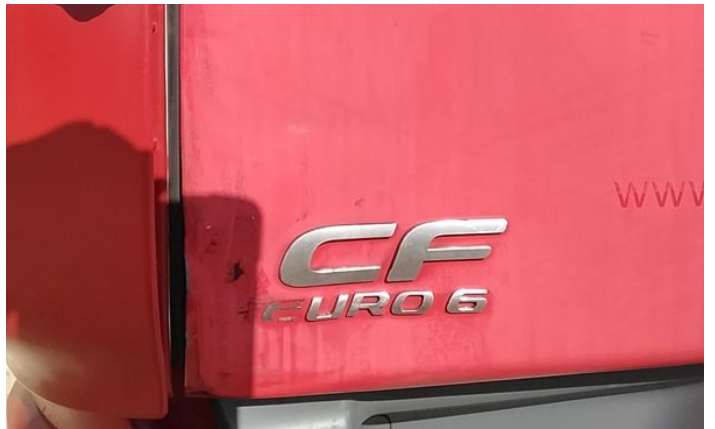
6: Door nsf  
Dented  
With Paint Damage

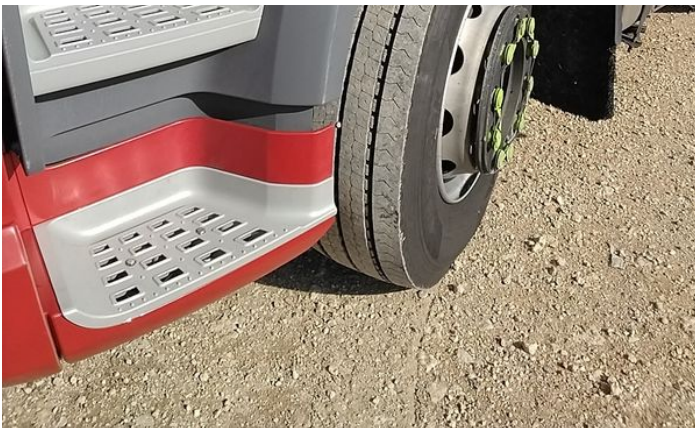
7: Wing Front Arch Extension ns  
Scuffed (Unpainted)  
Over 100mm

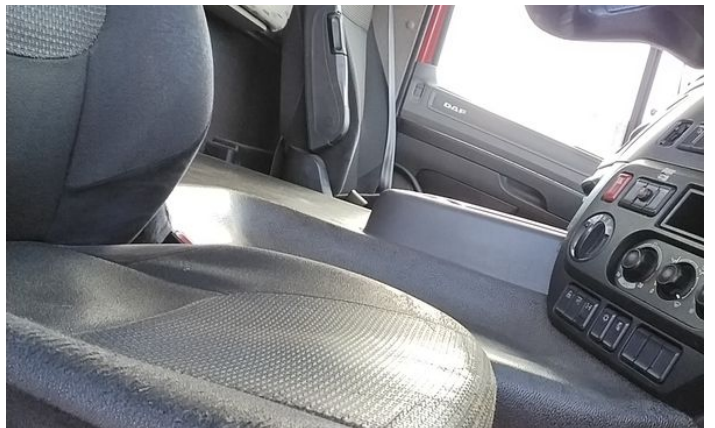
8: Seat Base Cover osf  
Holed  
Over 3mm
