VEHICLE INSPECTION REPORT

DG67EFP

Mercedes-Benz Actros 1824

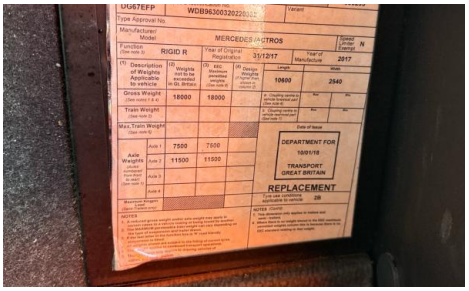
DG67EFP
MERCEDES-BENZ ACTROS
RIGID R
31/12/17
2017
18000
18000
10600
2540
7500
7500
11500
11500
DEPARTMENT FOR
TRANSPORT
GREAT BRITAIN
REPLACEMENT

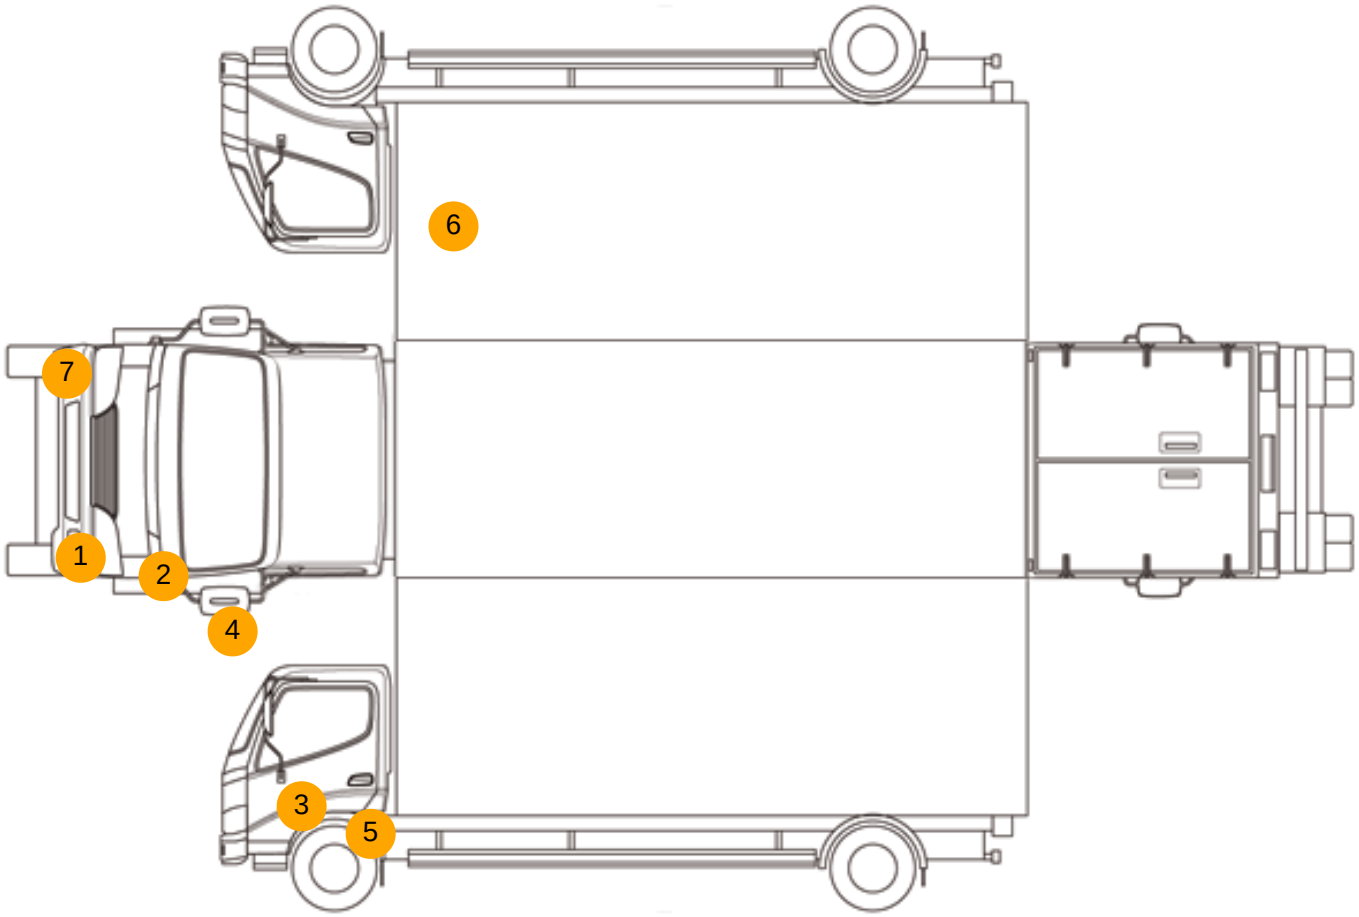
Condition Check

1: Bumper Front Moulding
Broken
Replace

2: Panel Front
Cracked
Replace

3: Door nsf
Dented
With Paint Damage

4: Door Mirror Assy nsf
Broken
Replace

6: Qtr Panel osr
Dented
With Paint Damage

7: Bumper Front Moulding
Broken
Replace

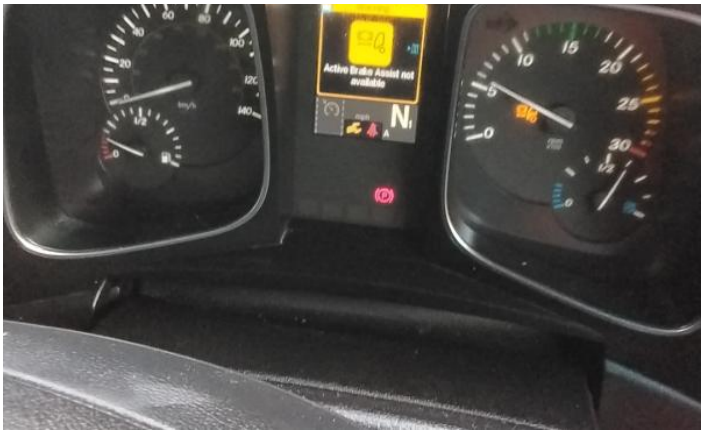
5: Wing nsf
Scratched
Over 25mm Thru Paint

8: Dash Warning Lights
Displayed
No Action

9: Dash Warning Lights
Displayed
No Action
