VEHICLE INSPECTION REPORT

CE74YDA

Vauxhall Vivaro F2900 1.5 TURBO D 120PS PRIME

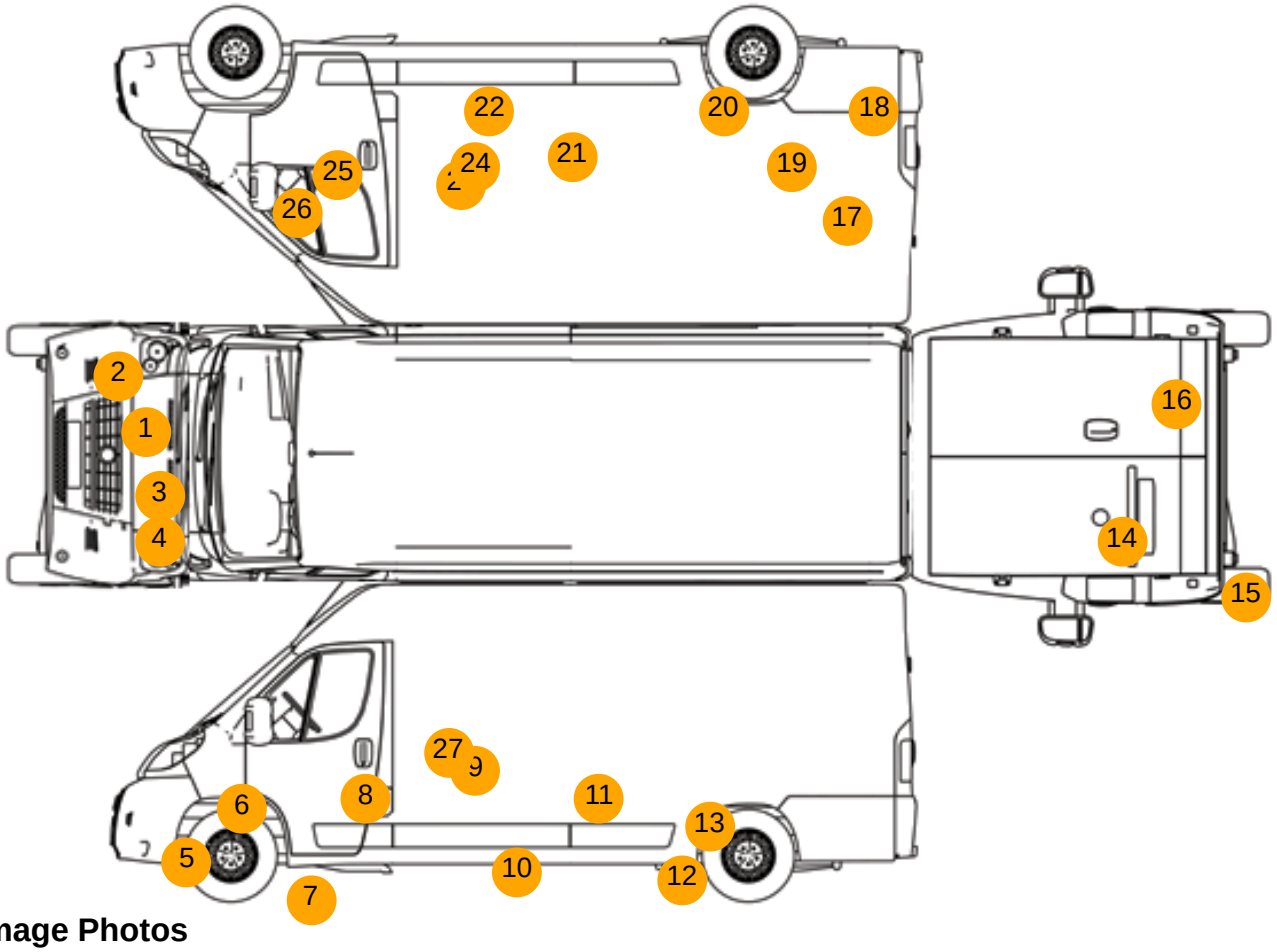
Condition Check

WARNING LIGHTS ON DASH, N/S SIDE DOOR HANDLE MISSING AD-BLUE, TWIN SIDE LOAD DOOR, E/ MIRRORS

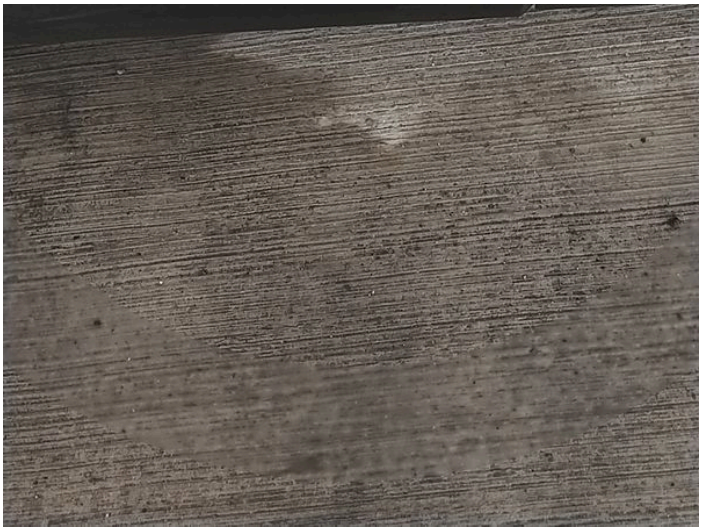
23: Qtr Panel osr
Scratched
Over 25mm Thru Paint
