VEHICLE INSPECTION REPORT

CE74YDD

Vauxhall Vivaro F2900 1.5 TURBO D 120PS PRIME

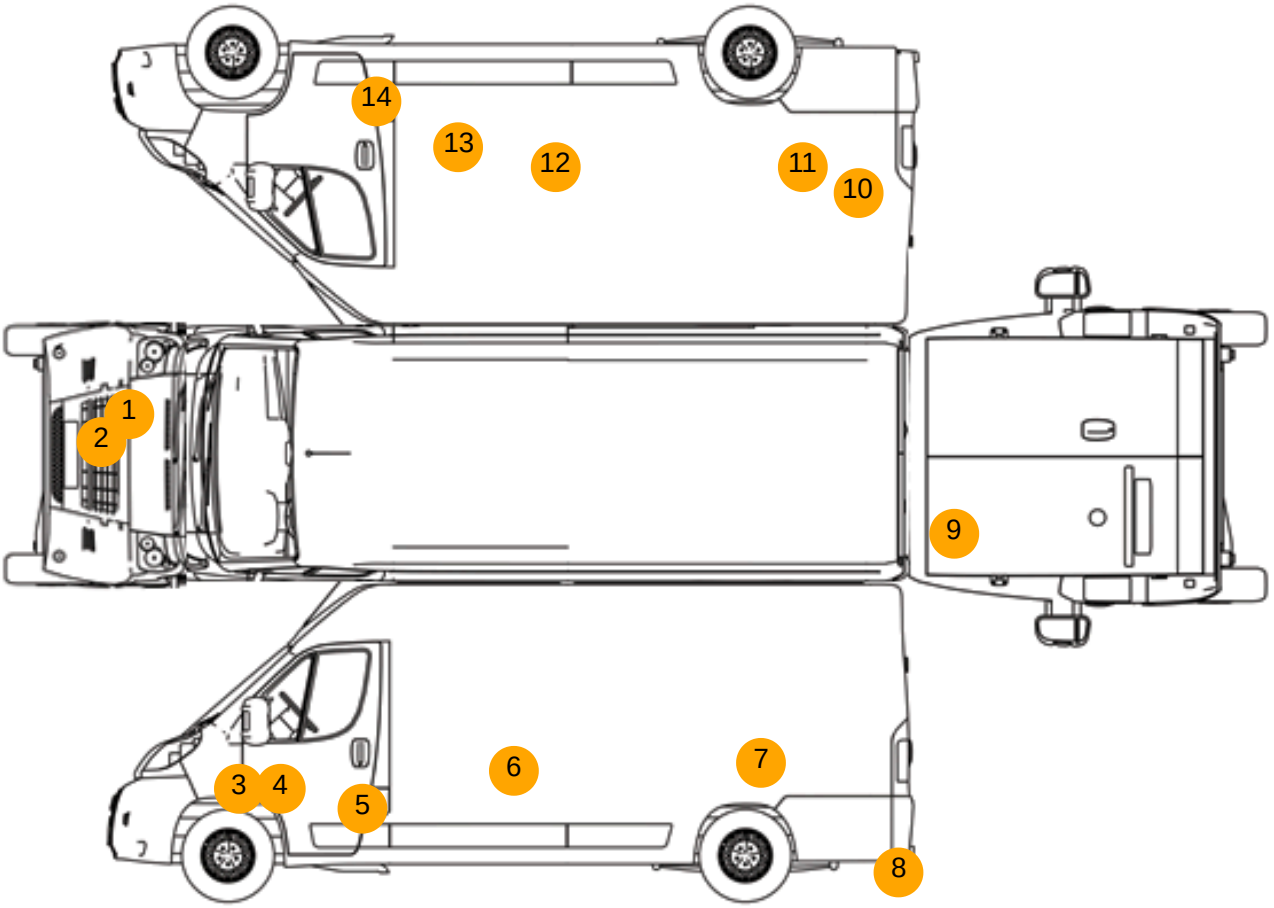
Condition Check

1: Panel Front
Scratched
Over 25mm Thru Paint

2: Bumper Front
Scratched
Over 100mm Thru Paint

3: Wing nsf
Dented
With Paint Damage

4: Wing nsf
Dented
Over 30mm

5: Door nsf
Dented
With Paint Damage

6: Qtr Panel nsr
Dented
Over 30% Of Panel

7: Qtr Panel nsr
Dented
With Paint Damage

8: Qtr Panel Moulding ns
Scuffed (Unpainted)
Over 100mm

9: Door nsr
Dented
With Paint Damage

10: Qtr Panel osr
Dented
Over 30mm

11: Qtr Panel osr
Scratched
Over 25mm Thru Paint

12: Qtr Panel osr
Scratched
Over 25mm Thru Paint

13: Qtr Panel osr
Scratched
Over 25mm Thru Paint

14: Door Moulding osf
Missing
Replace

15: Seat Base Cover osf
Torn
Over 3mm

16: Seat Base Cover nsf
Soiled
Heavy
