VEHICLE INSPECTION REPORT

CE74YDN

Vauxhall Vivaro XL F2900 1.5 TURBO D 120PS PRIME

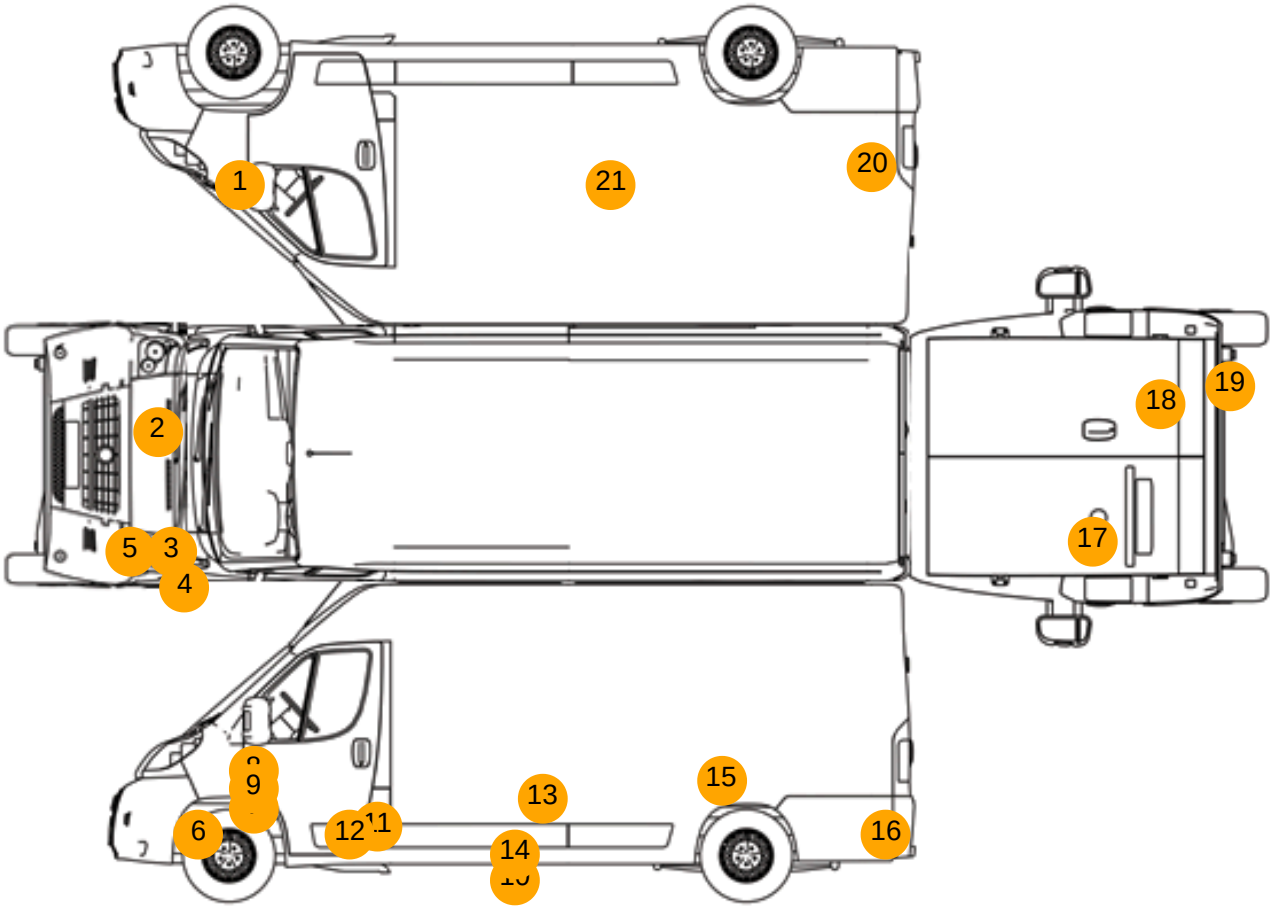
Condition Check

1: Wing osf
Scratched
Over 25mm Thru Paint

2: Panel Front
Scratched
Over 25mm Thru Paint

3: Panel Front
Cracked
Replace

4: Headlamp ns
Broken
Replace

5: Panel Front
Scratched
Over 25mm Thru Paint

6: Bumper Front
Scratched
Over 100mm Thru Paint

7: Wing nsf
Dented
With Paint Damage

8: Wing nsf
Scratched
Over 25mm Thru Paint

9: Wing nsf
Dented
Over 30mm

10: Sill ns
Dented
Over 30% Of Panel

11: Door nsf
Scratched
Over 25mm Thru Paint

12: Door Moulding nsf
Missing
Replace

13: Qtr Panel nsr
Dented
With Paint Damage

14: Qtr Panel Moulding ns
Missing
Replace

15: Qtr Panel nsr
Dented
With Paint Damage

16: Qtr Panel Moulding ns
Scuffed (Unpainted)
Over 100mm

17: Door nsr
Dented
Over 30mm

18: Door osr
Dented
Over 30% Of Panel

19: Bumper Rear Moulding
Broken
Replace

20: Qtr Panel osr
Dented
With Paint Damage

21: Qtr Panel osr
Scratched
Over 25mm Thru Paint

22: Seat Base Cover osf
Holed
Over 3mm

23: Seat Base Cover nsf
Soiled
Heavy
