VEHICLE INSPECTION REPORT

CF24UCJ

Vauxhall Vivaro F2900 1.5D 120PS Prime

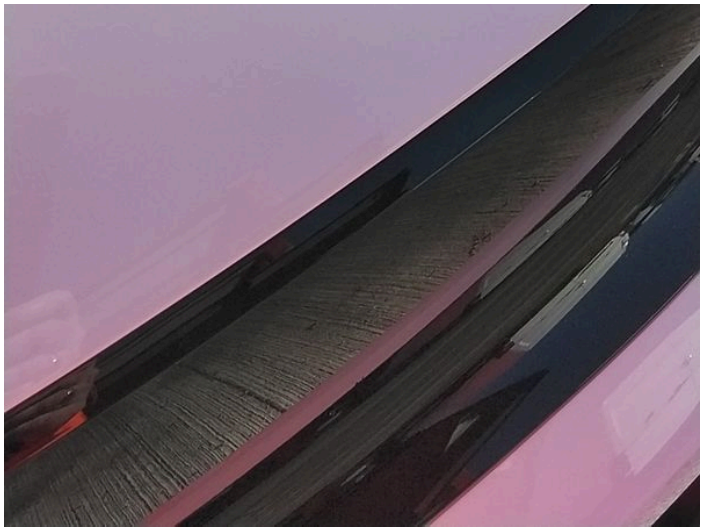
1: Wing osf
Scratched
Over 25mm Thru Paint

2: Bumper Front
Scratched
Over 100mm Thru Paint

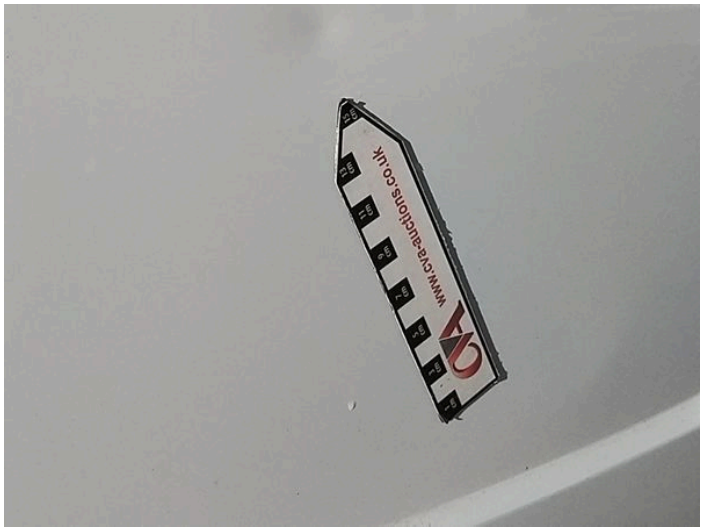
3: Panel Front
Dented
Over 30mm

4: Bumper Front
Scratched
Over 100mm Thru Paint

5: Sill ns
Dented
With Paint Damage

6: Door nsf
Dented
Over 30% Of Panel

7: Door Moulding nsf
Missing
Replace

8: Qtr Panel nsr
Dented
With Paint Damage

9: Qtr Panel nsr
Scratched
Over 25mm Thru Paint

10: Qtr Panel nsr
Dented
With Paint Damage

11: Qtr Panel nsr
Dented
With Paint Damage

12: Qtr Panel nsr
Dented
With Paint Damage

13: Door nsr
Dented
With Paint Damage

14: Door osr
Scratched
Over 25mm Thru Paint

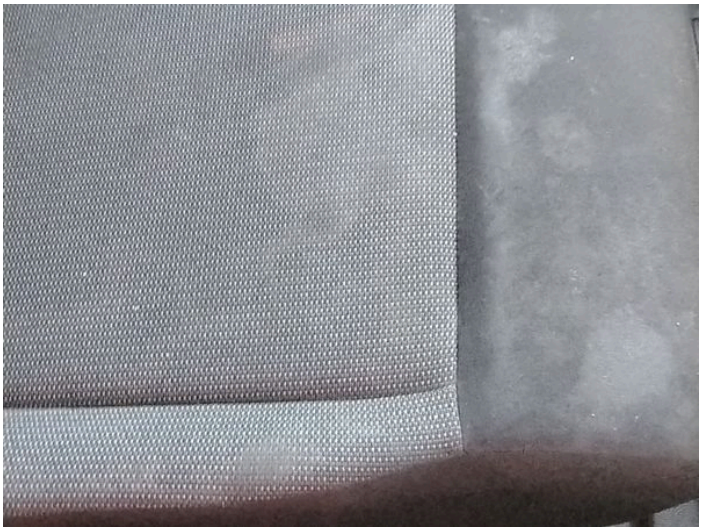
15: Door osr
Dented
Over 30mm

16: Door osr
Scratched
Over 25mm Thru Paint

17: Bumper Rear Moulding
Scuffed (Unpainted)
Over 100mm

18: Qtr Panel osr
Dented
Over 30mm

19: Qtr Panel Moulding os
Scuffed (Unpainted)
Over 100mm

20: Door osf
Dented
With Paint Damage

21: Door Moulding osf
Missing
Replace

22: Door Mirror Assy osf
Scuffed (Unpainted)
UpTo 100mm

23: Seat Base Cover osf
Holed
Over 3mm
