VEHICLE INSPECTION REPORT

DG23ZZN

Vauxhall Vivaro F2900 1.5D 100PS SPORTIVE

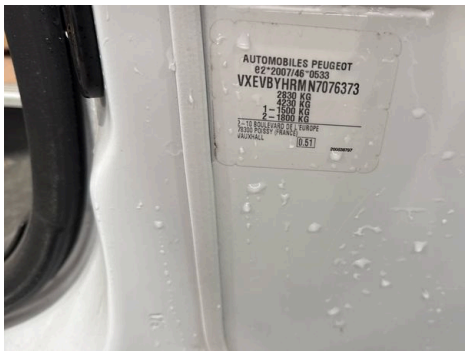
AUTOMOBILES PEUGEOT
VXEVBYHRMN7076373
2830 KG
4230 KG
1-1500 KG
2-1800 KG

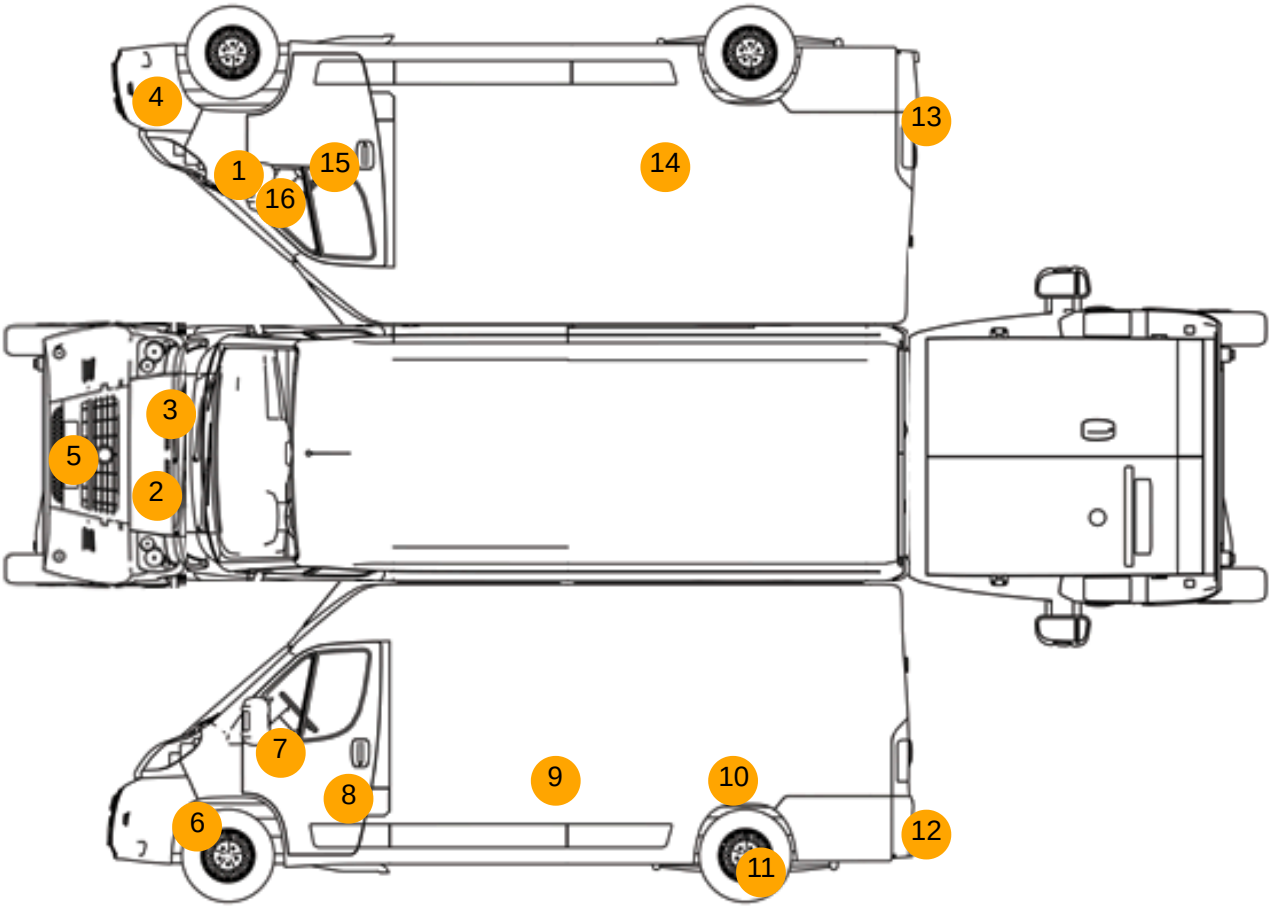
Condition Check

1: Wing osf
Dented
With Paint Damage

2: Bonnet
Dented
With Paint Damage

3: Panel Front
Scratched
Over 25mm Thru Paint

4: Bumper Front
Scratched
Over 100mm Thru Paint

5: Bumper Front
Scratched
Over 100mm Thru Paint

6: Bumper Front
Scratched
Over 100mm Thru Paint

7: Door Mirror Assy nsf
Missing
Replace

8: Door nsf
Dented
Over 30% Of Panel

9: Qtr Panel nsr
Dented
Over 30% Of Panel

10: Qtr Panel nsr
Dented
With Paint Damage

12: Qtr Panel Moulding ns
Scratched (Painted)
Over 25mm Thru Paint

13: Qtr Panel Moulding os
Scratched (Painted)
Over 25mm Thru Paint

14: Qtr Panel osr
Scratched
Over 25mm Thru Paint

15: Door osf
Scratched
Over 25mm Thru Paint

16: Door Mirror Assy osf
Scratched (Painted)
Over 25mm Thru Paint
