VEHICLE INSPECTION REPORT

MM23LLV

Ford Transit Custom 300 2.0 EcoBlue 130ps TREND

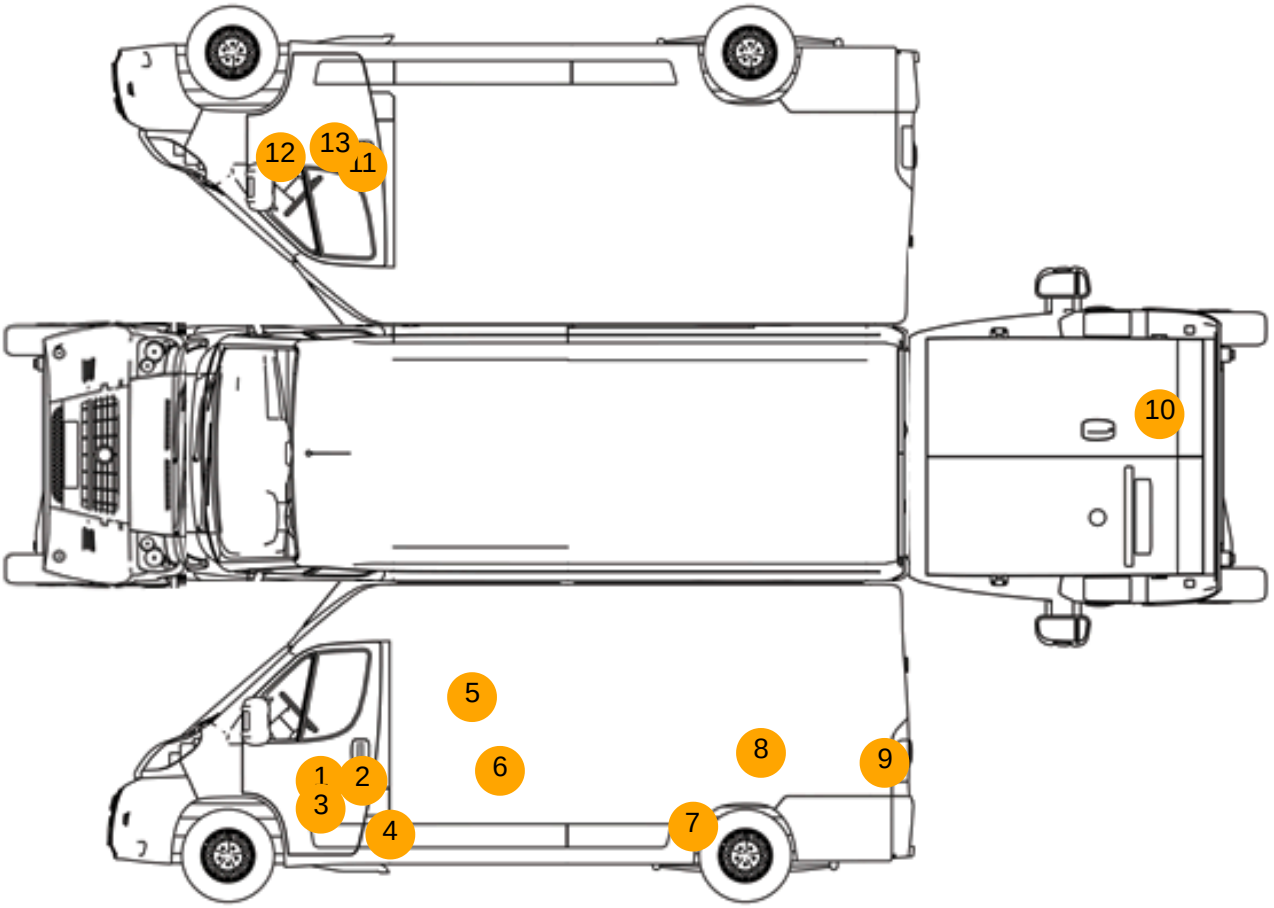
Condition Check

1: Door nsf
Scratched
Over 25mm Thru Paint

2: Door nsf
Dented
With Paint Damage

3: Door nsf
Scratched
Over 25mm Thru Paint

4: Door Moulding nsf
Missing
Replace

6: Qtr Panel nsr
Dented
With Paint Damage

7: Qtr Panel nsr
Dented
With Paint Damage

10: Door osr
Dented
With Paint Damage

12: Door osf
Dented
With Paint Damage

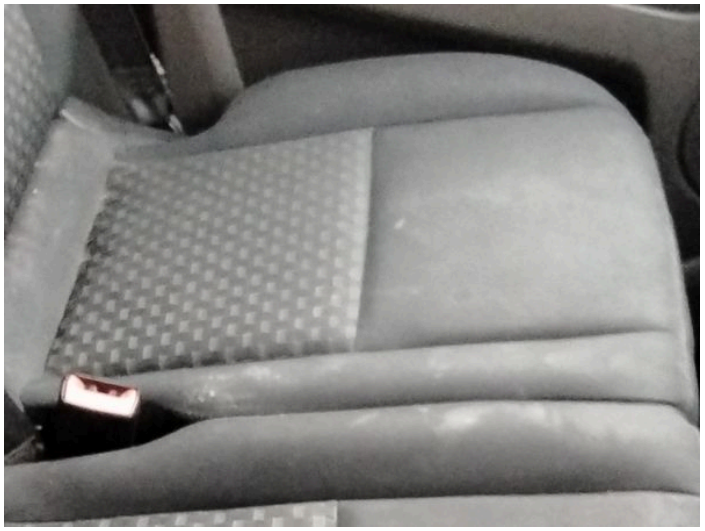
14: Seat Base Cover osf
Holed
Over 3mm
