VEHICLE INSPECTION REPORT

CJ71EUP

Citroen Berlingo 1.5 BlueHDi Enterprise Pro 100ps

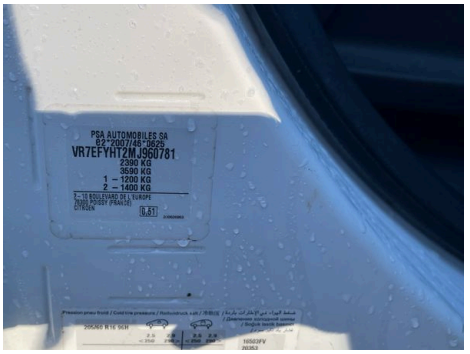
PSA AUTOMOBILES SA
VR7EFYHT2MJ960781
2390 KG
3690 KG
1 – 1200 KG
2 – 1400 KG

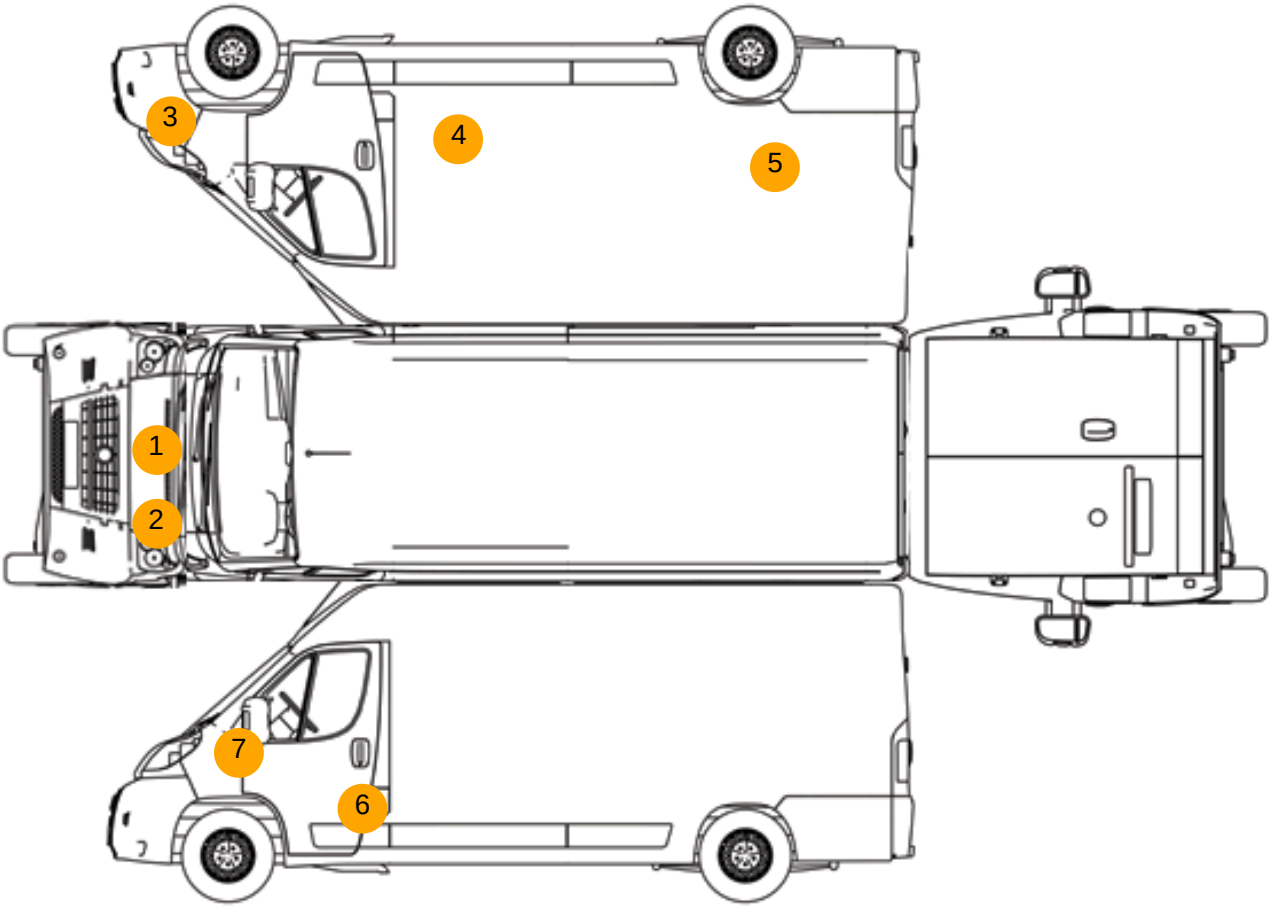
Condition Check

1: Bonnet
Chipped
Multiple Chips

2: Bumper Front
Dented
With Paint Damage

3: Bumper Front
Rusted
Over 5mm

4: Qtr Panel osr
Chipped
1 To 5

5: Qtr Panel osr
Dented
Over 30mm

6: Door nsf
Chipped
Multiple Chips

7: Wing nsf
Chipped
Multiple Chips
