VEHICLE INSPECTION REPORT

LR73ZXW

Maxus Deliver 9 2.0 D20 150PS

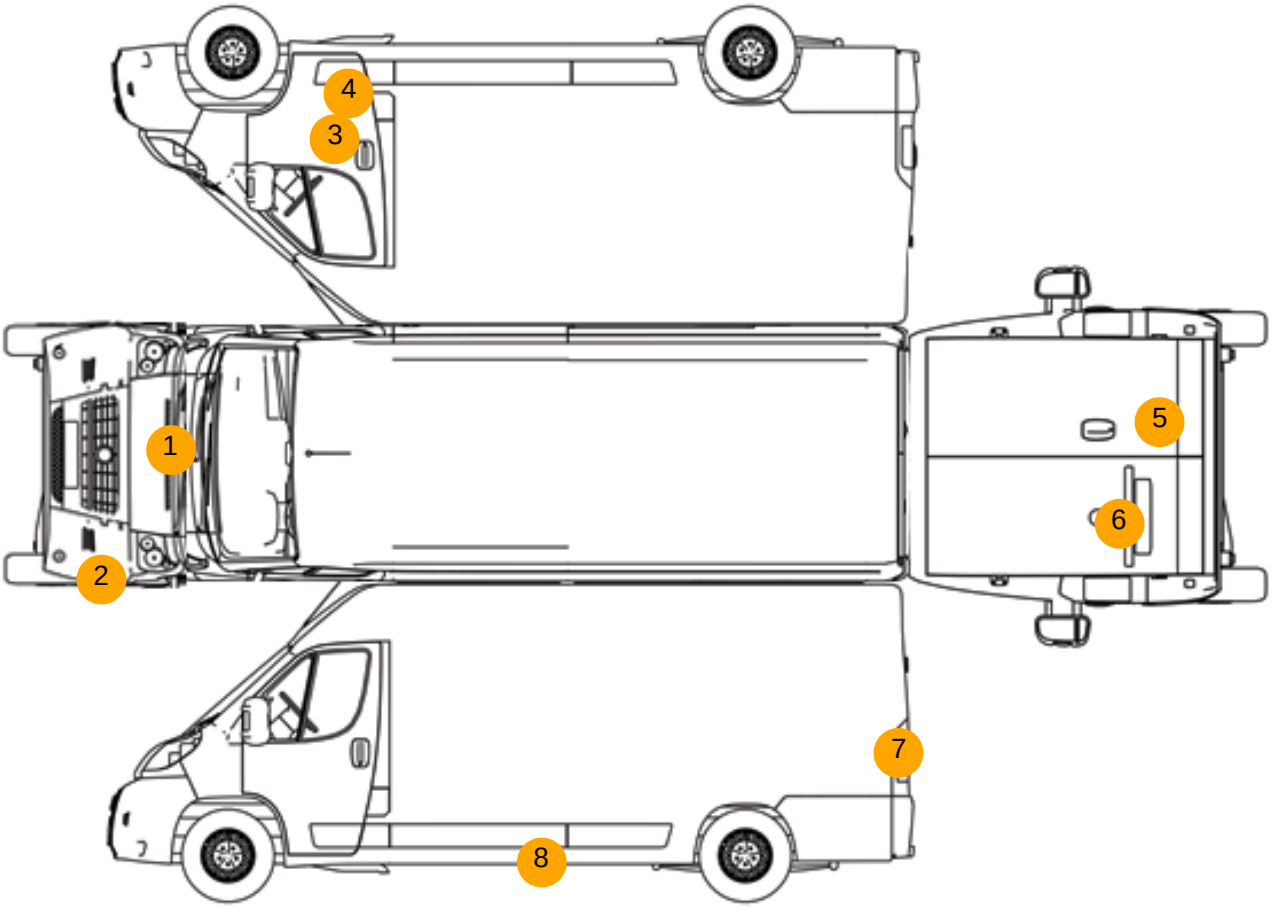
Condition Check

1: Bonnet
Chipped
Multiple Chips

2: Bumper Front
Scratched
25 to 100mm Thru Paint

3: Door osf
Dented
Over 30mm

4: Sill os
Rusted
Over 5mm

5: Badgedecal Rear
Missing
Replace

6: Tailgate
Dented
With Paint Damage

7: Qtr Panel nsr
Rusted
Over 5mm

8: Sill ns
Rusted
Over 5mm
