VEHICLE INSPECTION REPORT

FT73RRX

Ford Transit 350 2.0 ECOBLUE 170PS

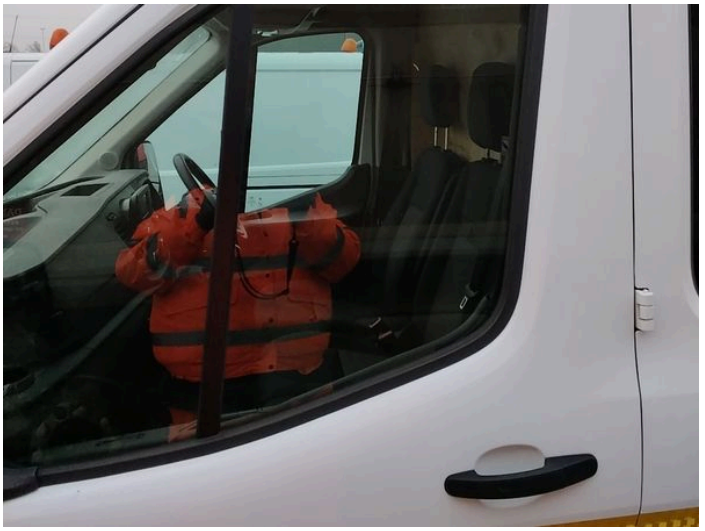
Damage Photos

1: Screen Front
Chipped
Over 10mm

2: Bonnet
Chipped
Over 5mm

3: Wheel nsf
Corroded
Light

4: Wing nsf
Chipped
Over 5mm

5: A Post ns
Scratched
Over 25mm Not Thru Paint

6: Door nsf
Scratched
Over 25mm Thru Paint

7: Door nsr
Scratched
Over 25mm Thru Paint

8: Door nsf
Dented
Over 30mm

9: Door nsf
Chipped
Edge Chip

10: Door nsr
Scratched
Over 25mm Not Thru Paint

11: Door nsr
Chipped
Over 5mm

12: D Post ns
Dented
With Paint Damage

13: Wheel nsr
Corroded
Light

14: Wheel osr
Corroded
Light

15: Door osr
Chipped
Over 5mm

16: D Post os
Scratched
Over 25mm Not Thru Paint

17: Door osf
Chipped
Over 5mm

18: Door osf
Dented
Over 30mm

19: Door osf
Scratched
Over 25mm Not Thru Paint

20: Handle Outer osf
Scratched (Painted)
UpTo 25mm Not Thru Paint

21: Wheel osf
Corroded
Light

22: Door osf
Chipped
Over 5mm

23: Bonnet
Chipped
Over 5mm

24: Number Plate Front
Broken
Replace

25: Bumper Front
Scratched
Over 100mm Thru Paint

26: Roof
Chipped
Over 5mm

27: Seat Base Cover osf
Torn
Over 3mm

28: Seat Base Cover nsf
Soiled
Light
