VEHICLE INSPECTION REPORT

LR73ZXN

Maxus Deliver 9 D20 2.0 150PS

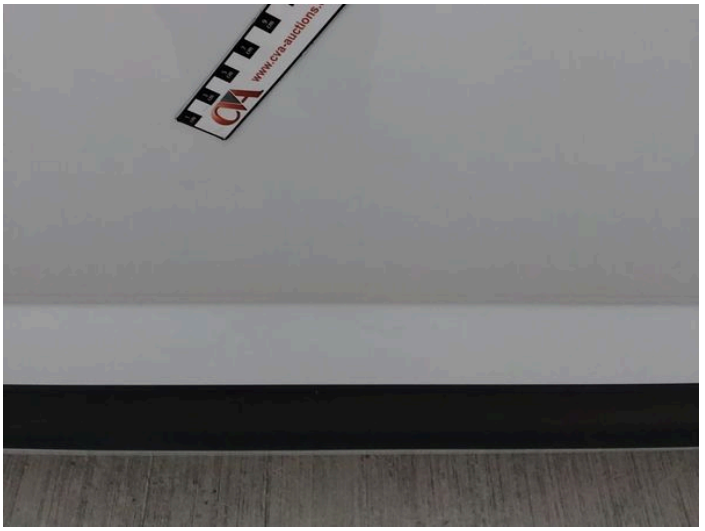
Damage Photos

1: Bonnet
Chipped
Multiple Chips

2: Screen Front
Chipped
UpTo 10mm

3: Bumper Front
Cracked
Over 25mm

4: Bumper Front
Insecure
Action Required

5: Door Mirror Assy nsf
Broken
Replace

6: Fuel Flap
Cracked
Replace

7: Qtr Panel nsr
Scratched
Over 25mm Not Thru Paint

8: Door osr
Chipped
Multiple Chips

9: Qtr Panel osr
Scratched
Over 25mm Thru Paint

10: Qtr Panel osr
Scratched
Over 25mm Thru Paint

11: B Post os
Chipped
Multiple Chips

12: Door osf
Scratched
UpTo 25mm Thru Paint

13: Carpets Front
Holed
Over 3mm

14: Dash Warning Lights
Displayed
No Action

15: Fascia Trim
Missing
Replace
