VEHICLE INSPECTION REPORT

LR73ZXX

Maxus Deliver 9 2.0 D20 150

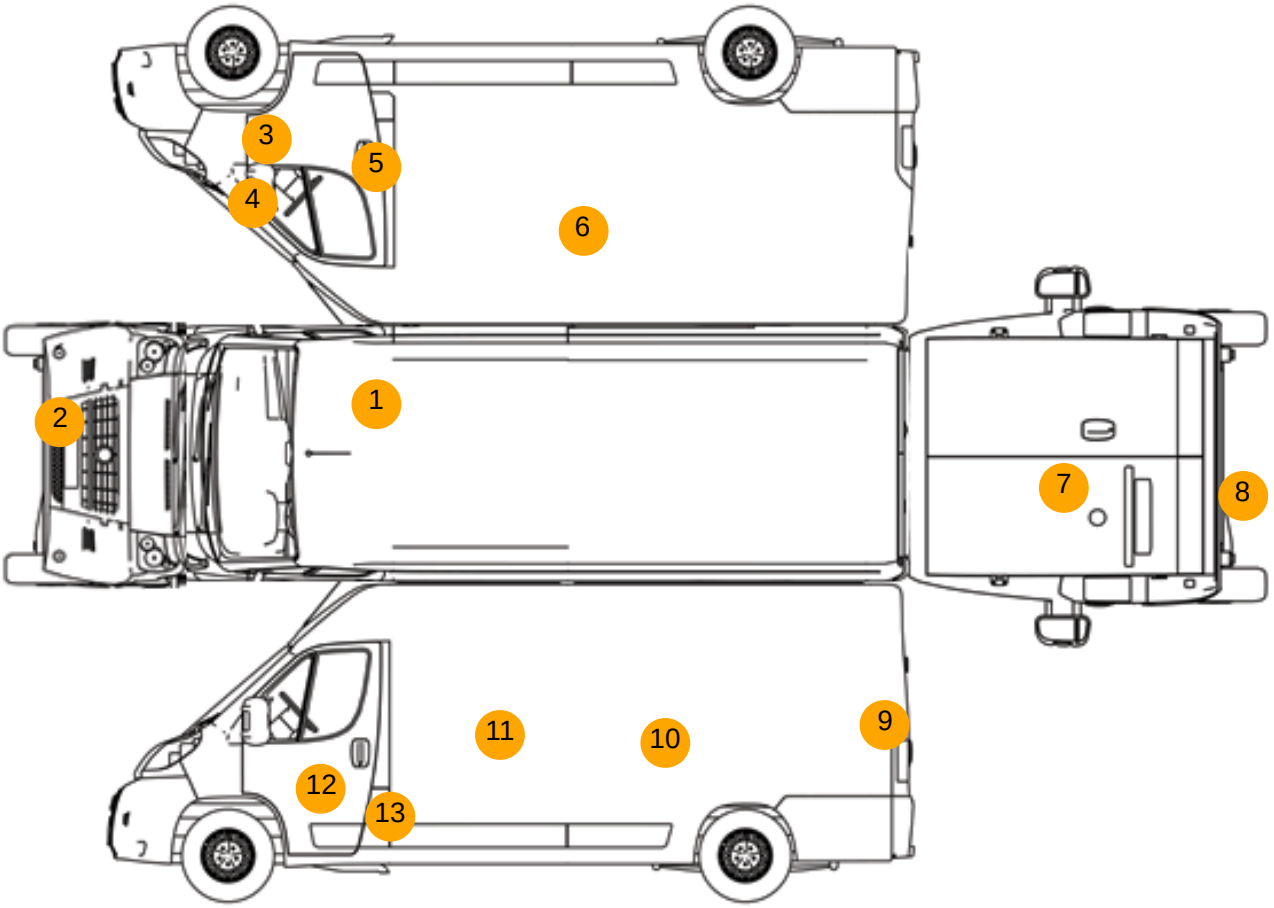
Condition Check

1: Seat Base Cover osf
Torn
Over 3mm

2: Carpets Front
Torn
Over 10mm

3: Sill os
Rusted
Over 5mm

4: Roof
Dented
Over 30% Of Panel
DENTED AND VERY POOR PREVIIOUS REPAIR

5: Bumper Front
Dented
With Paint Damage

6: Wing osf
Dented
With Paint Damage

7: Door Mirror Assy osf
Missing
Replace

8: Door osf
Dented
Over 30mm

9: Qtr Panel osr
Dented
With Paint Damage

10: Tailgate
Dented
With Paint Damage

11: Bumper Rear
Dented
Over 30mm

12: D Post ns
Dented
Over 30mm

13: Qtr Panel nsr
Dented
With Paint Damage

14: Door nsr
Dented
With Paint Damage

15: Door nsf
Dented
With Paint Damage

16: Fuel Flap
Missing
Replace
