VEHICLE INSPECTION REPORT

LR73ZYB

Maxus Deliver 9 2.0 D20 150

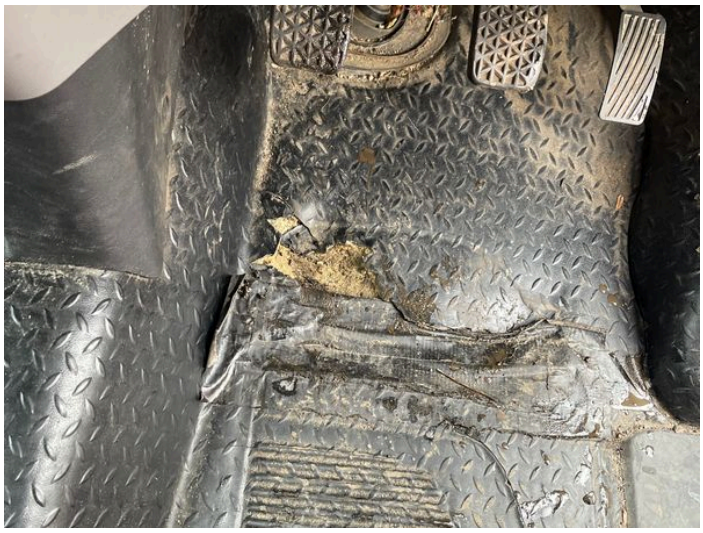
1: Carpets Front
Holed
Over 3mm

2: Bonnet
Chipped
Multiple Chips

3: Bumper Front
Chipped
Multiple Chips

4: Bumper Front
Insecure
Action Required

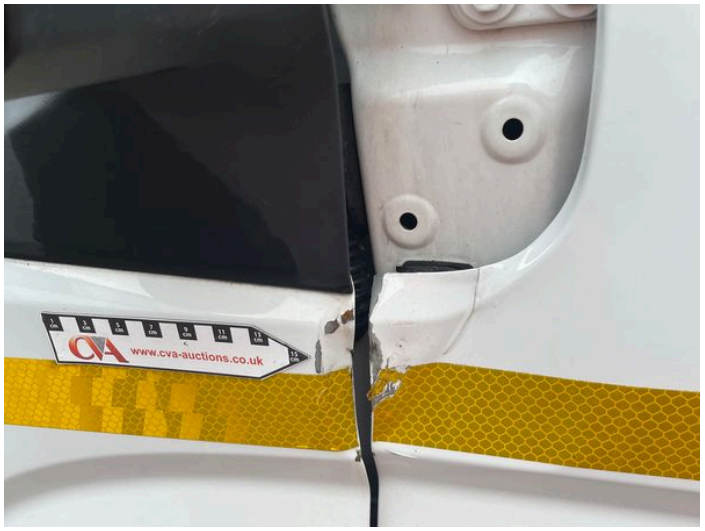
5: Wing osf
Dented
With Paint Damage

6: Qtr Panel osr
Dented
Over 30mm

7: Qtr Panel osr
Dented
With Paint Damage

8: Tailgate
Dented
With Paint Damage

9: Badgedecal Rear
Missing
Replace

10: Roof
Dented
With Paint Damage

11: Tailgate
Dented
With Paint Damage

12: Qtr Panel nsr
Dented
With Paint Damage

13: Qtr Panel nsr
Dented
With Paint Damage

14: Sill ns
Dented
Over 30mm

15: Wing nsf
Dented
With Paint Damage

16: Bumper Front
Cracked
Over 25mm

17: Wing nsf
Dented
With Paint Damage
