VEHICLE INSPECTION REPORT

LR73ZXL

Maxus Deliver 9 2.0 D20 150PS

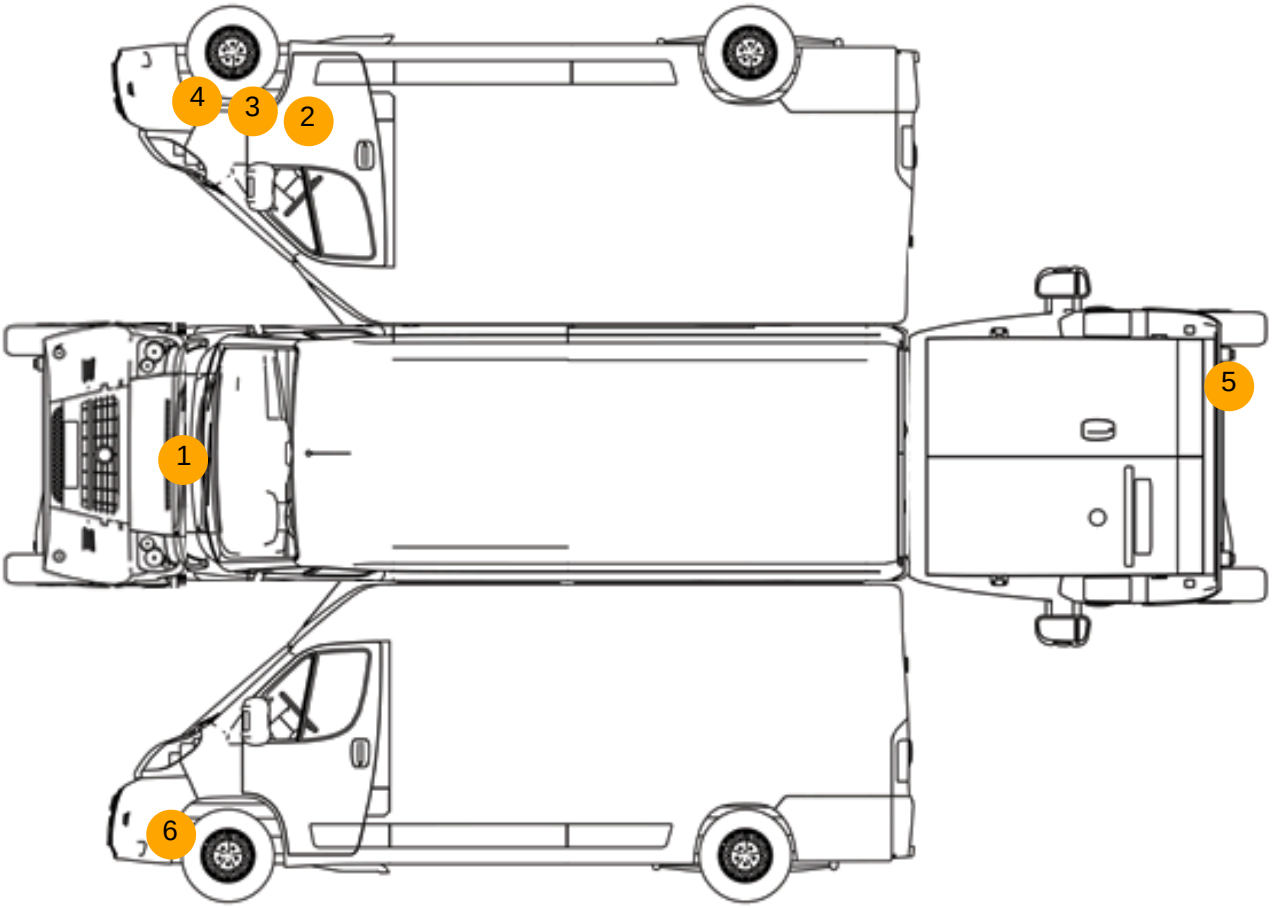
1: Bonnet
Chipped
Multiple Chips

2: Door osf
Dented
With Paint Damage

3: Wheel Trim osf
Broken
Replace

4: Qtr Panel Moulding os
Scuffed (Unpainted)
Over 100mm

5: Bumper Rear
Cracked
Over 25mm

6: Bumper Front
Chipped
Multiple Chips
