VEHICLE INSPECTION REPORT

BF70NRL

Iveco Daily 35-120

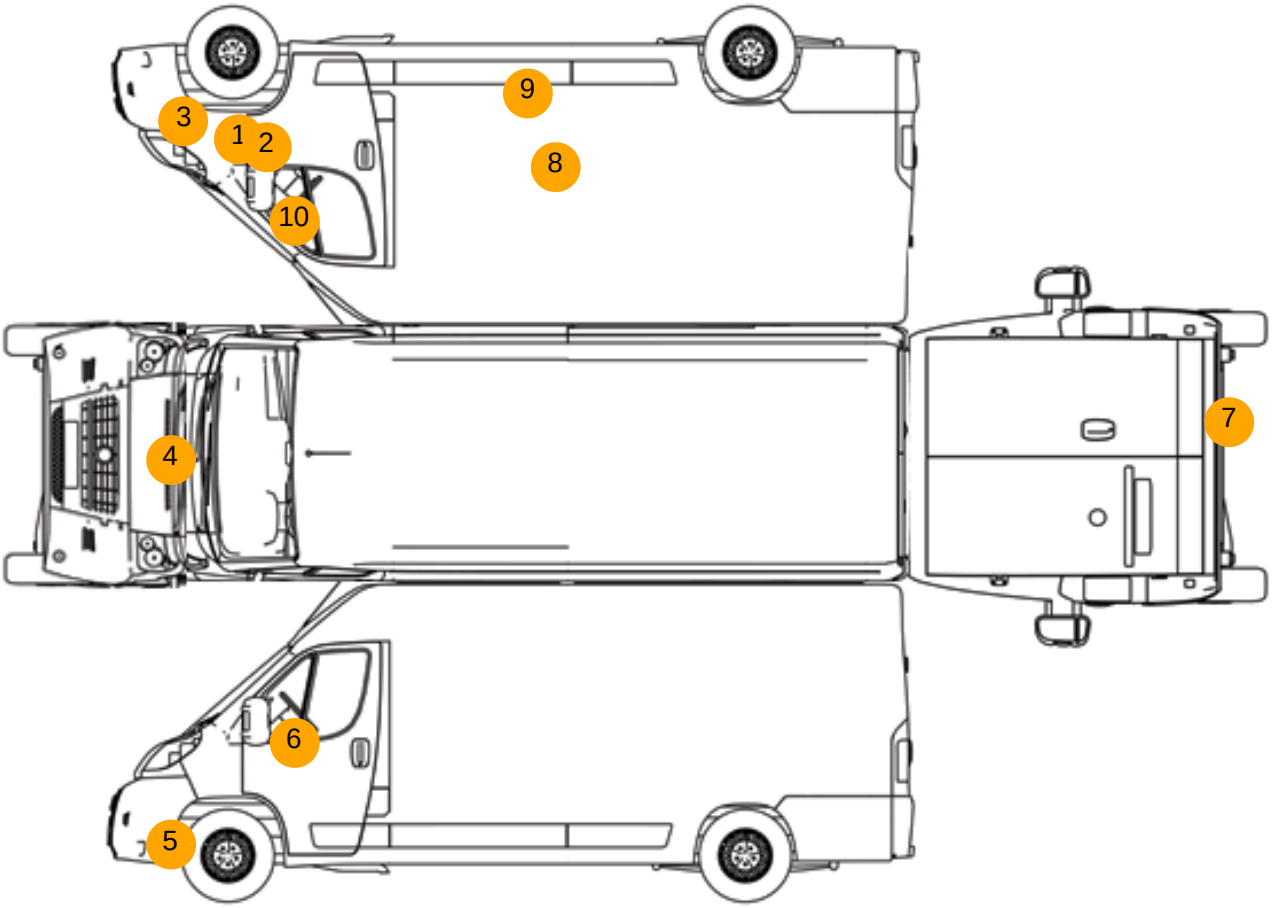
1: Wing osf
Dented
With Paint Damage

2: Wing Front Arch Extension os
Scuffed (Unpainted)
UpTo 100mm

3: Bumper Front Moulding
Scuffed (Unpainted)
UpTo 100mm

4: Bonnet
Chipped
Multiple Chips

5: Bumper Front Moulding
Scuffed (Unpainted)
Over 100mm

6: Door Mirror Assy nsf
Scuffed (Unpainted)
UpTo 100mm

7: Bumper Rear
Dented
Between 10mm + 30mm

8: Qtr Panel osr
Dented
With Paint Damage

9: Qtr Panel Moulding os
Scuffed (Unpainted)
Over 100mm

10: Flasher Side Repeater os
Broken
Replace

11: Seat Base Cover osf
Holed
Over 3mm
