VEHICLE INSPECTION REPORT

GA71NET

Mercedes-Benz Vito 116 CDI Premium

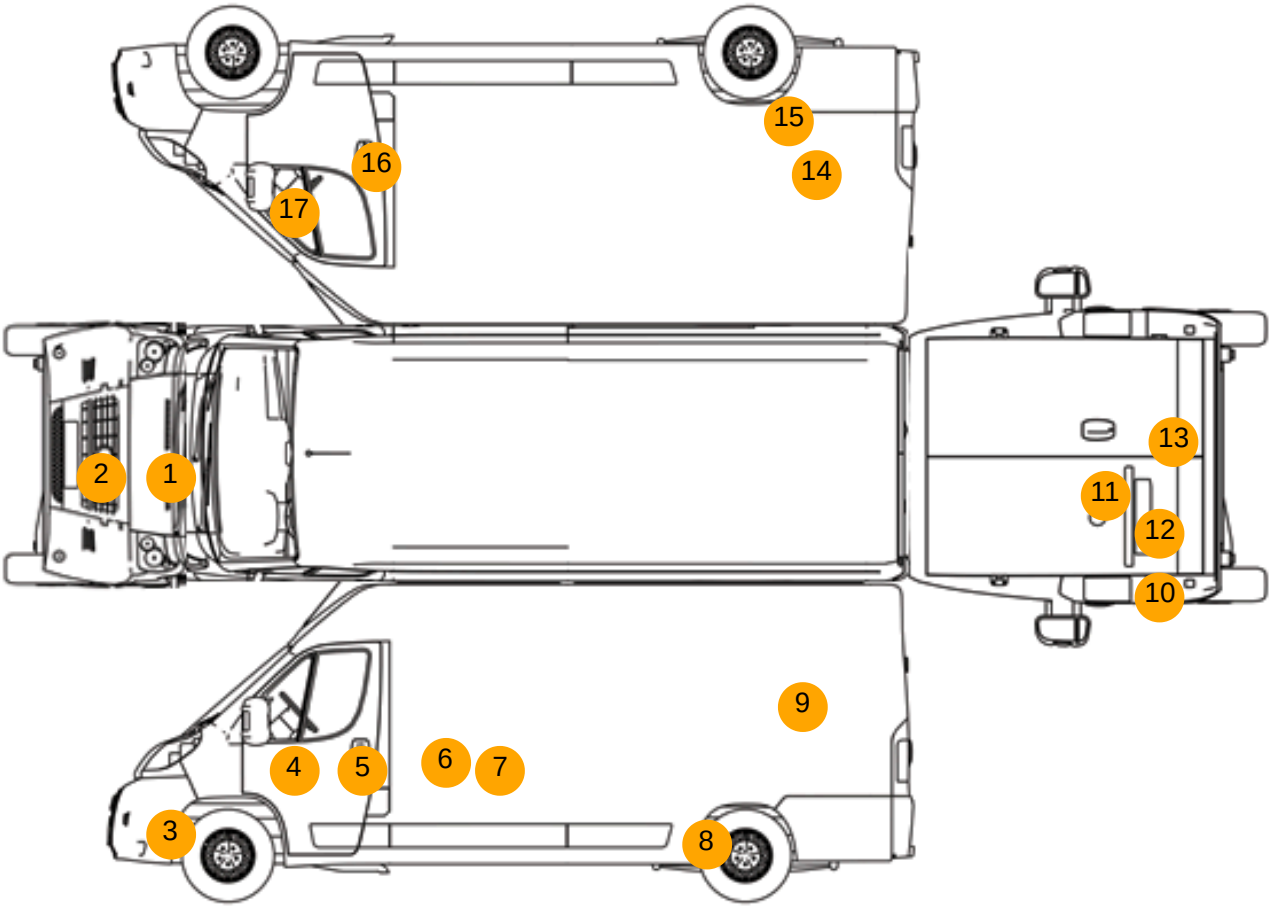
Condition Check

1: Bonnet
Chipped
Multiple Chips

2: Number Plate Front
Missing
Replace

3: Bumper Front
Scratched
Over 100mm Thru Paint

4: Door nsf
Dented
With Paint Damage

5: Door nsf
Dented
With Paint Damage

6: Door nsr
Dented
With Paint Damage

7: Door nsr
Scratched
Over 25mm Thru Paint

8: Qtr Panel nsr
Dented
With Paint Damage

9: Qtr Panel nsr
Dented
Over 30mm

10: Bumper Rear Moulding
Scratched (Painted)
Over 25mm Thru Paint

11: Door nsr
Dented
With Paint Damage

12: Number Plate Rear
Missing
Replace

13: Door osr
Dented
With Paint Damage

14: Qtr Panel osr
Scratched
Over 25mm Thru Paint

15: Qtr Panel osr
Dented
With Paint Damage

16: Door osf
Dented
With Paint Damage

17: Door Mirror Assy osf
Broken
Replace

18: Seat Base Cover nsr
Soiled
Heavy

19: Seat Base Cover osr
Soiled
Heavy

20: Seat Base Cover nsf
Soiled
Heavy

21: Seat Base Cover osf
Holed
Over 3mm

22: Dash Warning Lights
Displayed
No Action
