VEHICLE INSPECTION REPORT

BX17XBB

Iveco Daily 50-150

VERSALIFT ETM-38-F PLATFORM

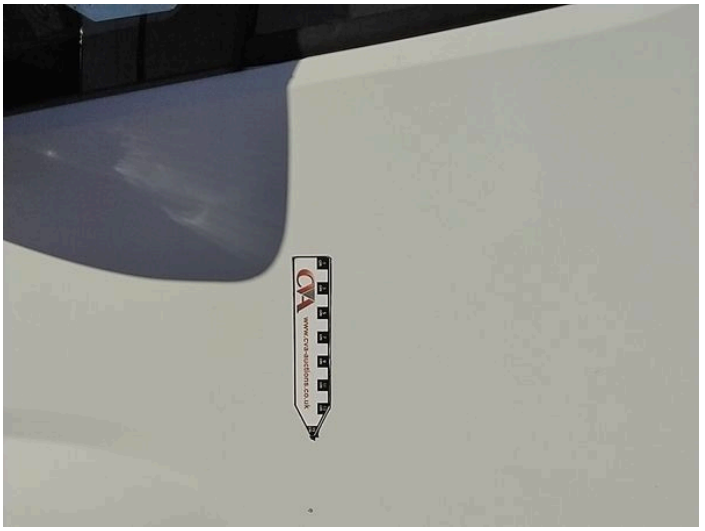
1: Front TowEye Cvr
Missing
Replace

2: Wing osf
Dented
With Paint Damage

3: Bumper Front Moulding
Scuffed (Unpainted)
UpTo 100mm

4: Panel Front
Scratched
UpTo 25mm Not Thru Paint

5: Bonnet
Chipped
Multiple Chips

6: Screen Front
Chipped
Over 10mm

7: Panel Front
Scratched
UpTo 25mm Thru Paint

8: Door Mirror Assy nsf
Scuffed (Unpainted)
UpTo 100mm

9: Bumper Front Moulding
Scuffed (Unpainted)
UpTo 100mm

10: Door nsf
Chipped
Over 5mm

11: Door Moulding nsf
Scuffed (Unpainted)
Over 100mm

12: Qtr Panel Moulding ns
Scuffed (Unpainted)
Over 100mm

13: Door nsr
Dented
With Paint Damage

14: Door osr
Dented
Between 10mm + 30mm

15: Qtr Panel Moulding os
Scuffed (Unpainted)
Over 100mm

16: Door osf
Chipped
Edge Chip

17: Seat Base Cover osf
Holed
Over 3mm
