VEHICLE INSPECTION REPORT

HN64DAO

Ford Transit 460 2.2 TDCI 125PS

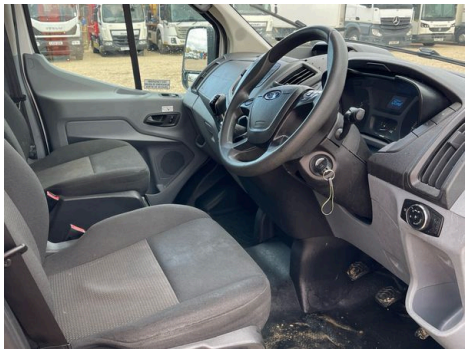
WARNING LIGHT ON DASH, MILEAGE ONLY DISPLAYING ON TACHO 16 SEATS PLUS DRIVER, AD BLUE, SIDE LOADING DOOR

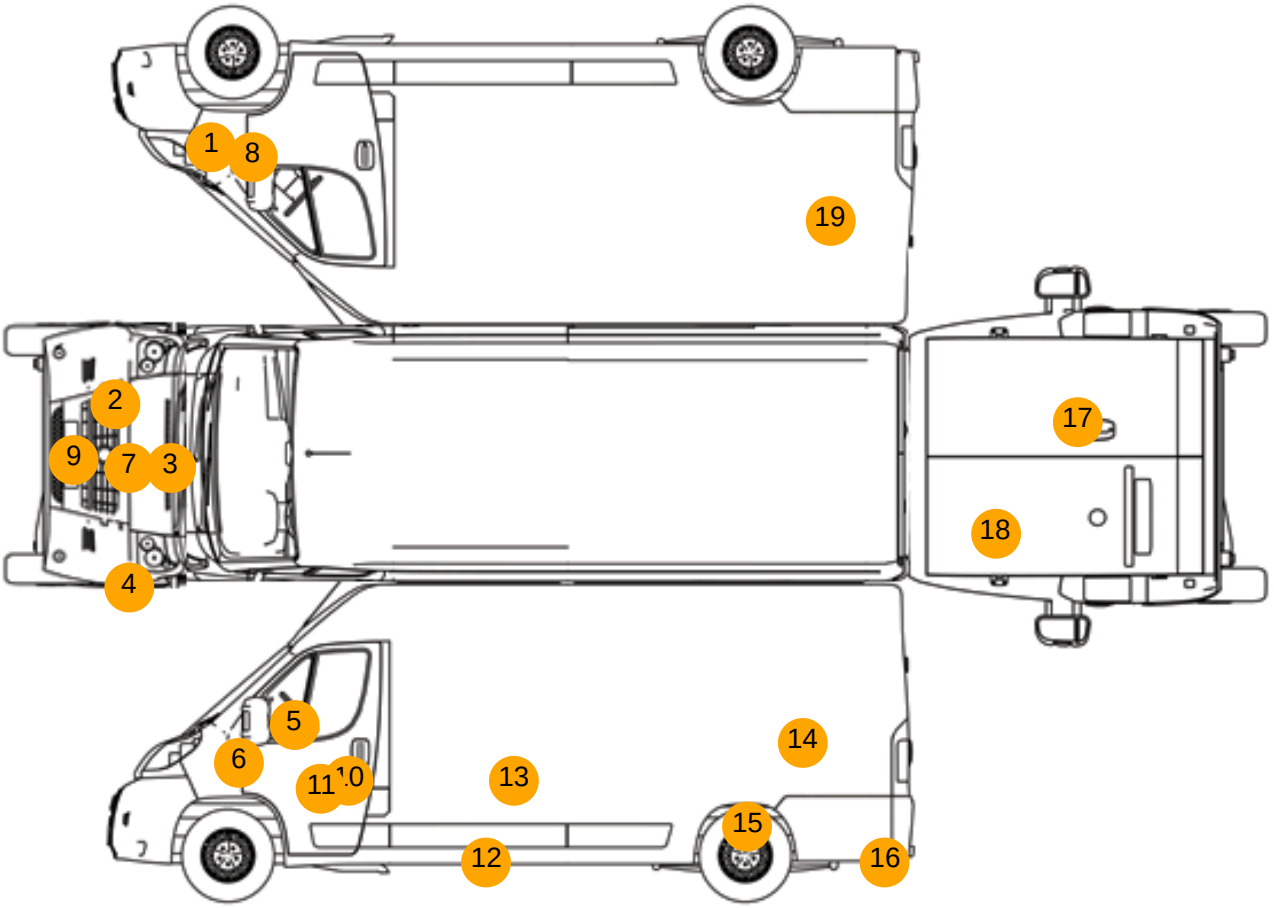
Condition Check

1: Bumper Front Moulding
Scuffed (Unpainted)
UpTo 100mm

2: Bumper Front Moulding
Scuffed (Unpainted)
UpTo 100mm

3: Bonnet
Chipped
Multiple Chips

4: Bumper Front Moulding
Scuffed (Unpainted)
UpTo 100mm

5: Door Mirror Assy nsf
Scuffed (Unpainted)
UpTo 100mm

6: Wing nsf
Dented
Between 10mm + 30mm

7: Panel Front
Dented
Between 10mm + 30mm

8: Wing osf
Dented
With Paint Damage

9: Bumper Front
Insecure
Action Required

10: Door nsf
Scratched
Over 25mm Not Thru Paint

11: Door nsf
Scratched
UpTo 25mm Thru Paint

12: Door Moulding nsr
Scuffed (Unpainted)
Over 100mm

13: Door nsr
Scratched
Over 25mm Not Thru Paint

14: Qtr Panel nsr
Scratched
Over 25mm Not Thru Paint

15: Qtr Panel Arch Extension ns
Scuffed (Unpainted)
Over 100mm

16: Bumper Rear Moulding
Scuffed (Unpainted)
Over 100mm

17: Door osr
Dented
With Paint Damage

18: Door nsr
Dented
Between 10mm + 30mm

19: Qtr Panel osr
Scratched
Over 25mm Not Thru Paint

20: Carpets Front
Holed
Over 3mm
