VEHICLE INSPECTION REPORT

LR23XDA

Maxus Deliver 9 2.0 D20 150PS

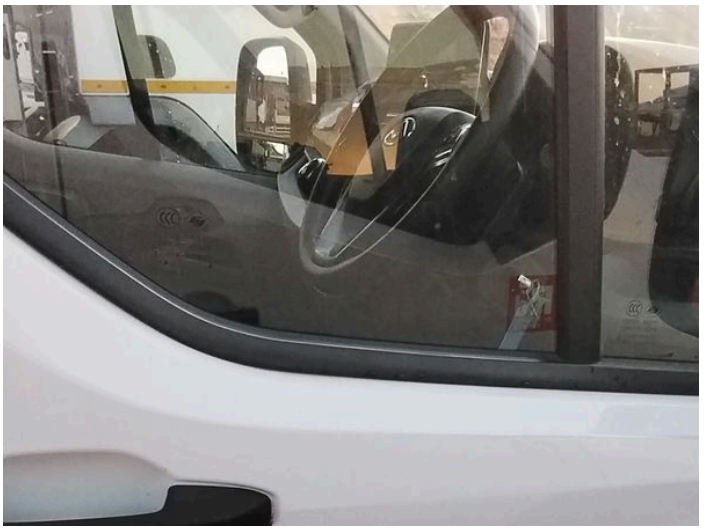
1: Number Plate Front
Broken
Replace

2: Bumper Front
Scratched
25 to 100mm Thru Paint

3: Bumper Front
Insecure
Action Required

4: Door Mirror Assy nsf
Scuffed (Unpainted)
Over 100mm

5: Door nsf
Scratched
Over 25mm Thru Paint

6: Door nsf
Dented
With Paint Damage

7: Qtr Panel nsr
Dented
With Paint Damage

8: Qtr Panel nsr
Dented
With Paint Damage

9: Qtr Panel nsr
Dented
Over 30mm

10: Badgedecal Rear
Broken
Replace

11: Qtr Panel osr
Scratched
Over 25mm Thru Paint

12: Qtr Panel osr
Scratched
Over 25mm Not Thru Paint

13: Qtr Panel osr
Scratched
Over 25mm Thru Paint

14: Door osf
Chipped
Multiple Chips

15: Door Mirror Assy osf
Scuffed (Unpainted)
Over 100mm

16: Door osf
Dented
With Paint Damage

17: Screen Front
Chipped
Over 10mm

18: Door Pad osf
Soiled
Heavy

19: Carpets Front
Holed
Over 3mm

20: Seat Base Cover osf
Soiled
Heavy

21: Seat Base Cover nsf
Soiled
Heavy
