VEHICLE INSPECTION REPORT

FN68GXS

Daf LF 150

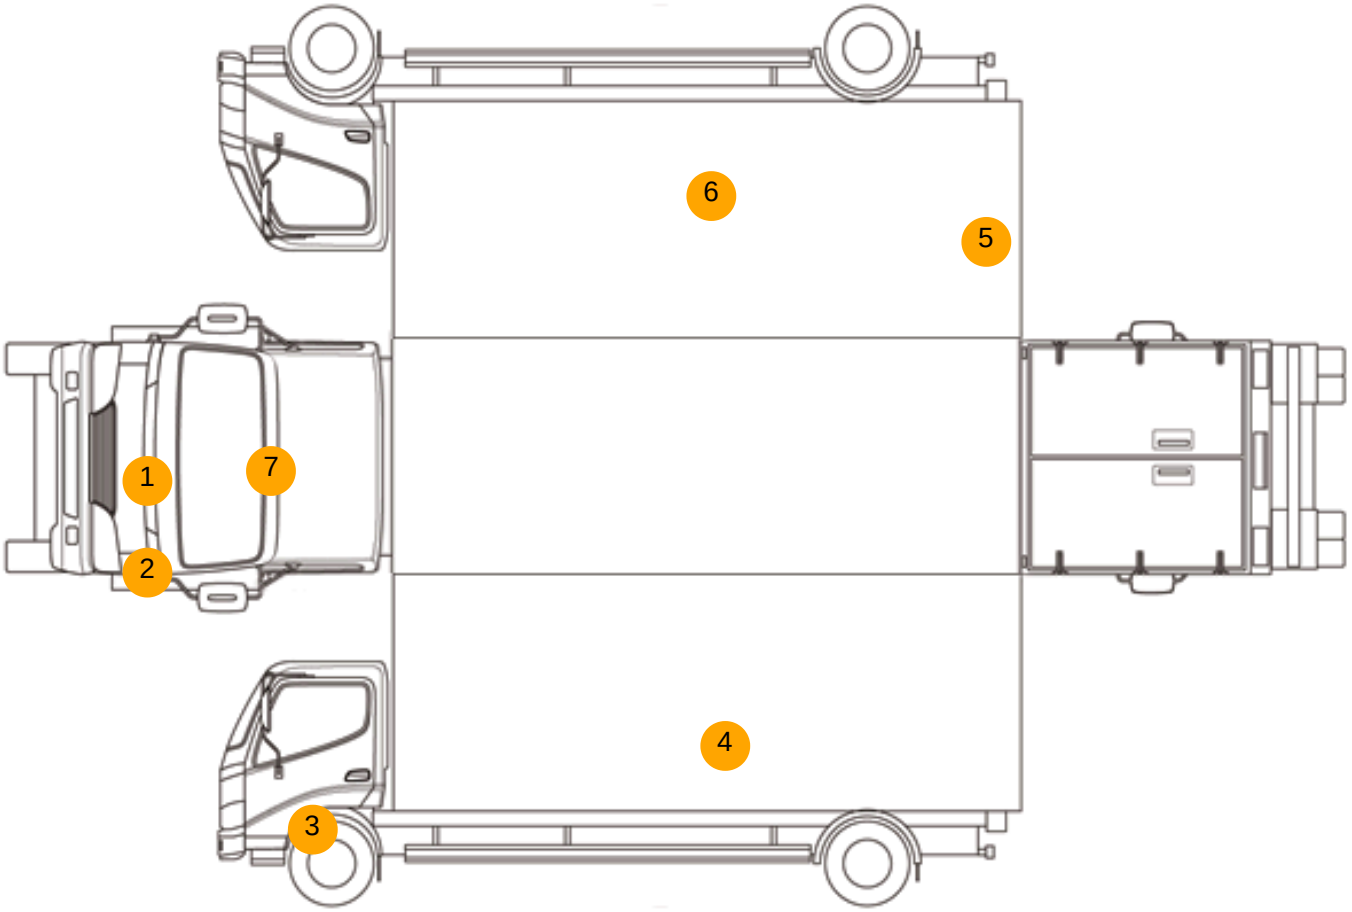
Condition Check

1: Panel Front
Chipped
Multiple Chips

2: Panel Front
Missing
Replace

3: Wing nsf
Cracked
Replace

4: Qtr Panel nsr
Scratched
Over 25mm Thru Paint

5: Qtr Panel osr
Scratched
Over 25mm Thru Paint

6: Qtr Panel osr
Scratched
Over 25mm Not Thru Paint

7: Screen Front
Cracked
Replace

8: Door Pad osf
Soiled
Heavy

9: Seat Base Cover nsf
Soiled
Heavy
