VEHICLE INSPECTION REPORT

LR23WZE

Maxus Deliver 3 90kW 50.2kWh

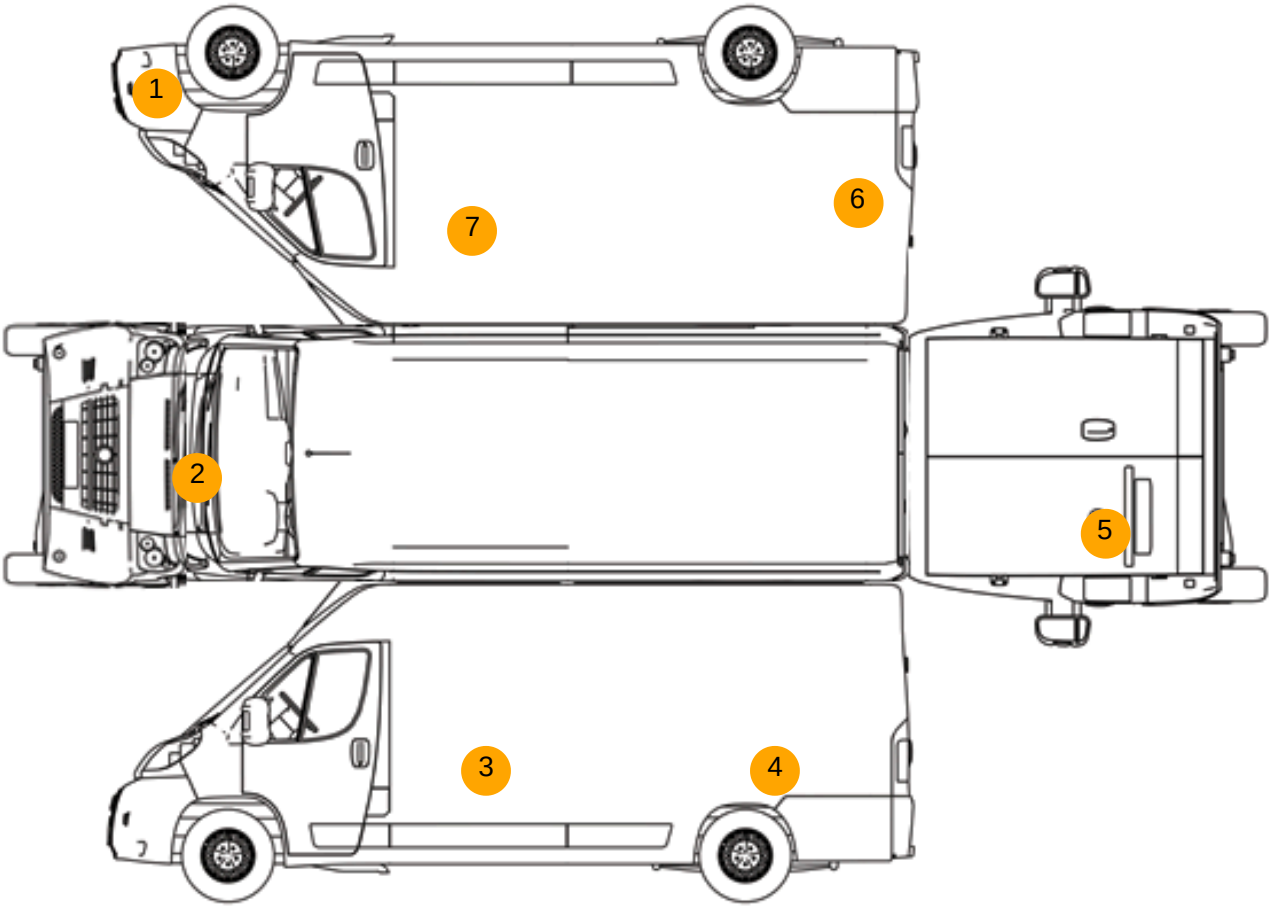
1: Bumper Front
Scratched
25 to 100mm Thru Paint

2: Bonnet
Chipped
Edge Chip

3: Door nsr
Scratched
Over 25mm Not Thru Paint

4: Qtr Panel nsr
Dented
Over 30mm

5: Door nsr
Dented
Over 30mm

6: Qtr Panel osr
Scratched
Over 25mm Not Thru Paint

7: Qtr Panel osr
Dented
With Paint Damage
