VEHICLE INSPECTION REPORT

LR23WZS

Maxus Deliver 3 90kW 50.2kWh

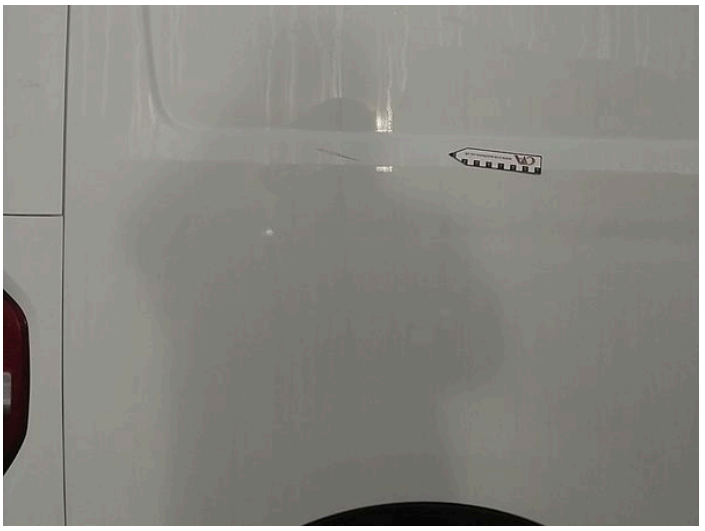
1: Bumper Front Moulding
Broken
Replace

2: Bumper Front Moulding
Broken
Replace

3: Bumper Front
Scratched
25 to 100mm Thru Paint

4: Door nsr
Scratched
Over 25mm Not Thru Paint

5: Door nsr
Dented
With Paint Damage

6: Door osr
Dented
Over 30mm

7: Bumper Rear
Cracked
Over 25mm

8: Qtr Panel osr
Scratched
Over 25mm Not Thru Paint

9: Seat Base Cover osf
Holed
Over 3mm

10: Bonnet
Chipped
Edge Chip
