# VEHICLE INSPECTION REPORT

**LR23WZM**

## Maxus Deliver 3 90KW 50.2KWH

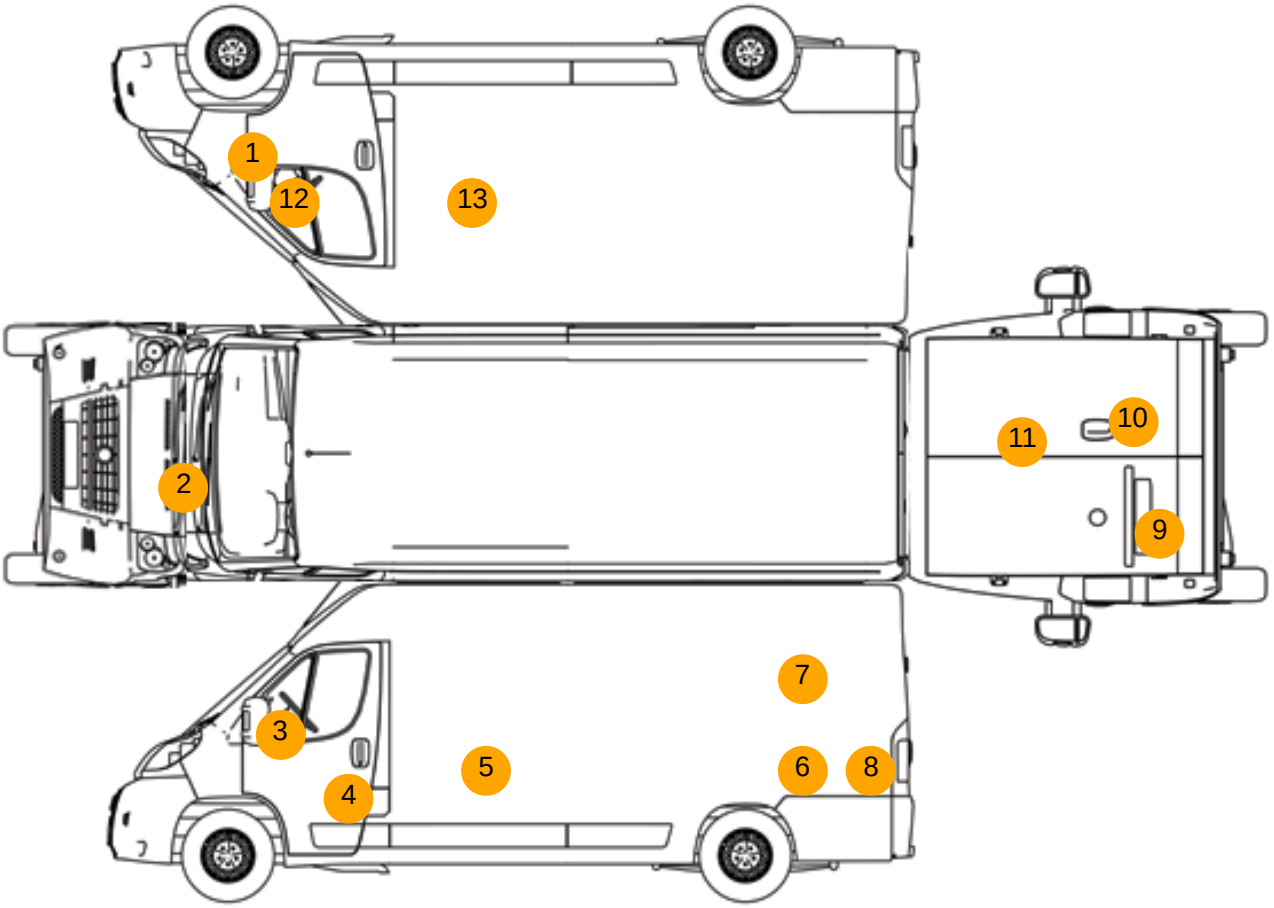
# Condition Check

1: Wing osf
Scratched
UpTo 25mm Not Thru Paint

2: Bonnet
Chipped
Edge Chip

3: Door Mirror Assy nsf
Scuffed (Unpainted)
UpTo 100mm

4: Door nsf
Dented
With Paint Damage

5: Door nsr
Dented
With Paint Damage

6: Qtr Panel nsr
Dented
With Paint Damage

7: Qtr Panel nsr
Scratched
Over 25mm Not Thru Paint

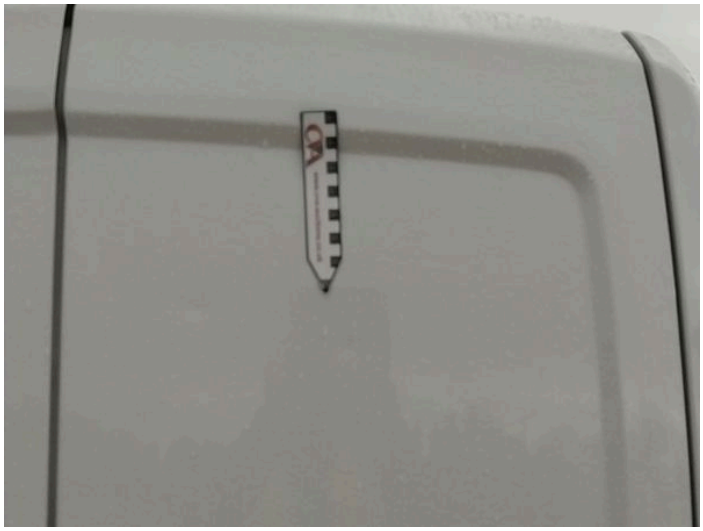
8: Qtr Panel nsr
Dented
With Paint Damage

9: Door nsr
Dented
Over 30mm

10: Door osr
Dented
Over 30mm

11: Door osr
Dented
Over 2 UpTo 10mm

12: Door Mirror Assy osf
Scuffed (Unpainted)
UpTo 100mm

13: Qtr Panel osr
Scratched
UpTo 25mm Not Thru Paint

14: Switches And Controls
Broken
Replace
