VEHICLE INSPECTION REPORT

CK75EHC

Peugeot Partner 1.5 BlueHDI 100PS

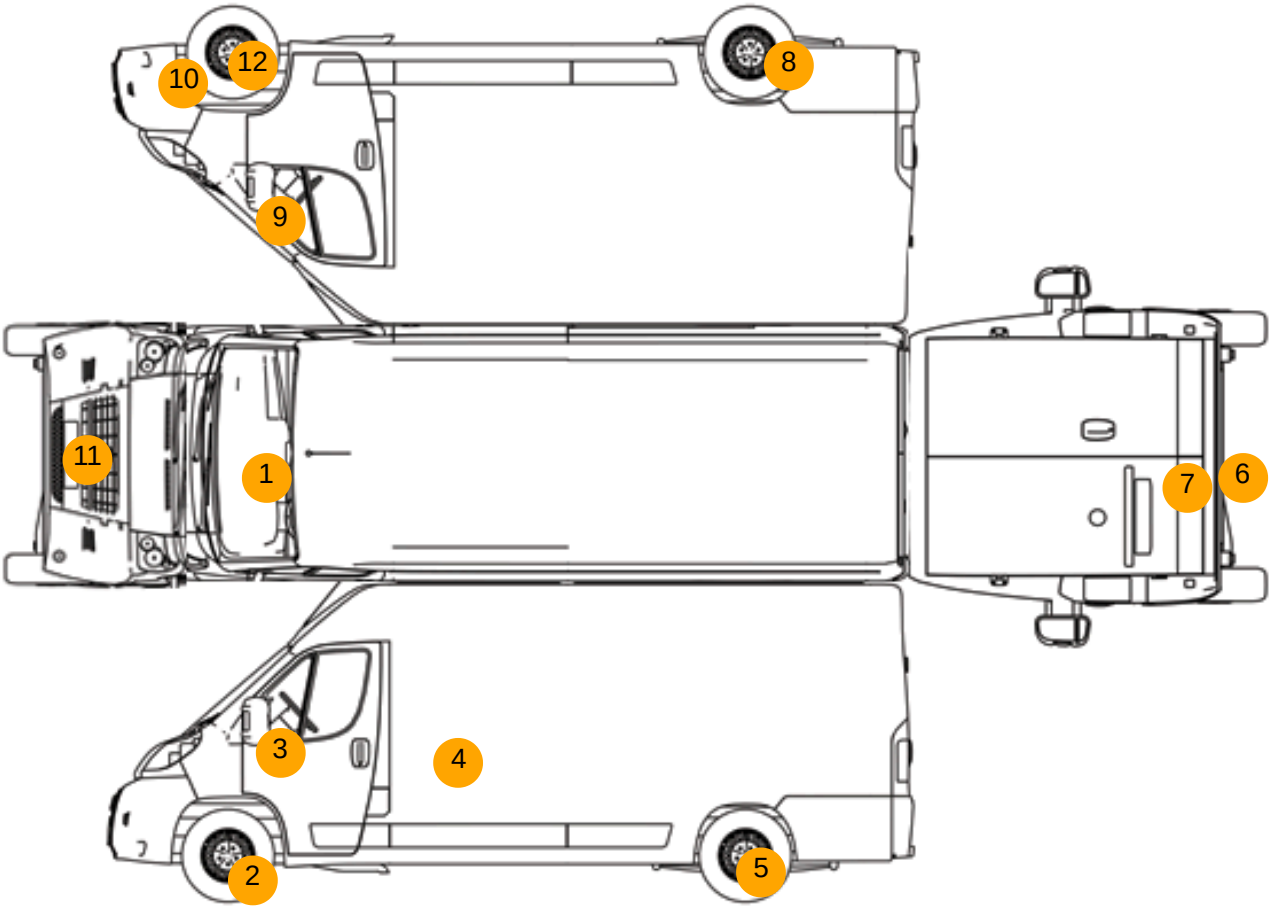
1: Screen Front
Chipped
Over 10mm

2: Wheel nsf
Corroded
Light

3: Door Mirror Assy nsf
Scuffed (Unpainted)
Over 100mm

4: Door nsr
Chipped
Over 5mm

5: Wheel nsr
Corroded
Light

6: Bumper Rear
Scratched
Over 25mm Not Thru Paint

7: Tailgate
Dented
Over 30mm

8: Wheel osr
Corroded
Light

9: Door Mirror Assy osf
Scuffed (Unpainted)
Over 100mm

10: Bumper Front
Scratched
Over 100mm Thru Paint

11: Grille Front
Scratched (Painted)
Over 25mm Thru Paint

12: Wheel osf
Corroded
Light
