VEHICLE INSPECTION REPORT

BT68LWO

Iveco Daily 35-120

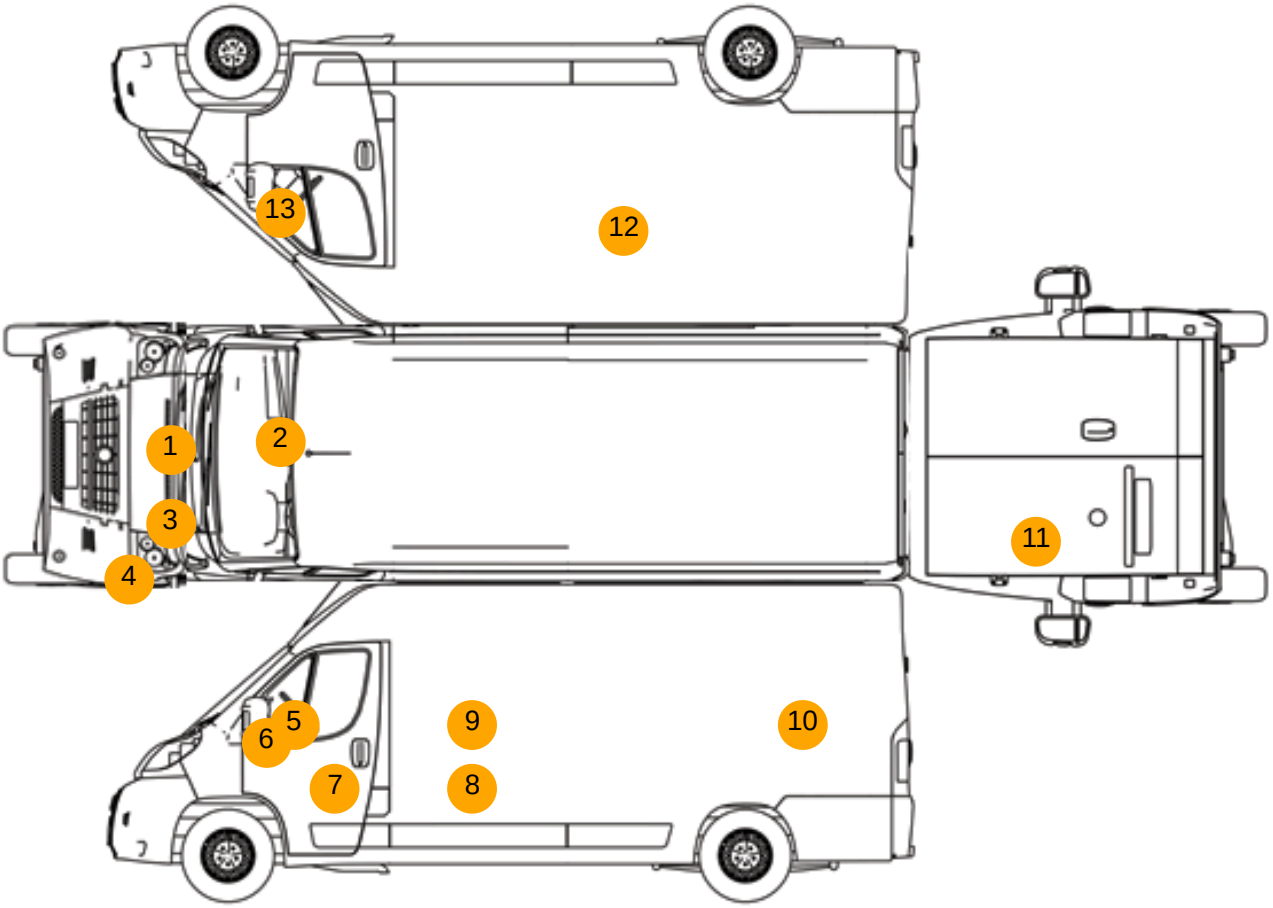
1: Bonnet
Scratched
Over 25mm Not Thru Paint

2: Screen Front
Chipped
Over 10mm

3: Bonnet
Chipped
Multiple Chips

4: Bumper Front Moulding
Scuffed (Unpainted)
Over 100mm
