VEHICLE INSPECTION REPORT

SJ20JJO

Renault Master 35 2.3

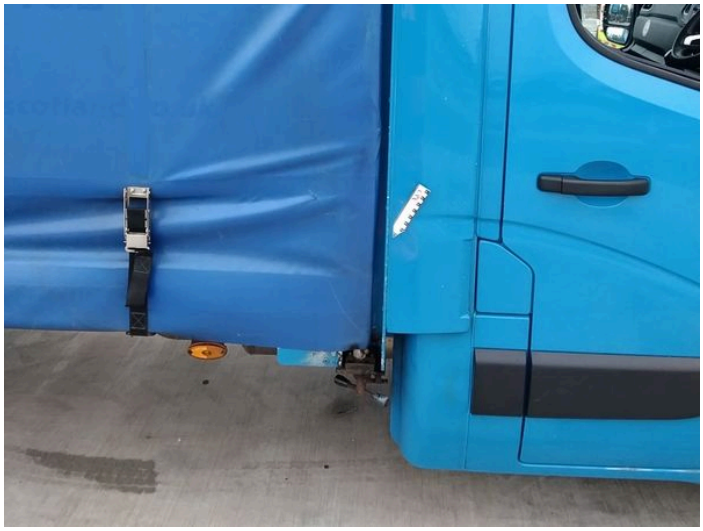
6: Wheel nsf
Corroded
Light

7: Door Mirror Assy nsf
Scuffed (Unpainted)
Over 100mm

8: Door nsf
Scratched
Over 25mm Thru Paint

9: Door nsf
Dented
Over 30mm

10: Roof
Cracked
Replace

11: B Post ns
Chipped
Over 5mm
