VEHICLE INSPECTION REPORT

FL20TWZ

Daf CF 320

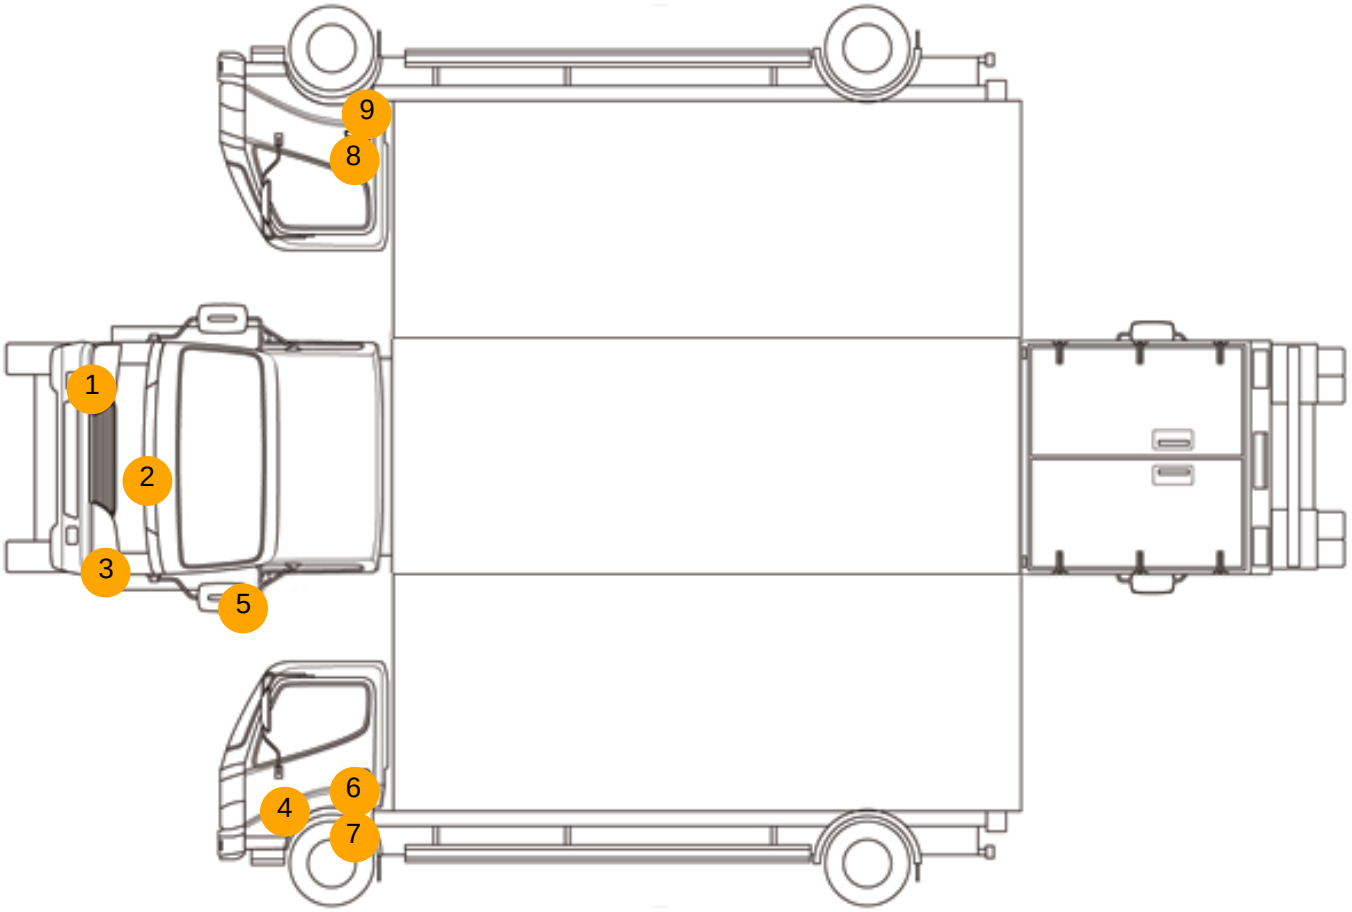
3: Bumper Front
Dented
With Paint Damage

4: Door nsf
Dented
With Paint Damage

7: Wing nsf
Cracked
Replace

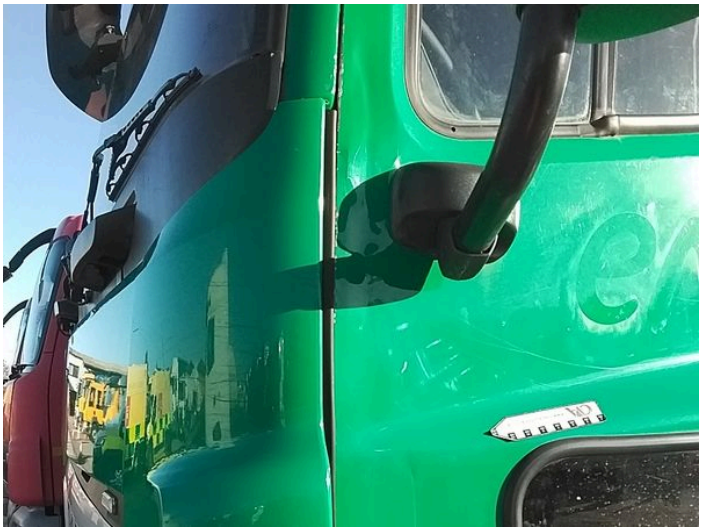
1: Bumper Front
Scratched
Over 100mm Thru Paint

2: Panel Front
Chipped
Multiple Chips

5: Door Mirror Assy nsf
Scuffed (Unpainted)
Over 100mm

6: Door nsf
Scratched
Over 25mm Thru Paint

8: Door osf
Dented
Over 30mm

9: Wing osf
Scratched
Over 25mm Thru Paint
