VEHICLE INSPECTION REPORT

PO70YCH

Fiat Ducato Maxi 35 2.3 Multijet 140PS

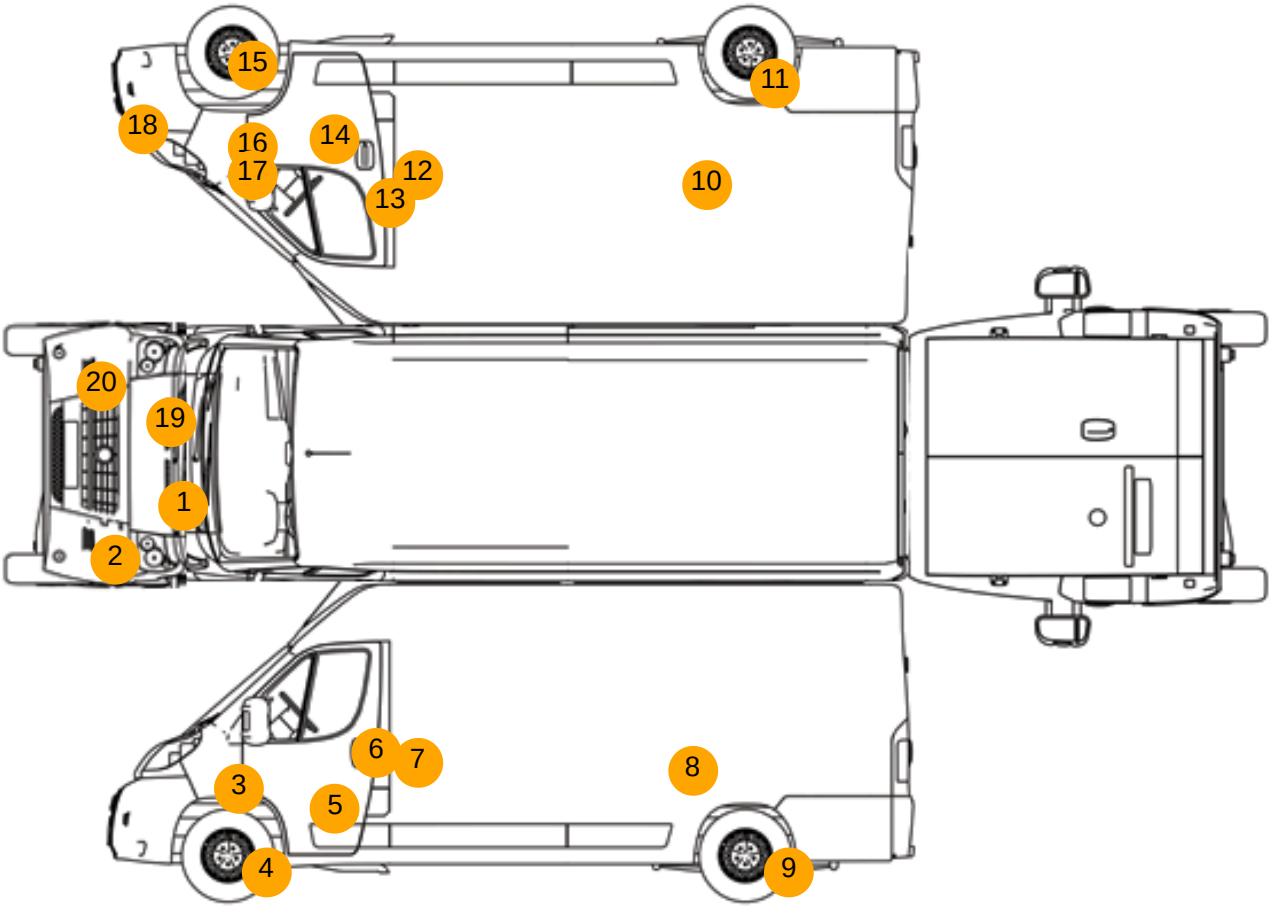
Condition Check

1: Bonnet
Chipped
Over 5mm

2: Bumper Front
Hole
Over 25mm

3: Wing nsf
Chipped
Over 5mm

4: Wheel nsf
Corroded
Light

5: Door nsf
Scratched
Over 25mm Thru Paint

6: Door nsf
Chipped
Over 5mm

9: Wheel nsr
Corroded
Light

11: Wheel osr
Corroded
Light

15: Wheel osf
Corroded
Light

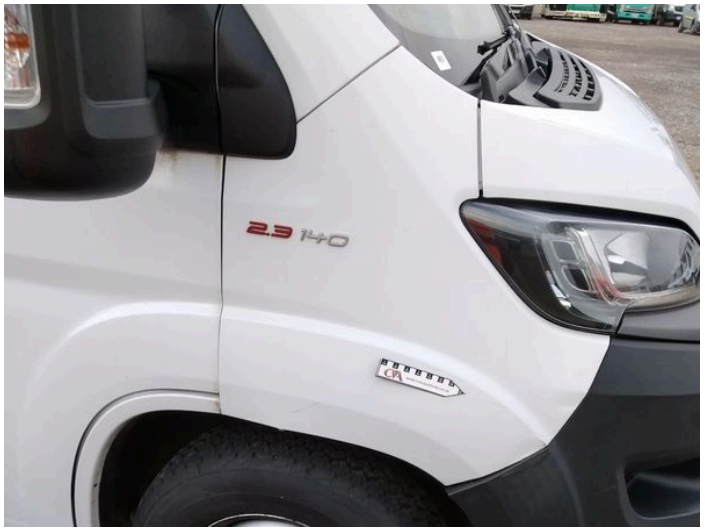
16: Wing osf
Dented
Over 30mm

17: Wing osf
Scratched
Over 25mm Thru Paint

18: Bumper Front
Scratched
Over 100mm Thru Paint

19: Bonnet
Chipped
Over 5mm

20: Bumper Front
Hole
Over 25mm

21: Carpets Front
Holed
Over 3mm
