VEHICLE INSPECTION REPORT

SV22UGO

Renault Master 35 2.3

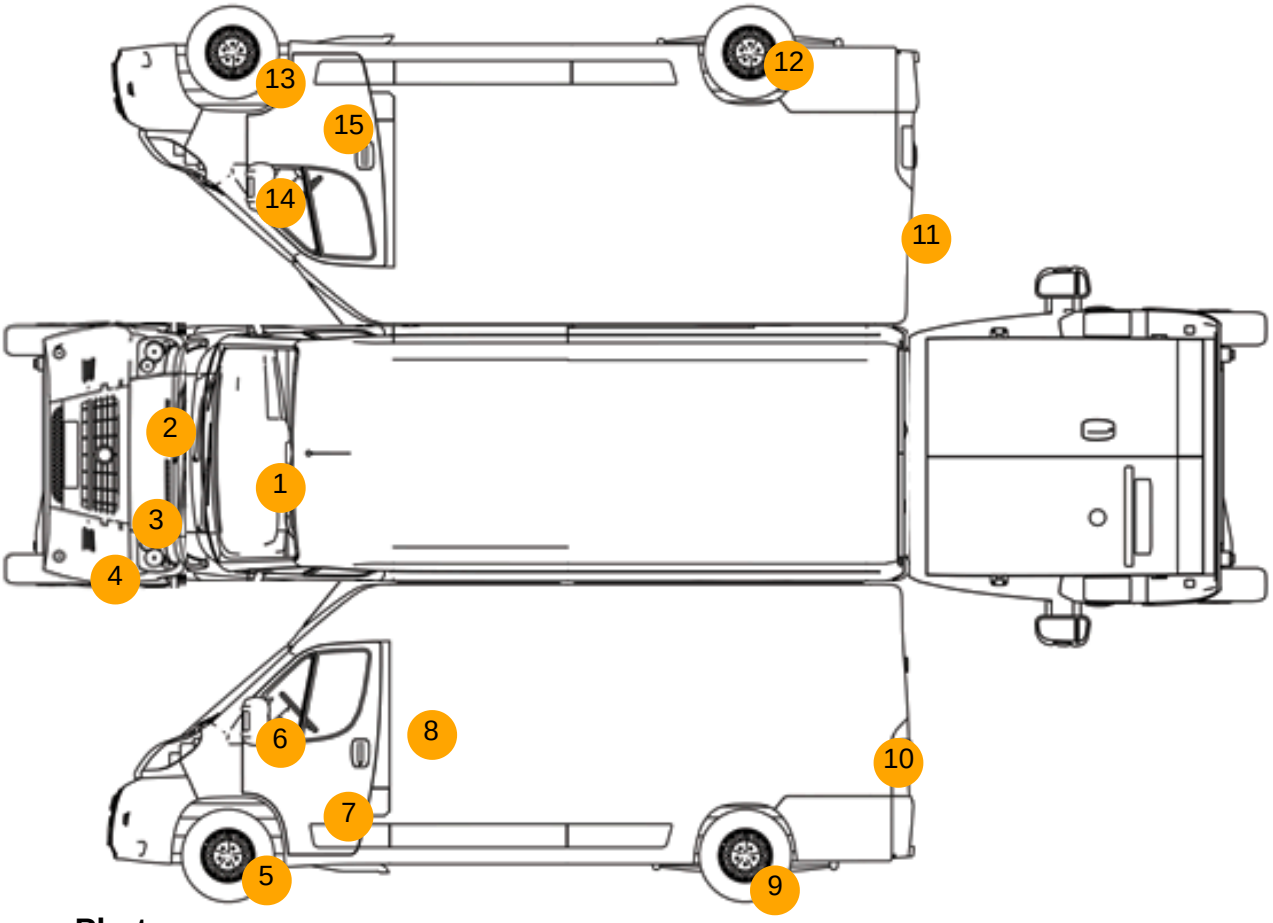
Condition Check

2: Bonnet
Scratched
Over 25mm Thru Paint

3: Bonnet
Chipped
Over 5mm

4: Bumper Front
Scratched
Over 25mm Not Thru Paint

5: Wheel nsf
Corroded
Light

6: Door Mirror Assy nsf
Scuffed (Unpainted)
Over 100mm

7: Door nsf
Scratched
Over 25mm Thru Paint

8: Qtr Panel nsr
Chipped
Over 5mm

9: Wheel nsr
Corroded
Light

10: Qtr Panel nsr
Scratched
Over 25mm Not Thru Paint

11: Qtr Panel osr
Chipped
Over 5mm

12: Wheel osr
Corroded
Light

13: Wheel osf
Corroded
Light

14: Door Mirror Assy osf
Scuffed (Unpainted)
Over 100mm

15: Door osf
Scratched
Over 25mm Thru Paint

16: Seat Back Cover osf
Holed
Over 3mm
