VEHICLE INSPECTION REPORT

YL69FPO

RENAULT TRAFIC SL28 ENERGY DCI 120PS

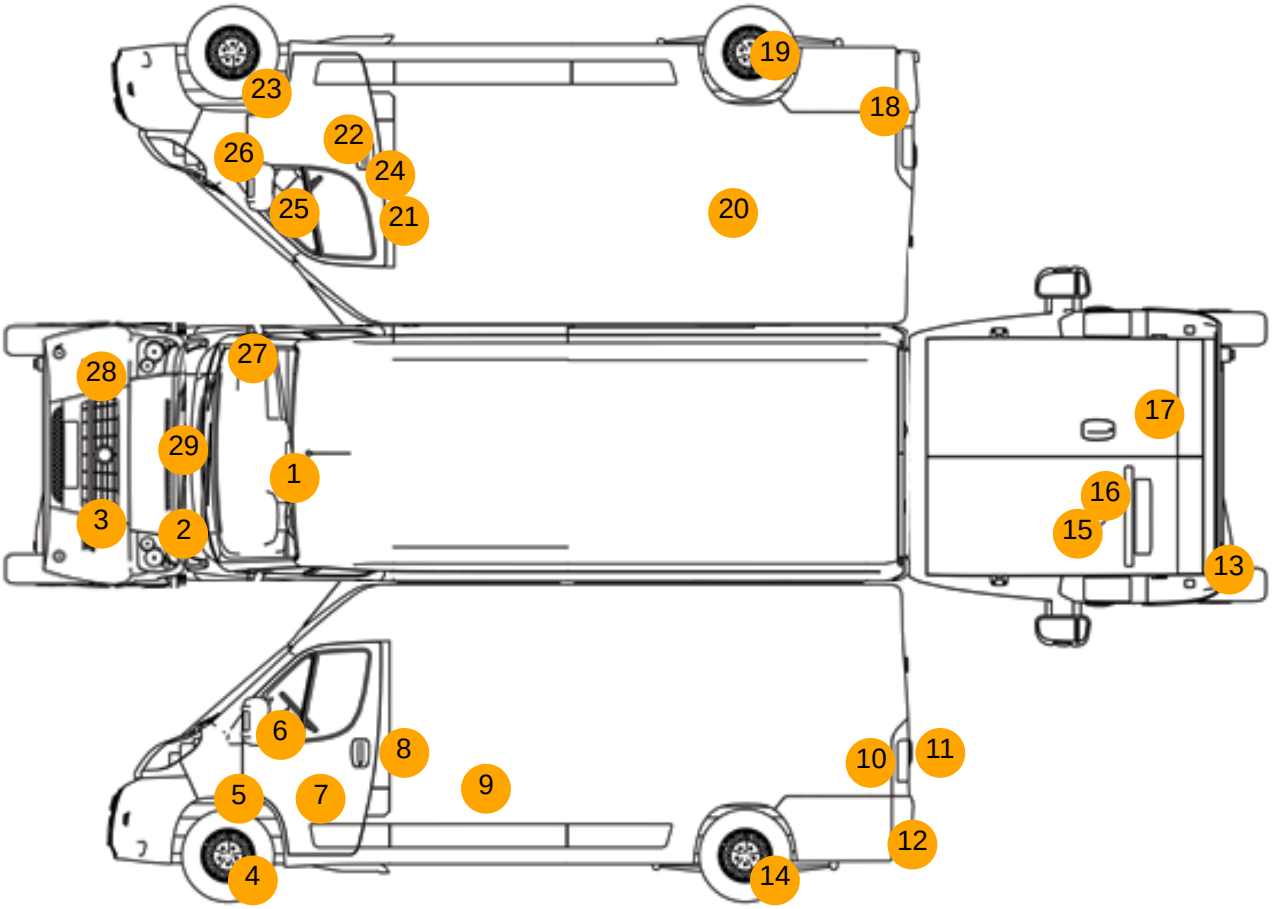
1: Screen Front
Chipped
Over 10mm

2: Bonnet
Chipped
Over 5mm

3: Bumper Front
Chipped
Over 5mm

4: Wheel nsf
Corroded
Light

5: Wing nsf
Chipped
Over 5mm

6: Door Mirror Assy nsf
Scuffed (Unpainted)
Over 100mm

7: Door nsf
Scratched
Over 25mm Thru Paint

8: Door nsf
Chipped
Over 5mm

9: Door nsr
Chipped
Over 5mm

10: Qtr Panel nsr
Chipped
Over 5mm

11: Qtr Panel nsr
Chipped
Over 5mm

12: Bumper Rear
Chipped
Over 5mm

13: Bumper Rear
Scratched
25 to 100mm Thru Paint

14: Wheel nsr
Corroded
Light

15: Tailgate
Chipped
Over 5mm

16: Tailgate
Scratched
Over 25mm Thru Paint

17: Tailgate
Scratched
Over 25mm Thru Paint

18: Bumper Rear
Scratched
Over 100mm Thru Paint

19: Wheel osr
Corroded
Light

20: Qtr Panel osr
Chipped
Over 5mm

21: Door osf
Chipped
Edge Chip

22: Door osf
Chipped
Over 5mm

23: Wheel osf
Corroded
Light

24: Handle Outer osf
Scratched (Painted)
Over 25mm Thru Paint

25: Door Mirror Assy osf
Scuffed (Unpainted)
Over 100mm

26: Wing osf
Chipped
Over 5mm

27: A Post os
Chipped
Over 5mm

28: Bumper Front
Chipped
Over 5mm
