VEHICLE INSPECTION REPORT

PE65UYZ

Daf LF 220

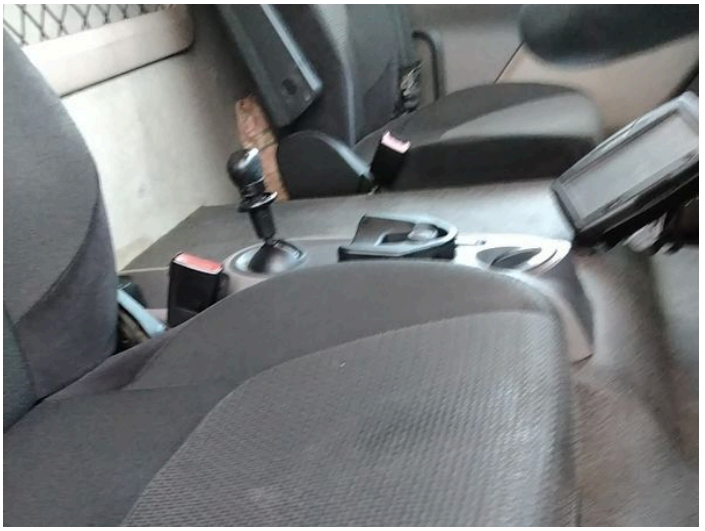
1: Panel Front
Chipped
Over 5mm

2: Wing nsf
Scratched
Over 25mm Thru Paint

3: Door nsf
Scratched
Over 25mm Thru Paint

4: Wheel nsf
Corroded
Light

5: Qtr Panel nsr
Chipped
Over 5mm

6: Qtr Panel nsr
Chipped
Over 5mm

7: Qtr Panel nsr
Scratched
Over 25mm Not Thru Paint

8: Wheel nsr
Corroded
Light

9: Qtr Panel nsr
Chipped
Over 5mm

10: Tailgate
Rusted
Over 5mm

11: Tailgate
Rusted
Over 5mm

12: Qtr Panel osr
Scratched
Over 25mm Thru Paint

13: Qtr Panel osr
Chipped
Over 5mm

14: Wheel osr
Corroded
Light

15: Qtr Panel osr
Hole
Over 10mm

16: Qtr Panel osr
Scratched
Over 25mm Thru Paint

17: Qtr Panel osr
Chipped
Over 5mm

18: Qtr Panel osr
Chipped
Over 5mm

19: Door osf
Chipped
Over 5mm

20: Wheel osf
Corroded
Light

21: Wing osf
Scratched
Over 25mm Thru Paint

22: Panel Front
Chipped
Over 5mm

23: Grille Front
Broken
Replace

24: Seat Base Cover osf
Holed
Over 3mm

25: Centre Console Front
Holed
Over 3mm

26: Centre Console Front
Missing
Replace
