VEHICLE INSPECTION REPORT

MC73OMJ

Ford Ranger WILDTRAK 2.0 ECOBLUE 205PS

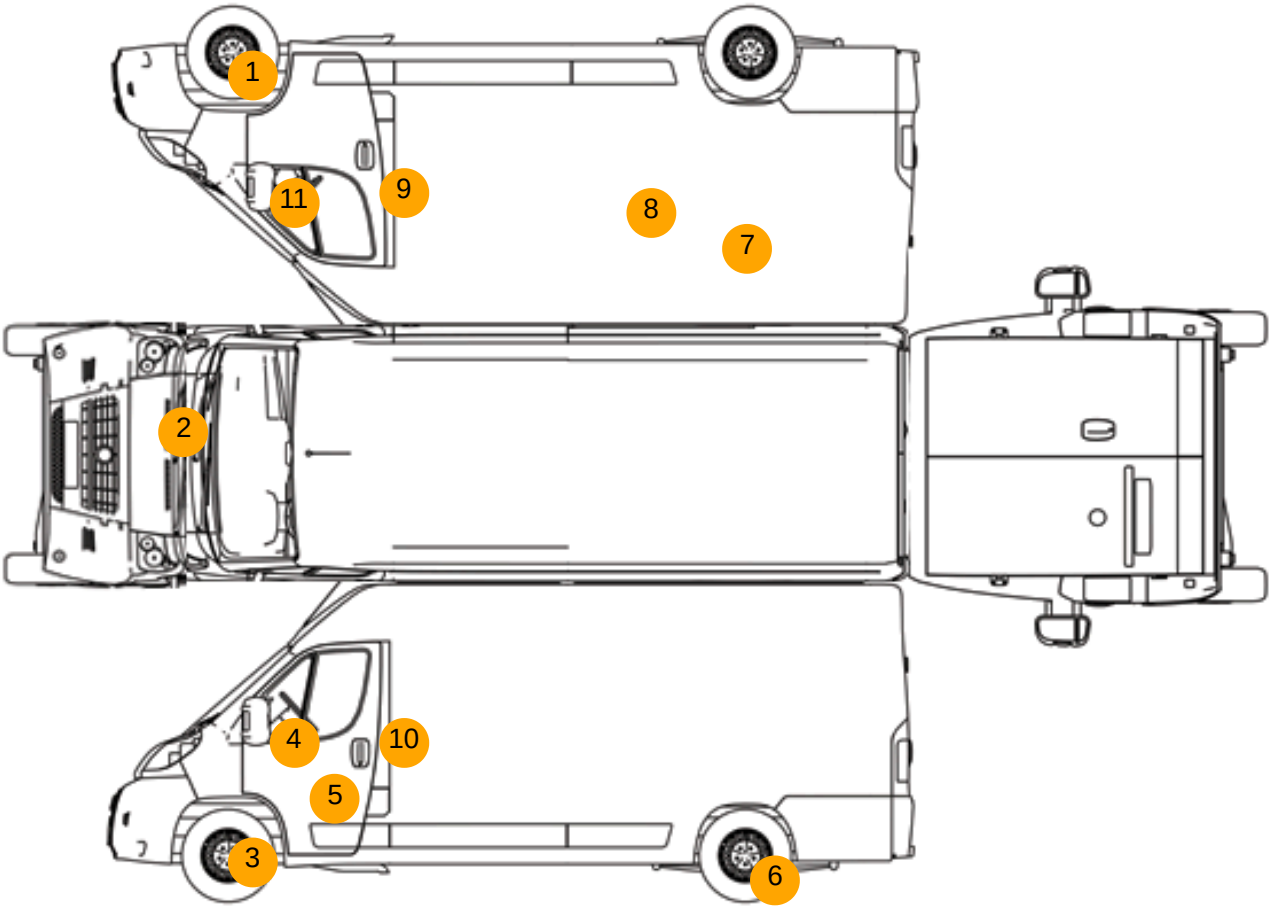
Damage Photos

1: Wheel osf
Scratched
Up To 50mm

2: Bonnet
Chipped
1 To 5

3: Wheel nsf
Scratched
Up To 50mm

4: Door Mirror Assy nsf
Scratched (Painted)
Over 25mm Not Thru Paint

5: Door nsf
Scratched
UpTo 25mm Thru Paint

6: Wheel nsr
Scratched
Up To 50mm

7: Qtr Panel osr
Scratched
UpTo 25mm Thru Paint

8: Door osr
Chipped
1 To 5

9: Door osf
Chipped
Edge Chip

10: Door nsf
Chipped
Edge Chip

11: Door Mirror Assy osf
Scratched (Painted)
UpTo 25mm Not Thru Paint
