VEHICLE INSPECTION REPORT

WP18BLJ

Vauxhall Corsa 1.3 CDTi 16V 95PS ECOTEC

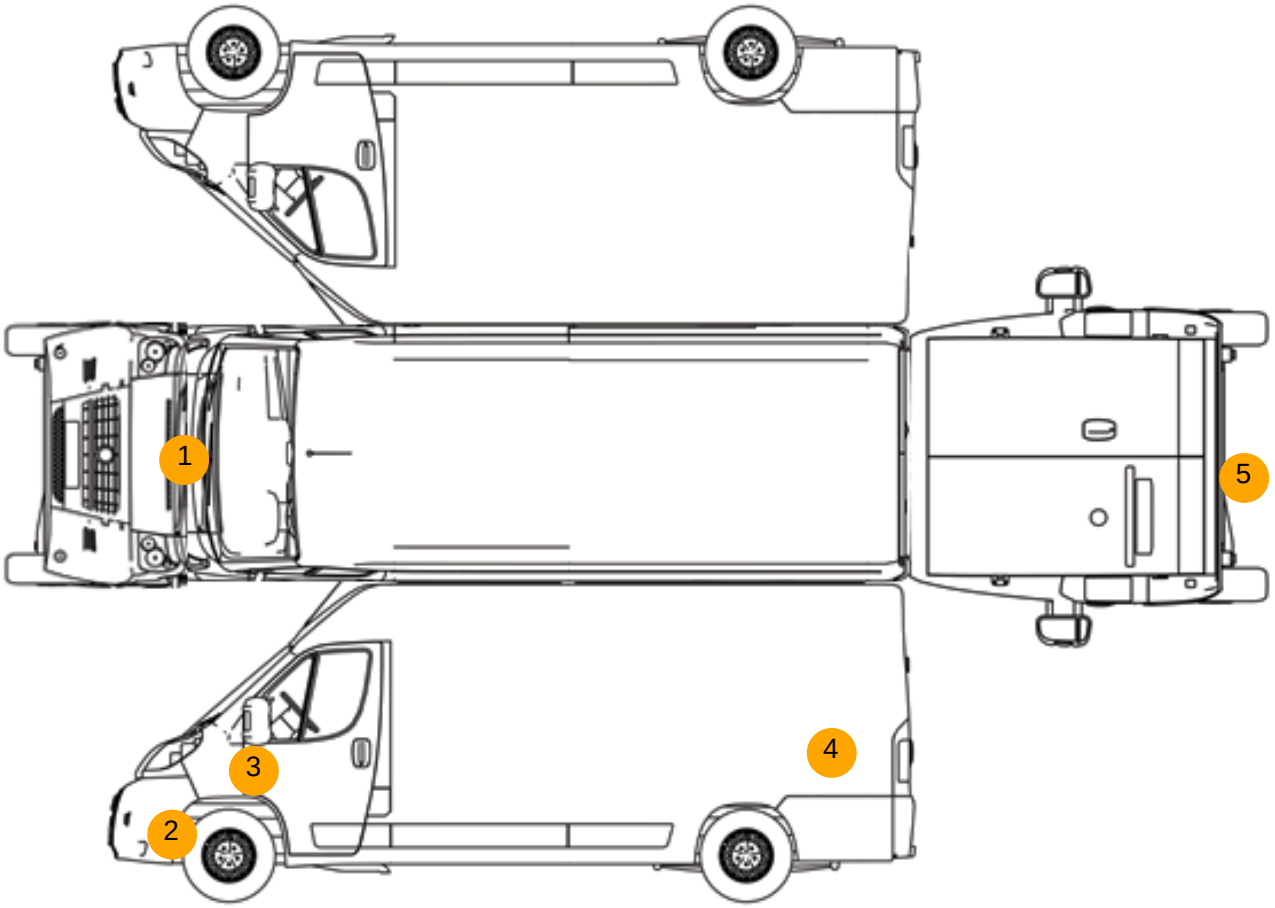
1: Bonnet
Chipped
Multiple Chips

2: Bumper Front
Scratched
25 to 100mm Thru Paint

3: Wing nsf
Dented
With Paint Damage

4: Qtr Panel nsr
Scratched
Over 25mm Thru Paint

5: Bumper Rear
Scratched
Over 100mm Thru Paint
