VEHICLE INSPECTION REPORT

PE63NVN

Daf LF 55.220

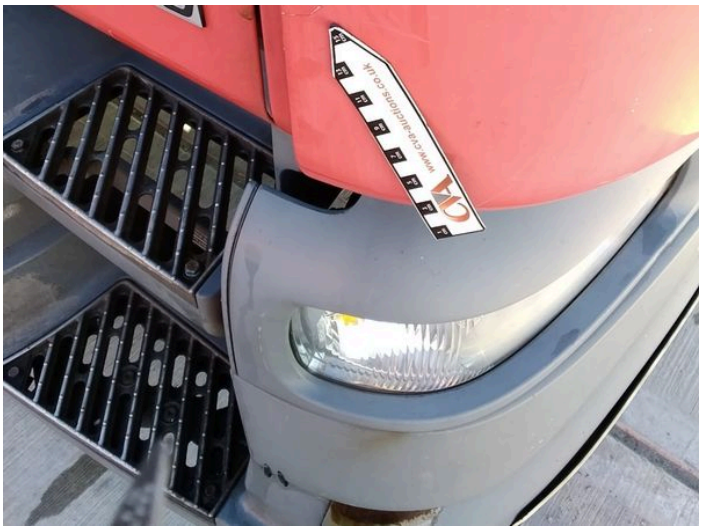
1: Bonnet
Chipped
Multiple Chips

2: Bumper Front
Cracked
Over 25mm

3: Bumper Front
Cracked
Over 25mm

4: Door nsf
Chipped
Multiple Chips

5: Qtr Panel nsr
Poor Previous Repair
Poor Paint

6: Door osf
Chipped
Multiple Chips

7: Door osf
Scratched
Over 25mm Thru Paint

8: Moulding osf Wing
Scratched (Painted)
Over 25mm Thru Paint

9: Bumper Front
Insecure
Action Required

10: Switches And Controls
Missing
Replace

11: Fascia Trim
Missing
Replace

12: In Car Entertainment
Broken
Replace

13: Centre Console Front
Holed
Over 3mm

14: Dash Warning Lights
Displayed
No Action
