VEHICLE INSPECTION REPORT

PE64EYP

Daf LF 220

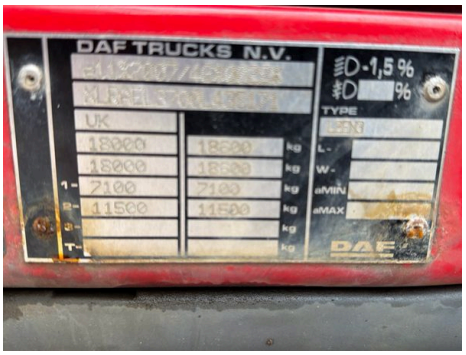
Vehicle Identification No.
YT RAEL3700L438171
DAF /LF220 FA
RIGID
11/09/14
2540
18000
18000
7100
11500
DEPARTMENT FOR
09/01/15
TRANSPORT
GREAT BRITAIN
REPLACEMENT

DAF TRUCKS N.V.
D-1,5 %
TYPE
UK
18000
18000
7100
11500
DAF
