VEHICLE INSPECTION REPORT

GJ65ZXC

Mercedes-Benz Actros 1824

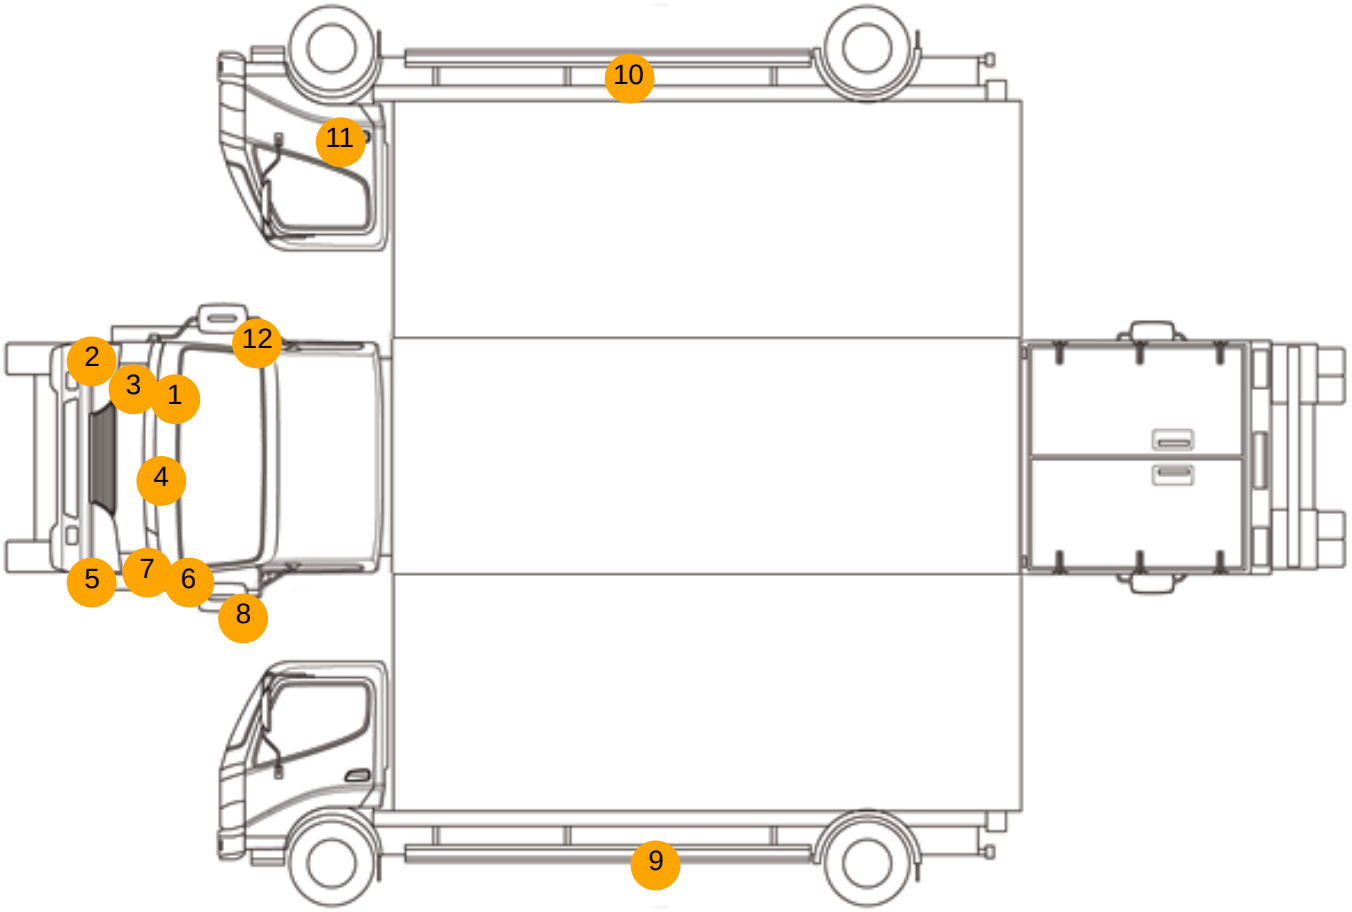
Damage Photos

1: Wing osf
Chipped
Multiple Chips

2: Bumper Front
Dented
Between 10mm + 30mm

3: Fog Lamp Surround os
Scratched (Painted)
UpTo 25mm Thru Paint

4: Bonnet
Chipped
Multiple Chips

5: Bumper Front
Cracked
UpTo 25mm

6: Wing nsf
Poor Previous Repair
Poor Paint

7: Fog Lamp Surround ns
Scratched (Painted)
Over 25mm Thru Paint

8: Door Mirror Assy nsf
Broken
Replace

9: Qtr Panel nsr
Dented
Over 30mm

10: Qtr Panel osr
Dented
Over 30mm

11: Qtr Panel Arch Extension os
Scratched (Painted)
Over 25mm Thru Paint

12: Door Mirror Assy osf
Broken
Replace

13: Seat Base Cover osf
Holed
Over 3mm
