VEHICLE INSPECTION REPORT

PE17HPL

Daf CF 440

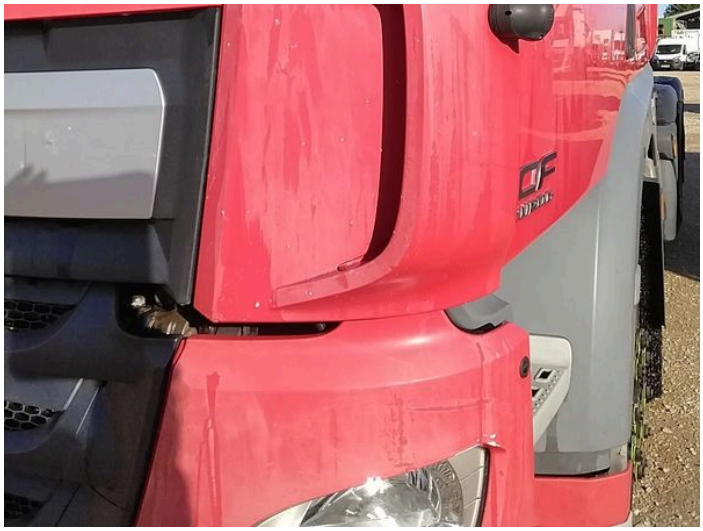
1: Wing osf
Chipped
Multiple Chips

2: Bumper Front
Poor Previous Repair
Poor Paint

3: Bonnet
Chipped
Multiple Chips

4: Screen Front
Chipped
Over 10mm

5: Wing nsf
Chipped
Multiple Chips

6: Door Mirror Assy nsf
Broken
Replace

7: Door nsf
Dented
Between 10mm + 30mm

8: Wing Front Arch Extension ns
Scuffed (Unpainted)
Over 100mm

9: Qtr Panel nsr
Scratched
Over 25mm Not Thru Paint

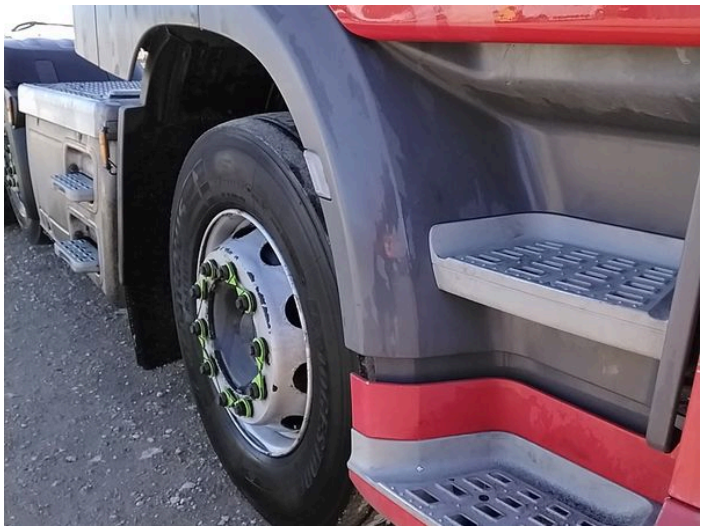
10: Qtr Panel Arch Extension ns
Missing
Replace

11: Door osf
Scratched
Over 25mm Thru Paint

12: Door Mirror Assy osf
Scuffed (Unpainted)
Over 100mm

13: Wing Front Arch Extension os
Scuffed (Unpainted)
UpTo 100mm

14: Door osf
Chipped
Edge Chip

15: Switches And Controls
Broken
Replace
