VEHICLE INSPECTION REPORT

PE17HSZ

Daf CF 440

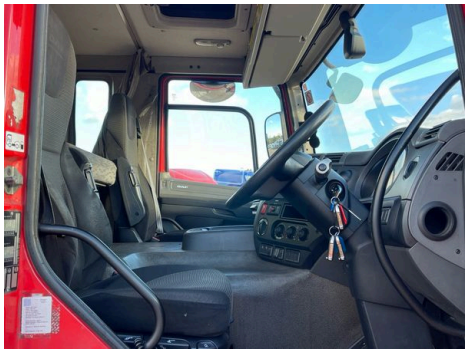
WARNING LIGHTS ON DASH
