COMMERCIAL VEHICLE AUCTIONS LTD
THE UK'S MOST ESTABLISHED COMMERCIAL VEHICLE AUCTIONEERS

VEHICLE INSPECTION REPORT

PE63NVO

Daf LF 55.220

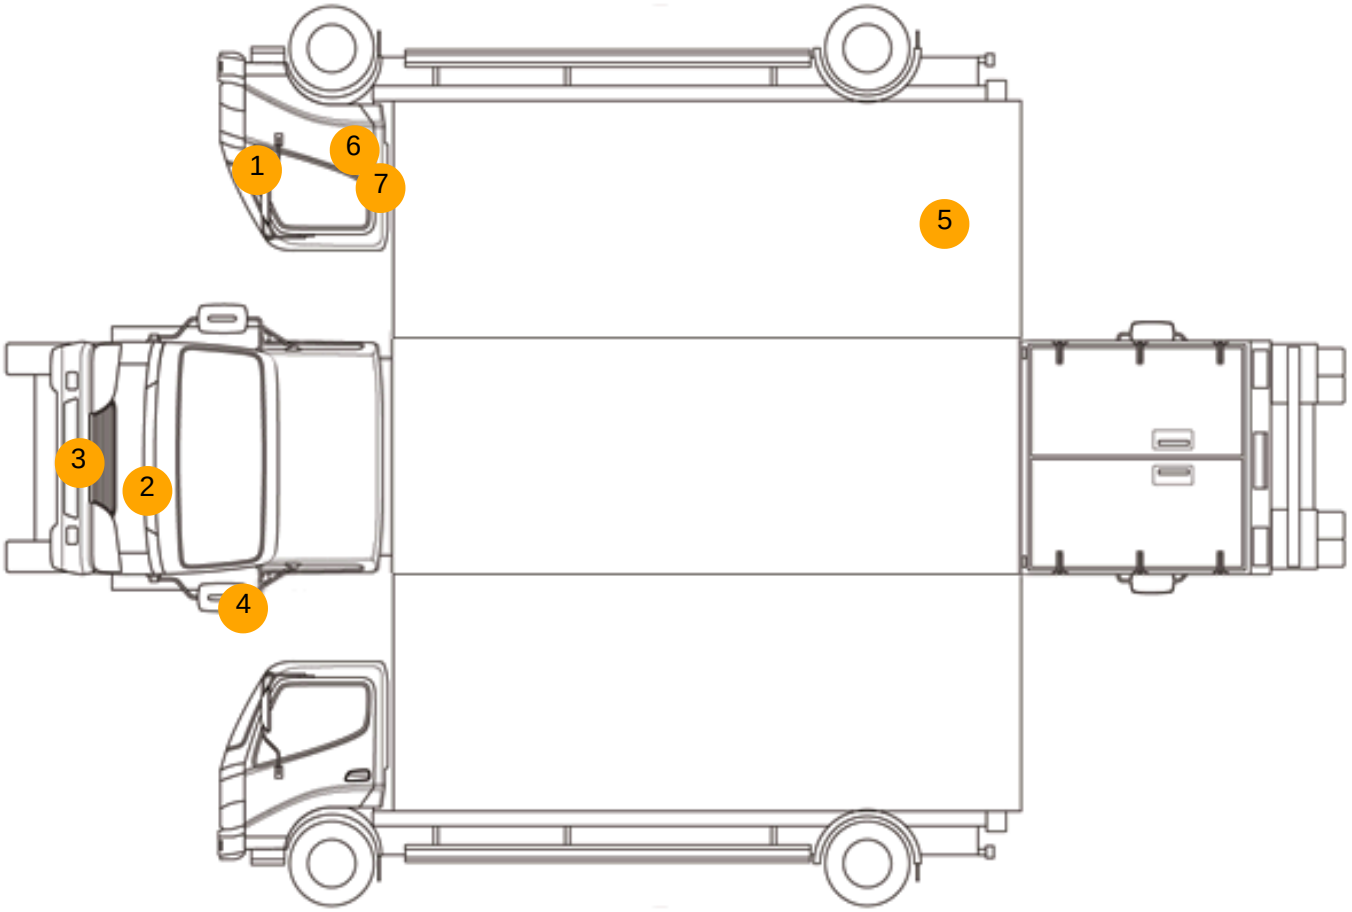
1: Panel Front
Cracked
Replace

2: Panel Front
Chipped
Multiple Chips

3: Bumper Front
Chipped
Multiple Chips

4: Door Mirror Assy nsf
Scuffed (Unpainted)
UpTo 100mm

5: Qtr Panel osr
Scratched
Over 25mm Thru Paint

6: Door osf
Dented
With Paint Damage

7: Door osf
Scratched
Over 25mm Thru Paint

8: Door Pad osf
Soiled
Heavy
