VEHICLE INSPECTION REPORT

PE65UZA

Daf LF 220

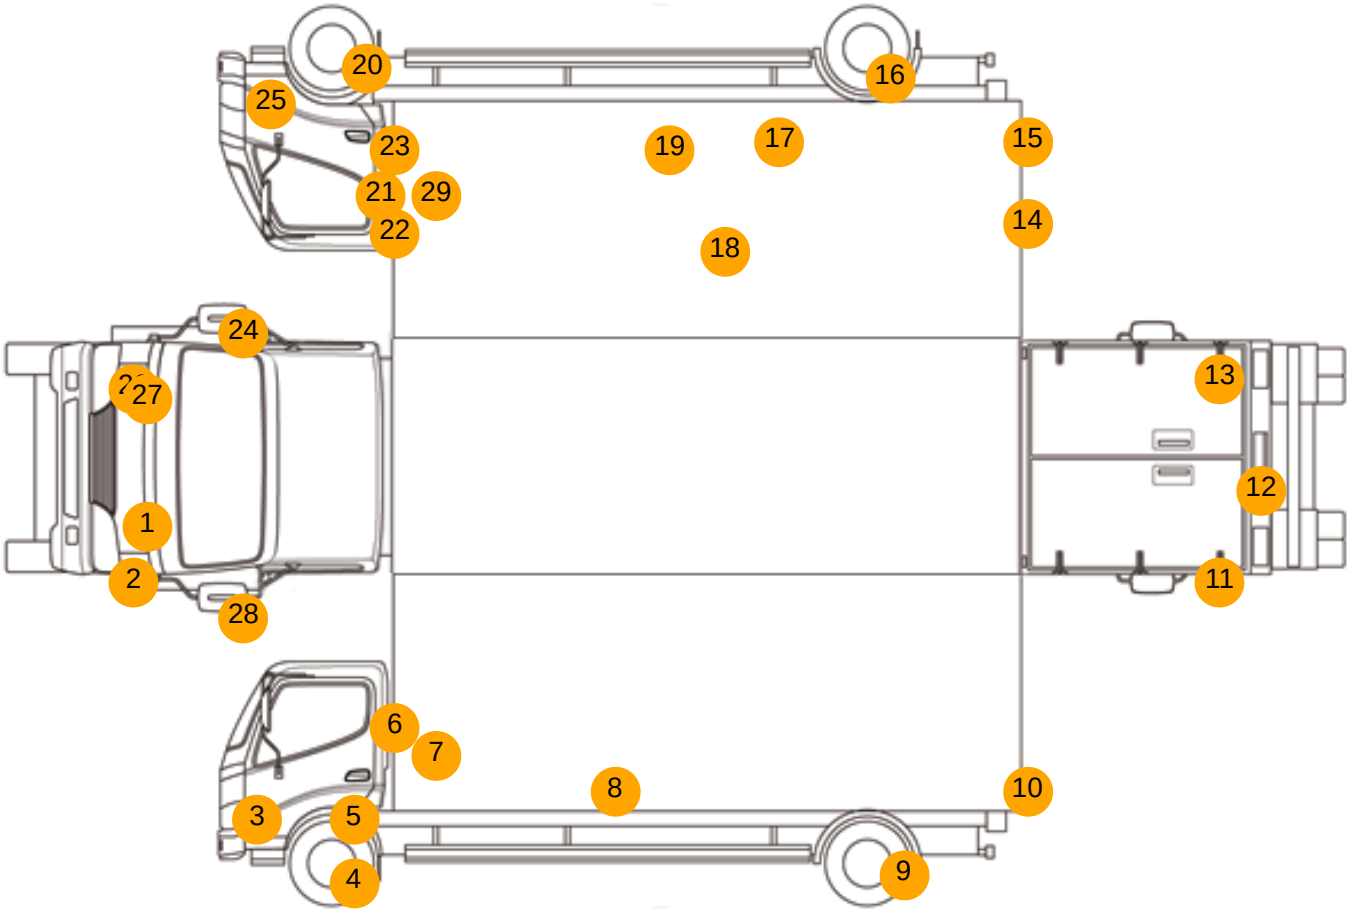
Damage Photos

1: Panel Front
Chipped
Over 5mm

2: Panel Front
Scratched
Over 25mm Thru Paint

3: Wing nsf
Scratched
Over 25mm Thru Paint

4: Wheel nsf
Corroded
Light

5: Door nsf
Chipped
Over 5mm

6: Door nsf
Chipped
Edge Chip

7: Qtr Panel nsr
Chipped
Over 5mm

8: Qtr Panel nsr
Chipped
Over 5mm

9: Wheel nsr
Corroded
Light

10: Qtr Panel nsr
Chipped
Over 5mm

11: Tailgate
Rusted
Over 5mm

12: Tailgate
Chipped
Over 5mm

13: Tailgate
Rusted
Over 5mm

14: Qtr Panel osr
Scratched
Over 25mm Thru Paint

15: Qtr Panel osr
Chipped
Over 5mm

16: Wheel osr
Corroded
Light

17: Qtr Panel osr
Chipped
Over 5mm

18: Qtr Panel osr
Scratched
Over 25mm Thru Paint

19: Qtr Panel osr
Scratched
Over 25mm Thru Paint

20: Wheel osf
Corroded
Light

21: Door osf
Chipped
Edge Chip

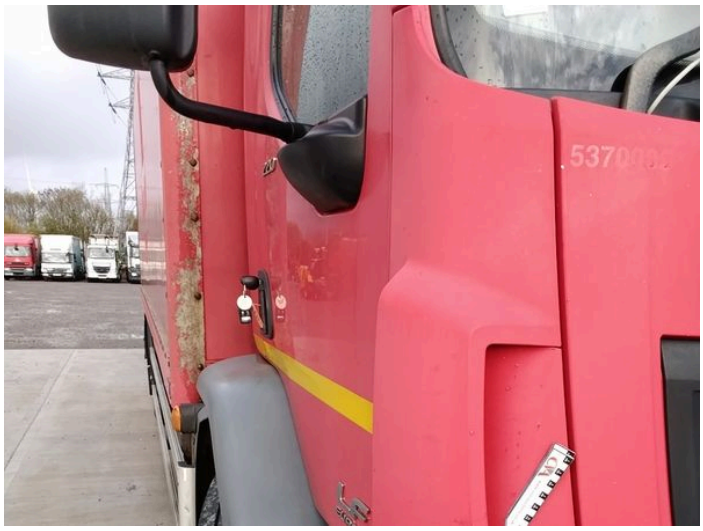
22: Qtr Panel osr
Chipped
Over 5mm

23: Door osf
Scratched
Over 25mm Thru Paint

24: Door Mirror Assy osf
Broken
Replace

25: Wing osf
Chipped
Over 5mm

26: Bumper Front
Scratched
Over 100mm Thru Paint

27: Panel Front
Chipped
Over 5mm

28: Door Mirror Assy nsf
Broken
Replace

29: Qtr Panel osr
Chipped
Over 5mm

30: Centre Console Front
Holed
Over 3mm
