VEHICLE INSPECTION REPORT

MT23ERO

Ford Ranger WILDTRAK 2.0 ECOBLUE 213PS

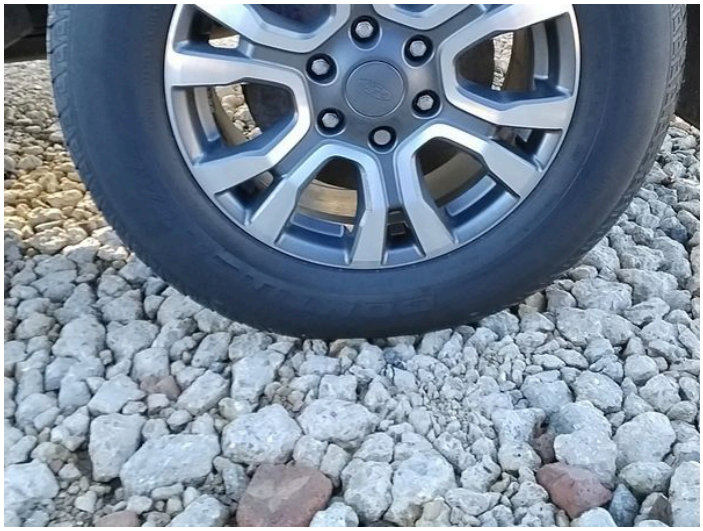
2: Wheel nsf
Scratched
Up To 50mm
