VEHICLE INSPECTION REPORT

V555JWT

Mercedes-Benz Tourismo

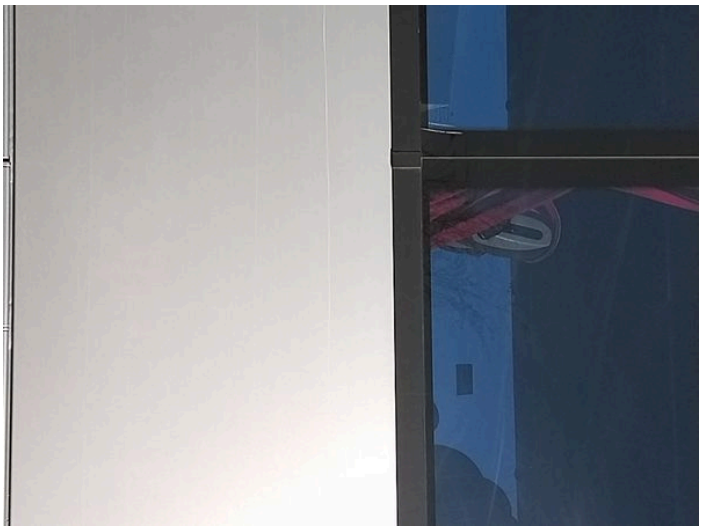
1: Bumper Front
Chipped
Multiple Chips

2: Wing nsf
Scratched
UpTo 25mm Thru Paint

3: Wing nsf
Rusted
Over 5mm

4: Wing nsf
Scratched
Over 25mm Thru Paint

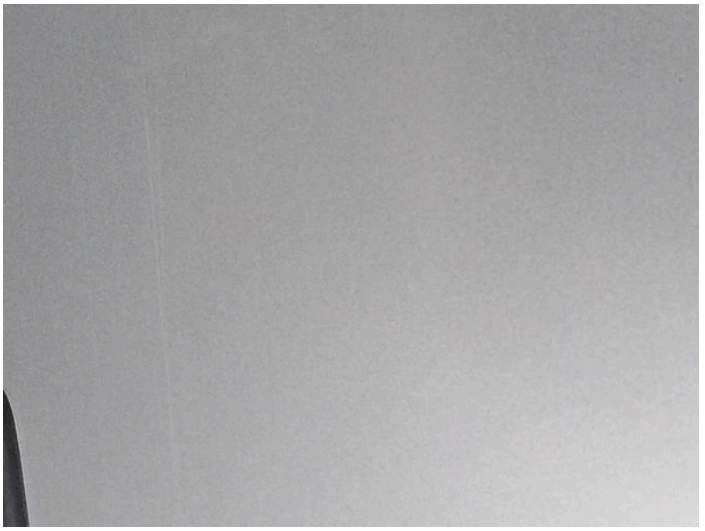
5: Qtr Panel nsr
Scratched
UpTo 25mm Thru Paint

6: Qtr Panel nsr
Scratched
Over 25mm Thru Paint

7: Qtr Panel nsr
Chipped
Over 5mm

8: Qtr Panel nsr
Scratched
Over 25mm Thru Paint

9: Tailgate
Chipped
Over 5mm

10: Tailgate
Scratched
Over 25mm Thru Paint

11: Tailgate
Chipped
Multiple Chips

12: Qtr Panel osr
Chipped
Over 5mm
