VEHICLE INSPECTION REPORT

MK65CXB

Vauxhall Vivaro 2700 1.6 CDTI 115PS

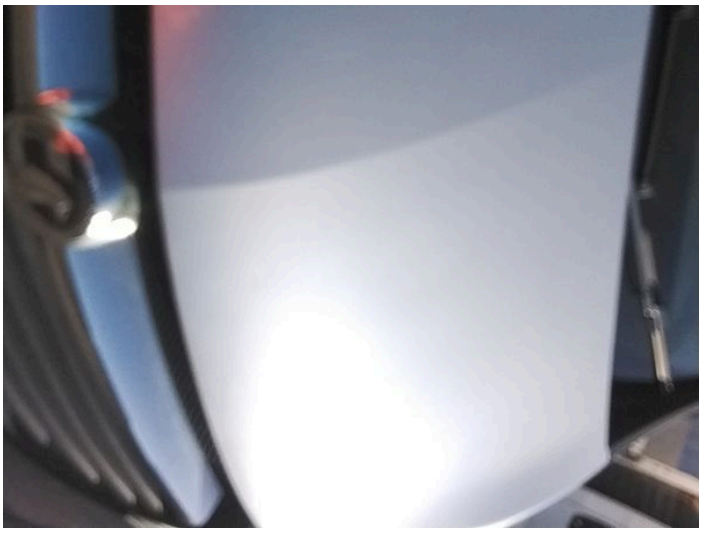
1: Bumper Front
Cracked
Over 25mm

2: Bonnet
Chipped
Multiple Chips

3: Bumper Front
Insecure
Action Required

4: Door Mirror Assy nsf
Scuffed (Unpainted)
Over 100mm

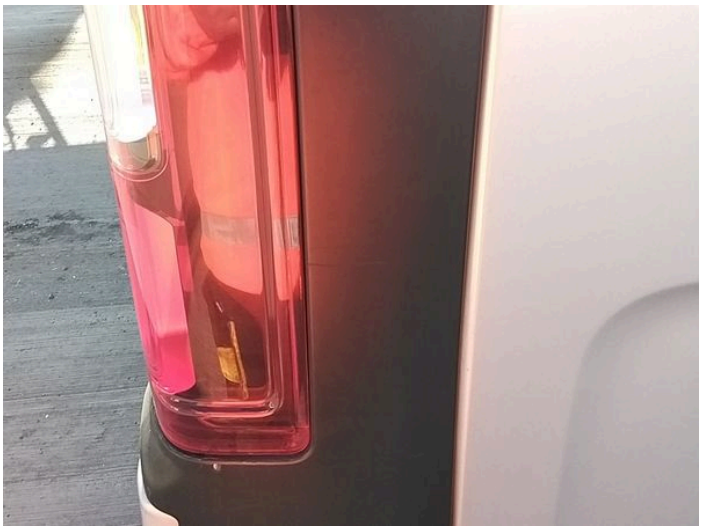
5: Qtr Panel nsr
Dented
With Paint Damage

6: Qtr Panel Moulding ns
Scuffed (Unpainted)
Over 100mm

7: Qtr Panel osr
Dented
Over 30mm

8: Qtr Panel Moulding os
Scuffed (Unpainted)
UpTo 100mm

9: Qtr Panel osr
Scratched
Over 25mm Thru Paint

10: Door osf
Dented
With Paint Damage

11: Wing osf
Scratched
Over 25mm Thru Paint

12: Seat Base Cover nsf
Soiled
Heavy
