VEHICLE INSPECTION REPORT

YE23OPH

Iveco S-Way 490

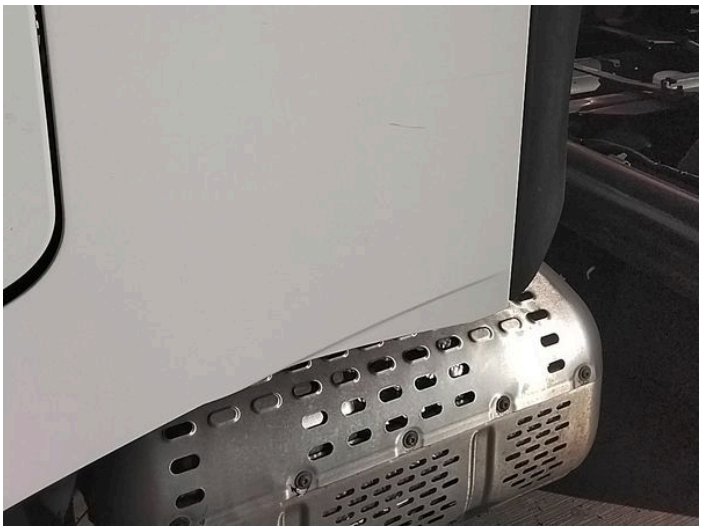
1: Bumper Front Moulding
Broken
Replace

2: Panel Front
Missing
Replace

3: Panel Front
Chipped
Multiple Chips

4: Panel Front
Missing
Replace

5: Bumper Front Moulding
Broken
Replace

6: Door Mirror Assy nsf
Broken
Replace

7: Qtr Panel Moulding ns
Scratched (Painted)
Over 25mm Thru Paint

8: Qtr Panel Trim ns
Scuffed
Over 25mm

9: Door osf
Scratched
Over 25mm Thru Paint

10: Door Moulding osf
Broken
Replace
