VEHICLE INSPECTION REPORT

PO21YWC

Mercedes-Benz Sprinter 317 CDI PROGRESSIVE

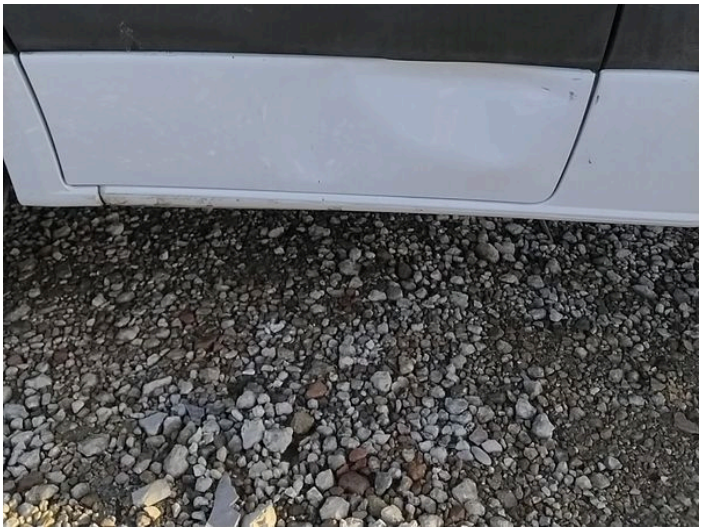
2: Wing nsf
Dented
Between 10mm + 30mm
