VEHICLE INSPECTION REPORT

KP71UWU

Vauxhall Movano F3500 CDTI 2.3 Turbo D 150ps

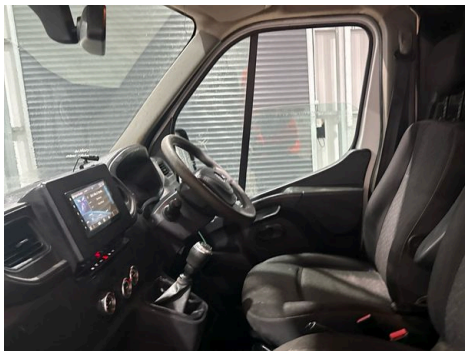
9:39
8°C
128803 miles
2498.2 miles
mph

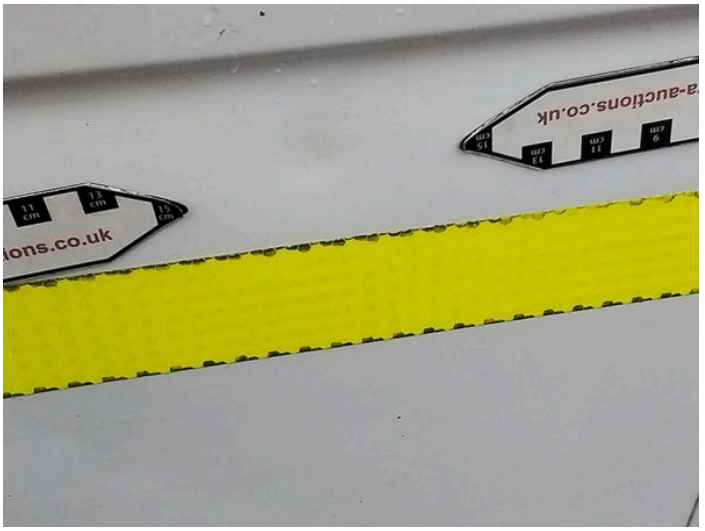
1: Bonnet
Chipped
Multiple Chips

2: Sill ns
Dented
With Paint Damage

3: Door nsf
Dented
With Paint Damage

4: Door Moulding nsf
Missing
Replace

5: Qtr Panel nsr
Scratched
Over 25mm Thru Paint

6: Qtr Panel nsr
Dented
Over 30mm

7: Qtr Panel nsr
Dented
With Paint Damage

8: Qtr Panel Moulding ns
Missing
Replace

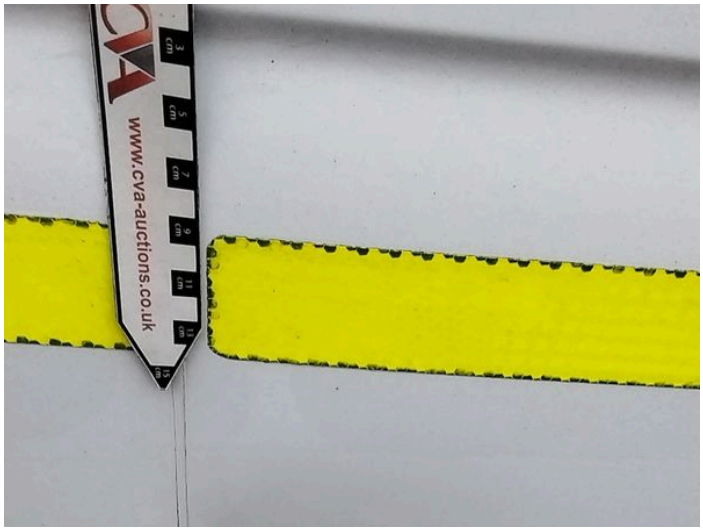
9: Qtr Panel nsr
Scratched
Over 25mm Thru Paint

10: Qtr Panel nsr
Scratched
Over 25mm Thru Paint

11: Qtr Panel nsr
Scratched
Over 25mm Thru Paint

12: Qtr Panel nsr
Dented
Over 30mm

13: Bumper Rear Moulding
Scuffed (Unpainted)
Over 100mm
